# Most Probable Stressor

## Lower MF Cunningham Creek

# X-TRIB TO NORTH FORK (NF) CUNNINGHAM CREEK

# LOWER NORTH FORK (NF) CUNNINGHAM CREEK

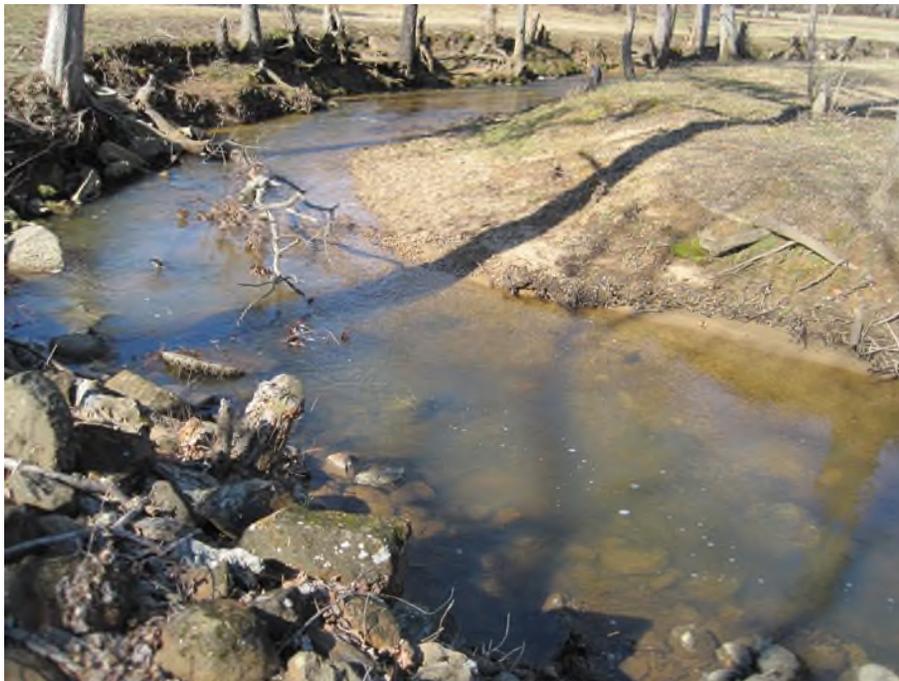
Downstream from 2-CNM001.75,  
March 2016

- **Most probable stressor currently:** sediment due to lack of riparian vegetation.

- Pro-Active Implementation is recommended
  - Upper MF: monitor benthics; check septics
  - Lower MF: install riparian vegetation; check for isolated bank stability issues
  - Lower NF: fix dam outlet erosion
  - X-trib to NF: stabilize areas near outlet; add a buffer to unknown livestock activity

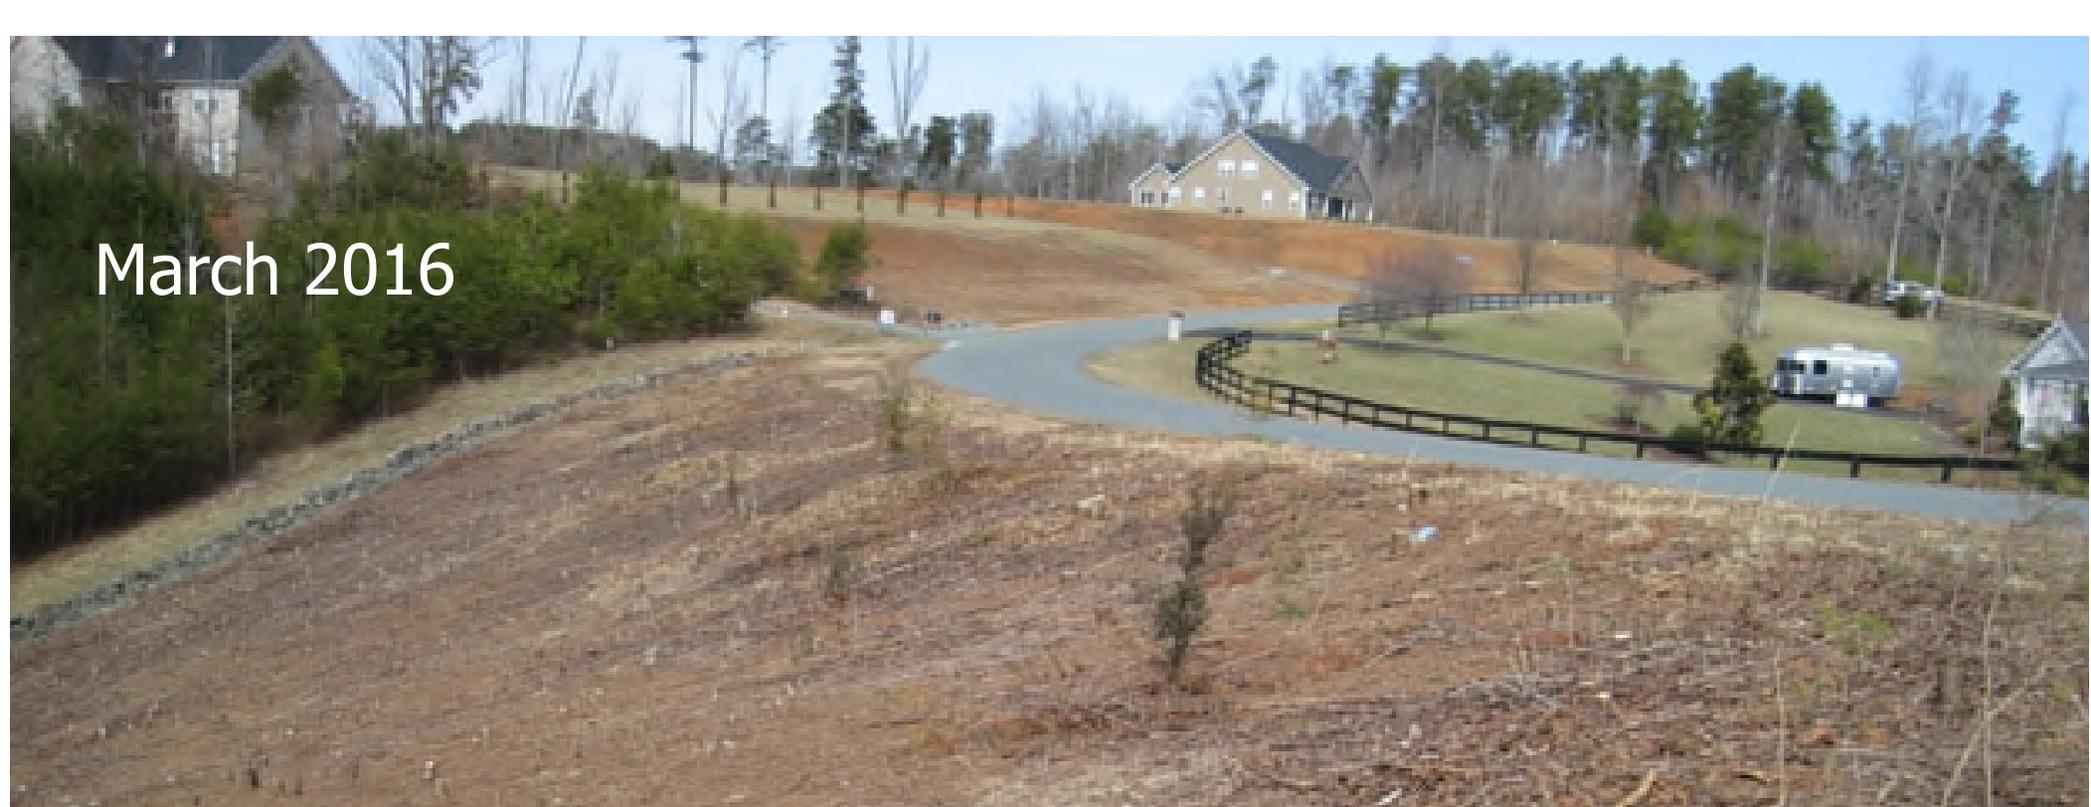
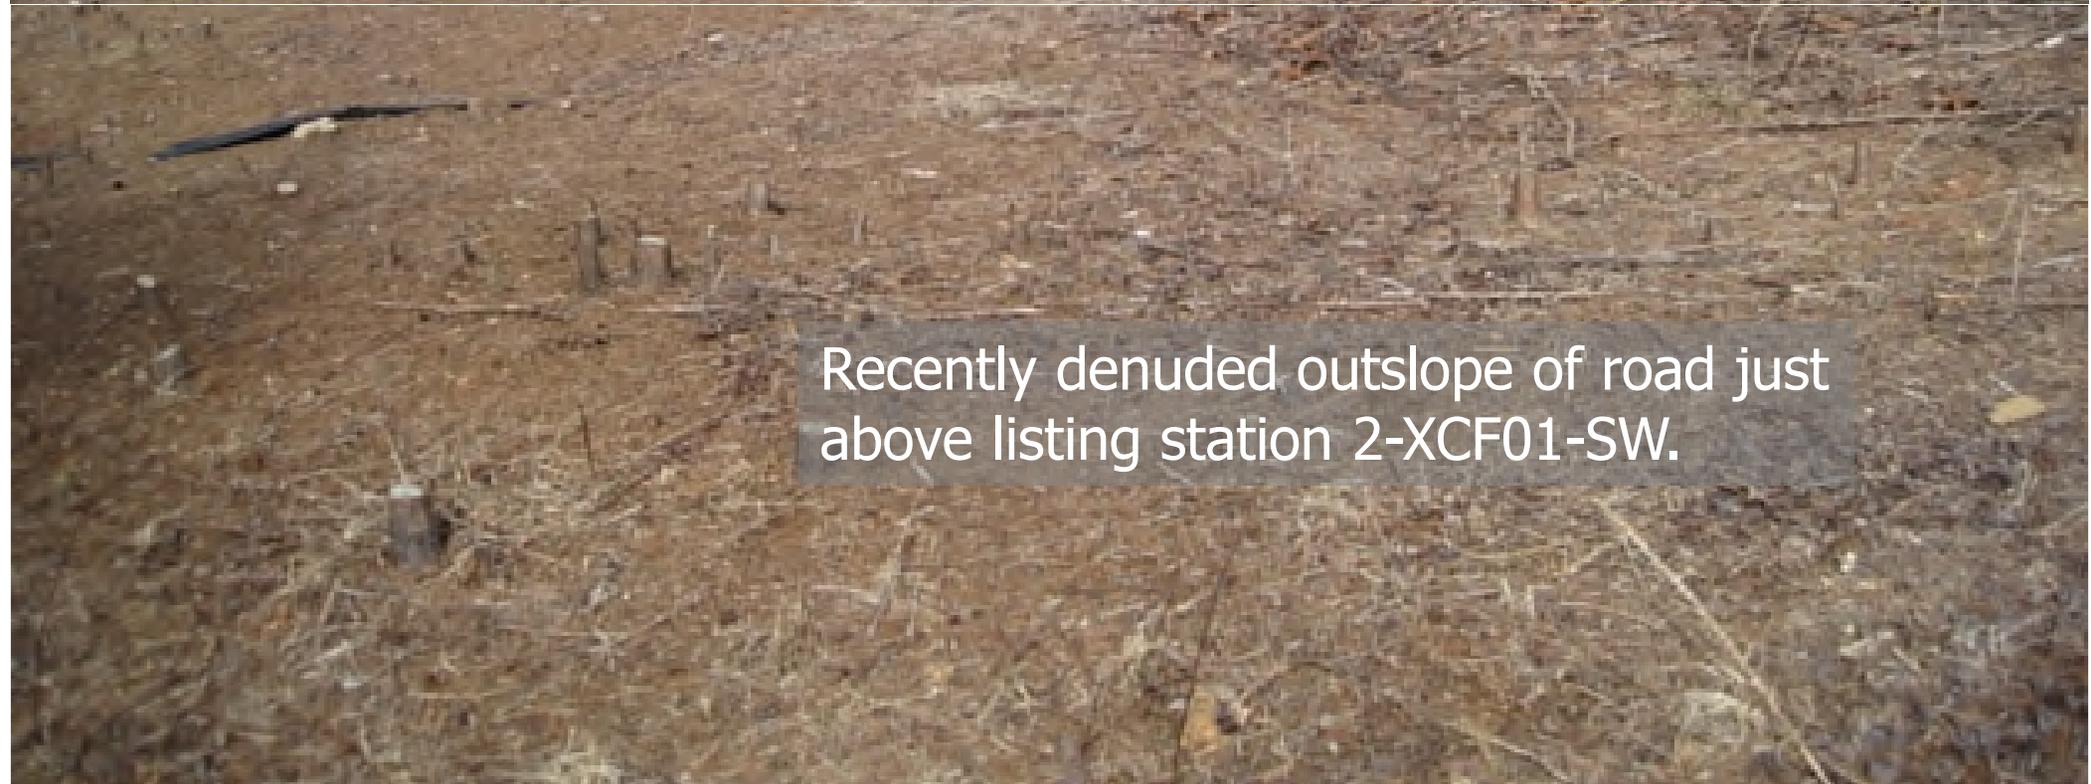
March 2016

Recently denuded outslope of road just above listing station 2-XCF01-SW.

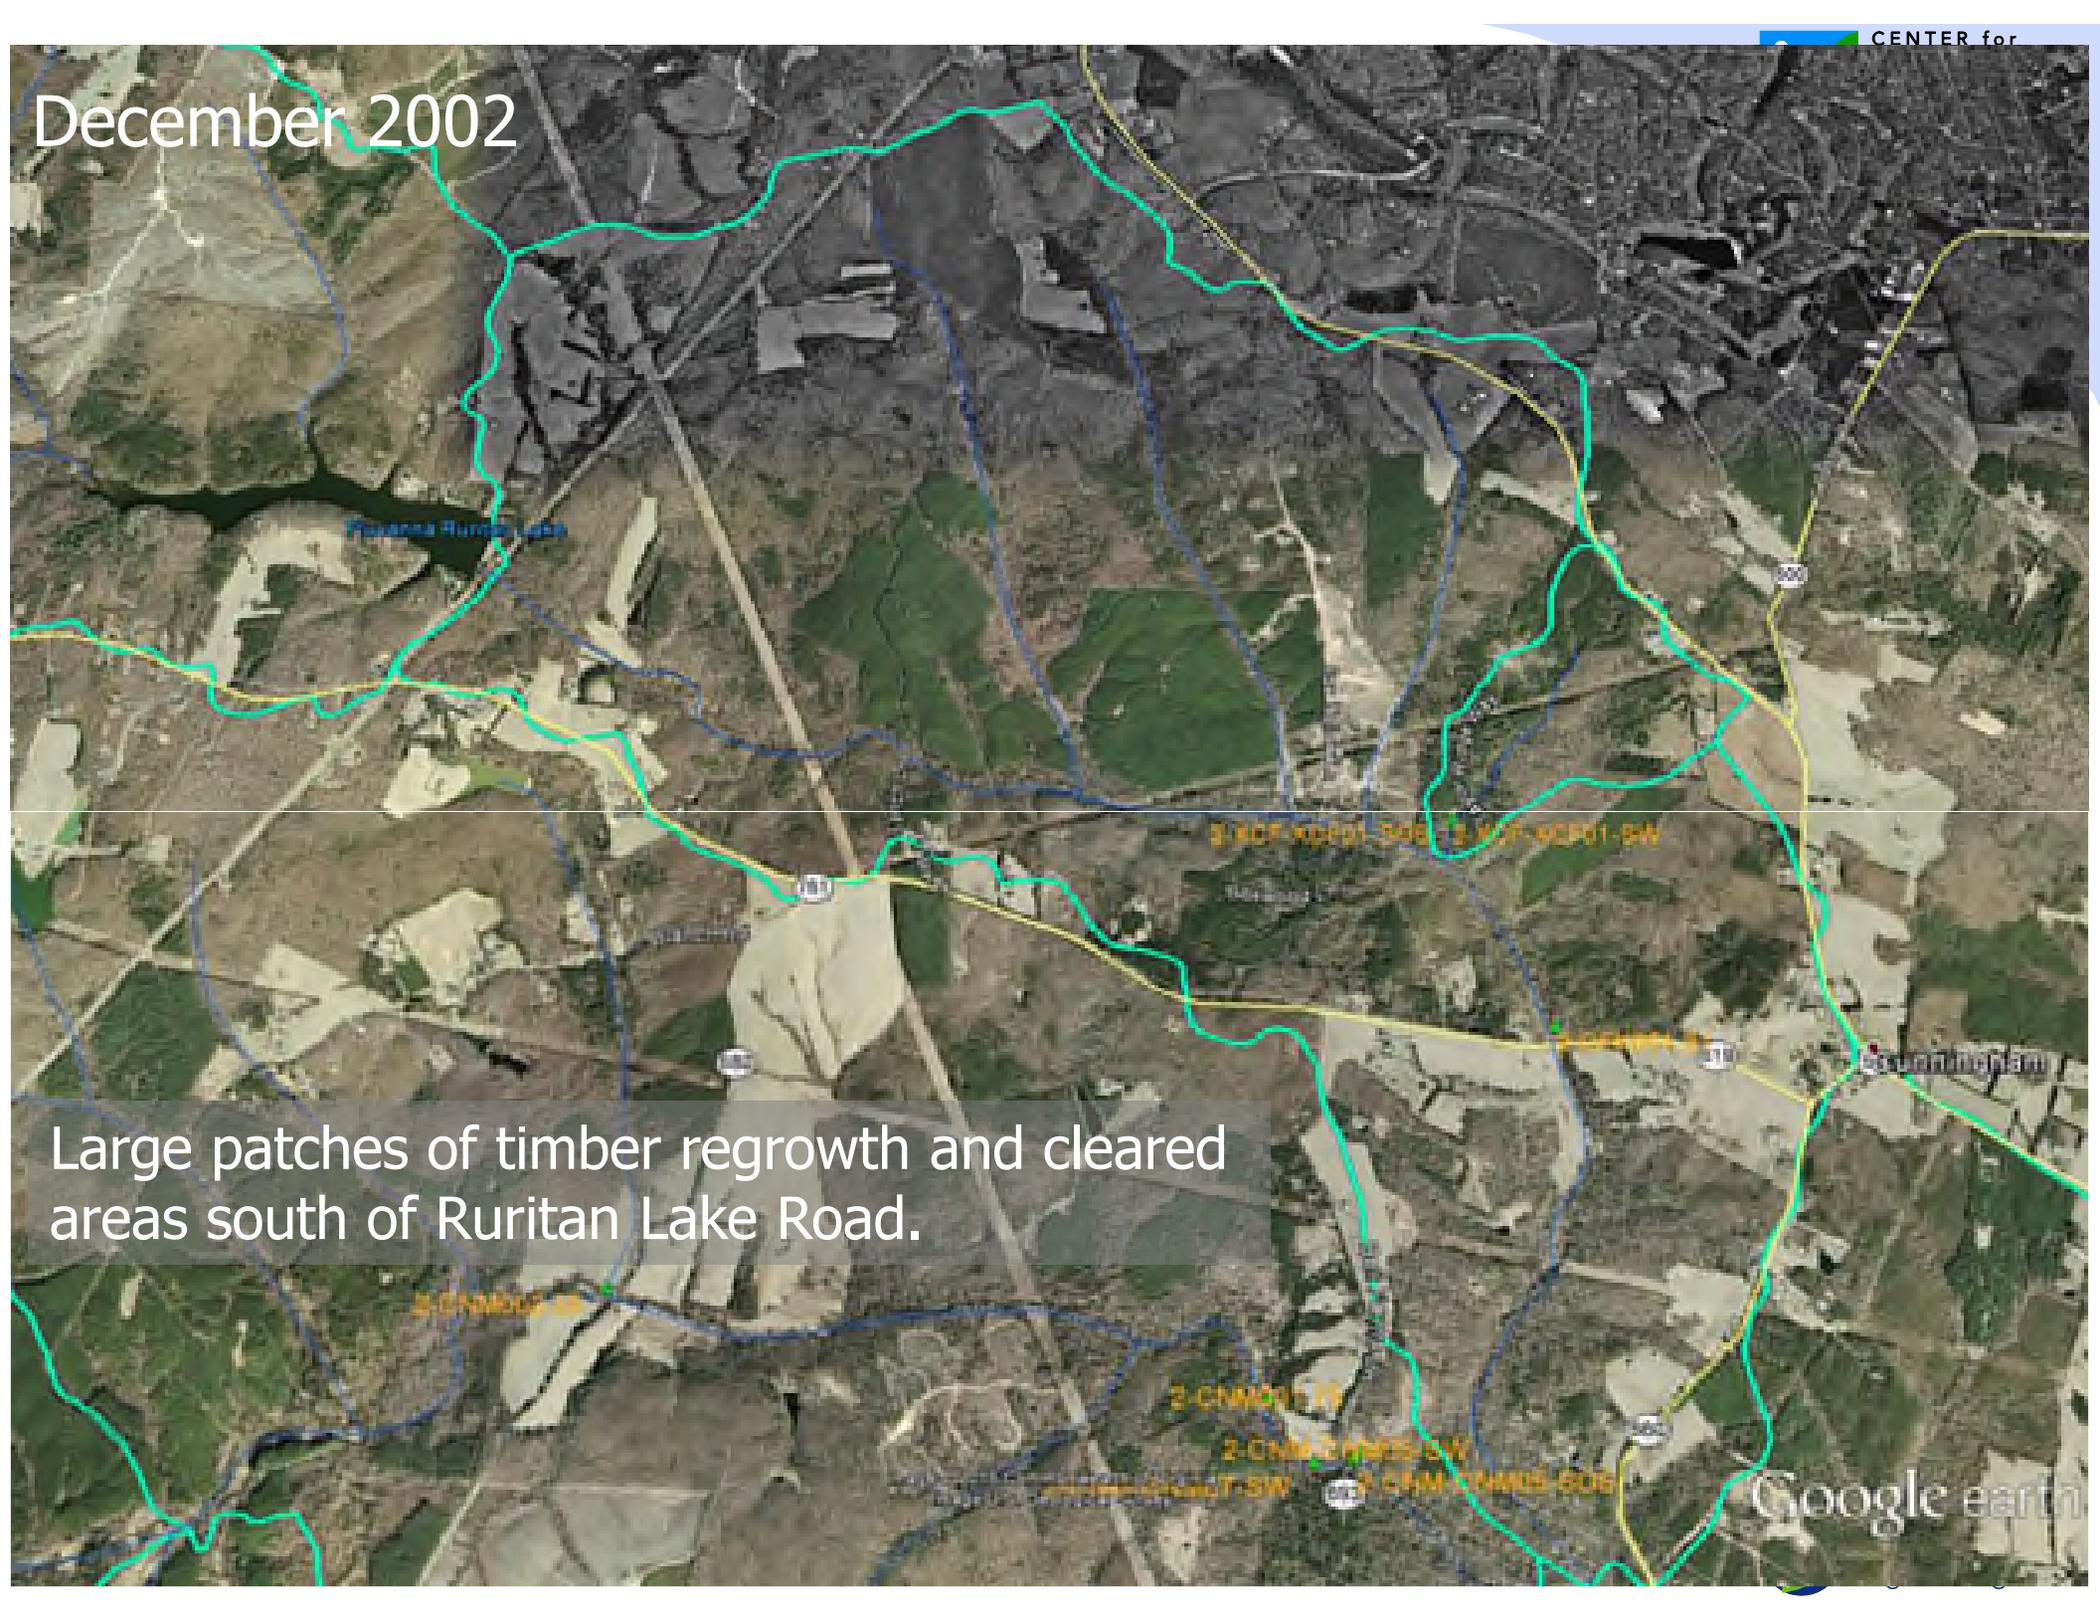
December 2002

Large patches of timber regrowth and cleared areas south of Ruritan Lake Road.

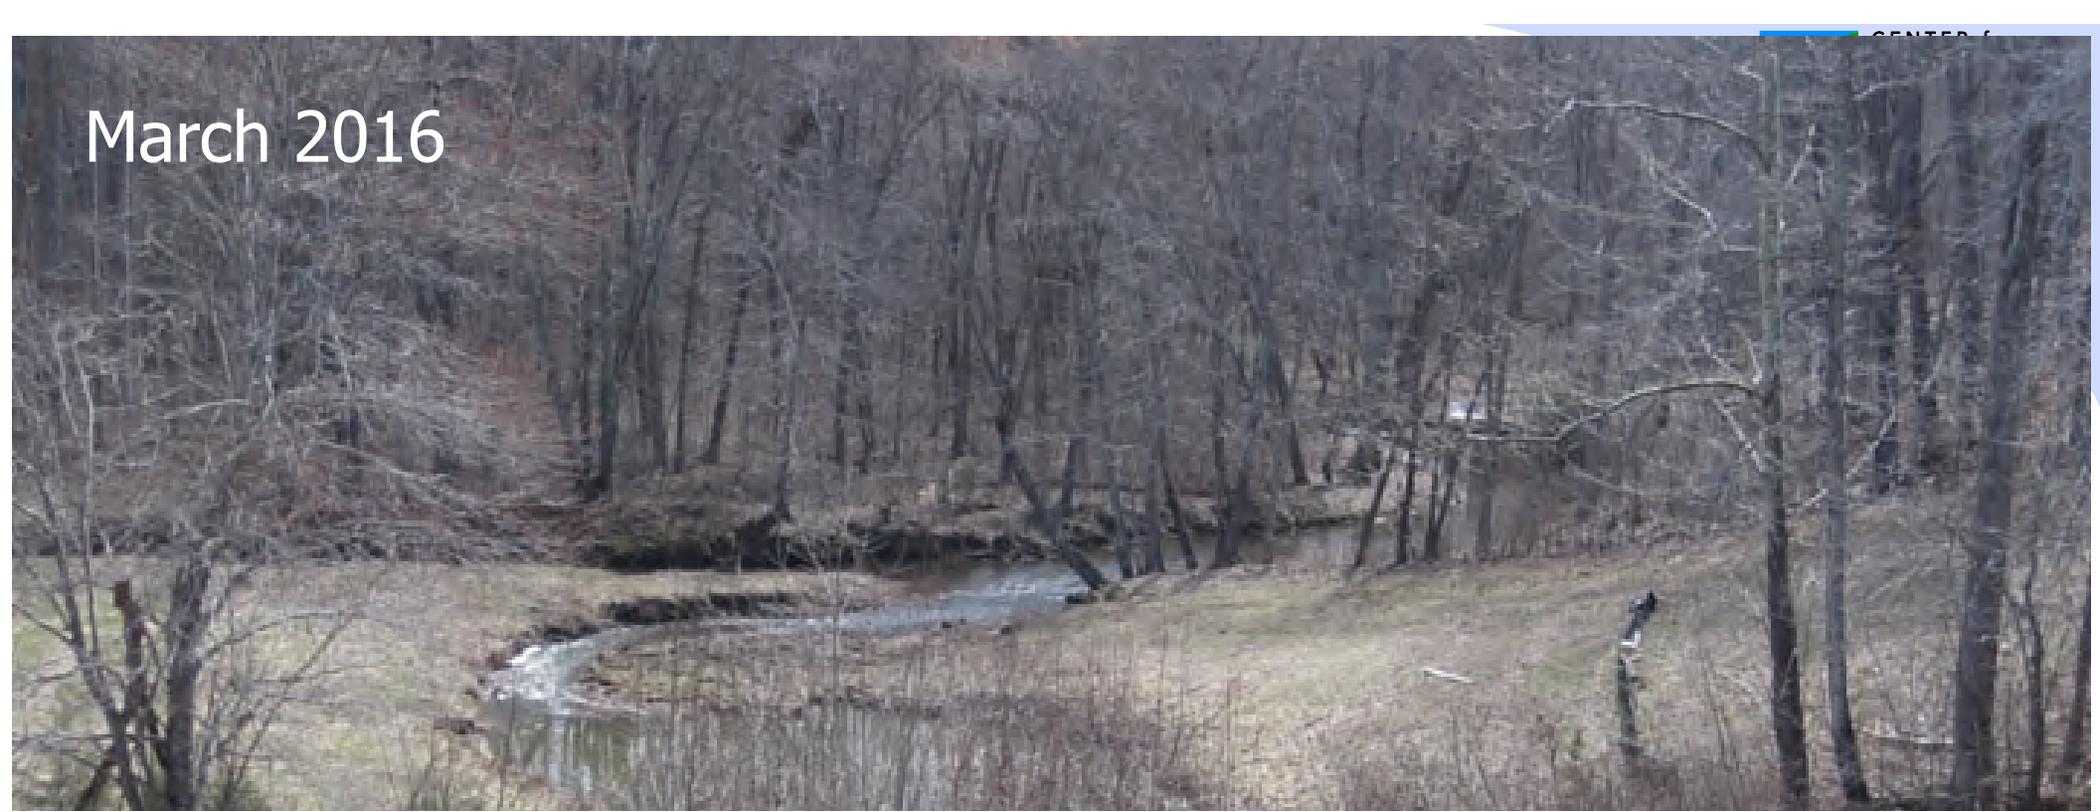
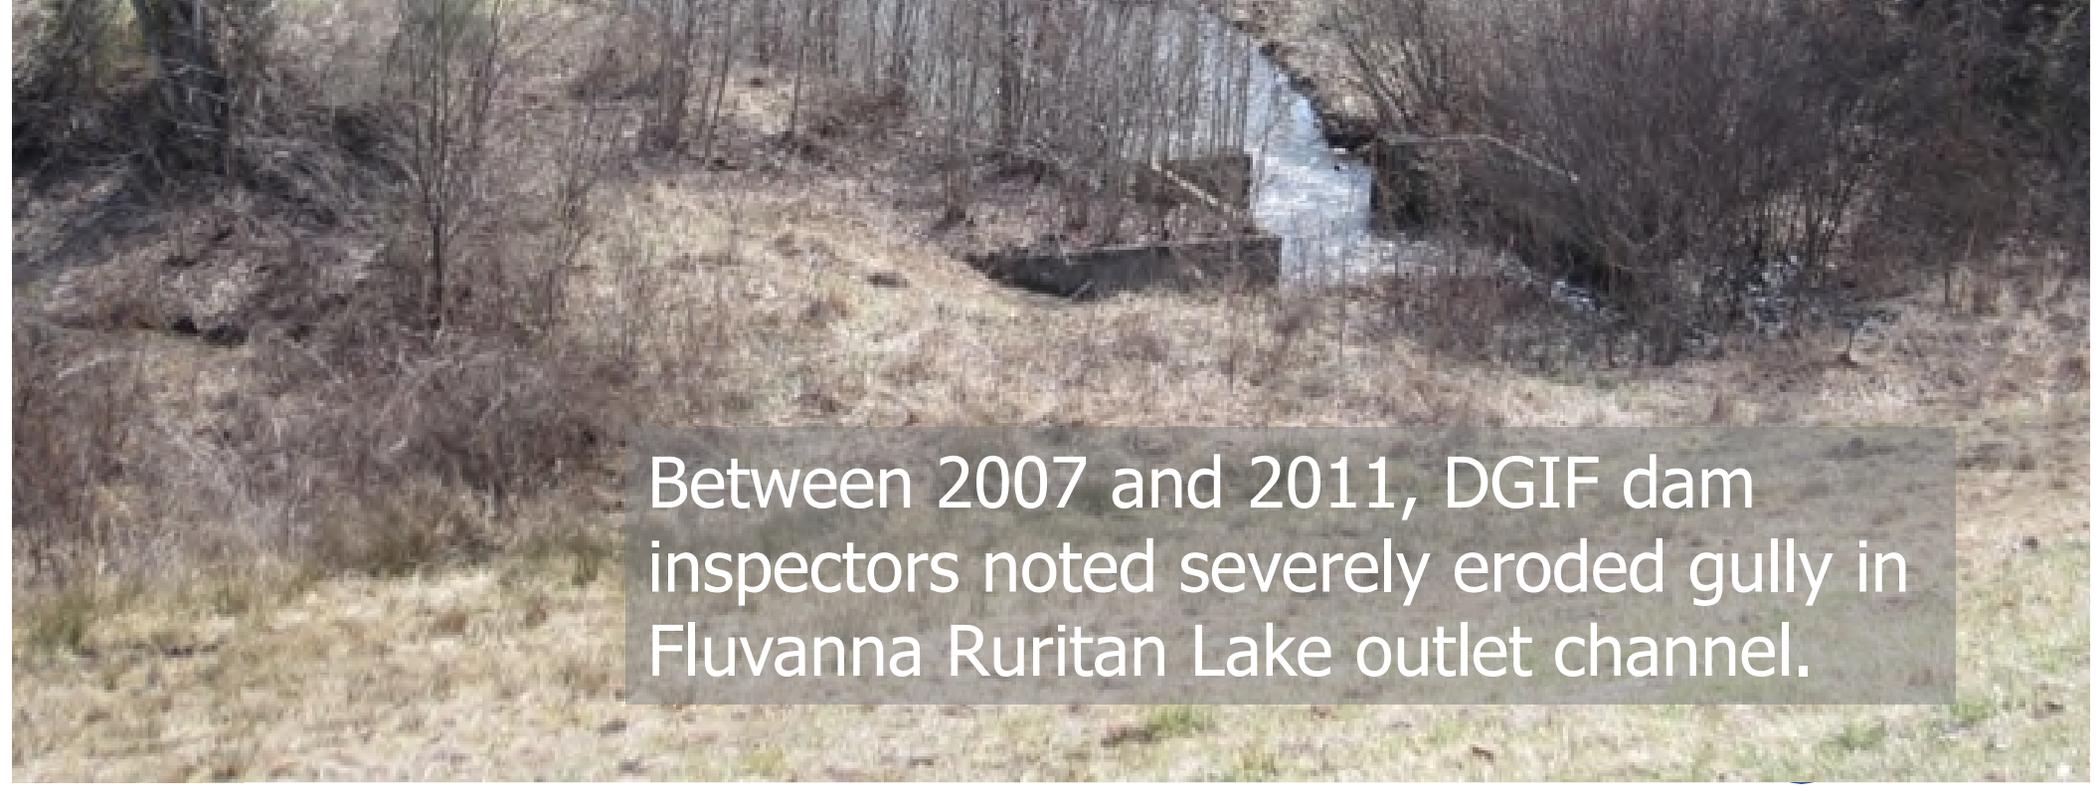
March 2016

Between 2007 and 2011, DGIF dam inspectors noted severely eroded gully in Fluvanna Ruritan Lake outlet channel.

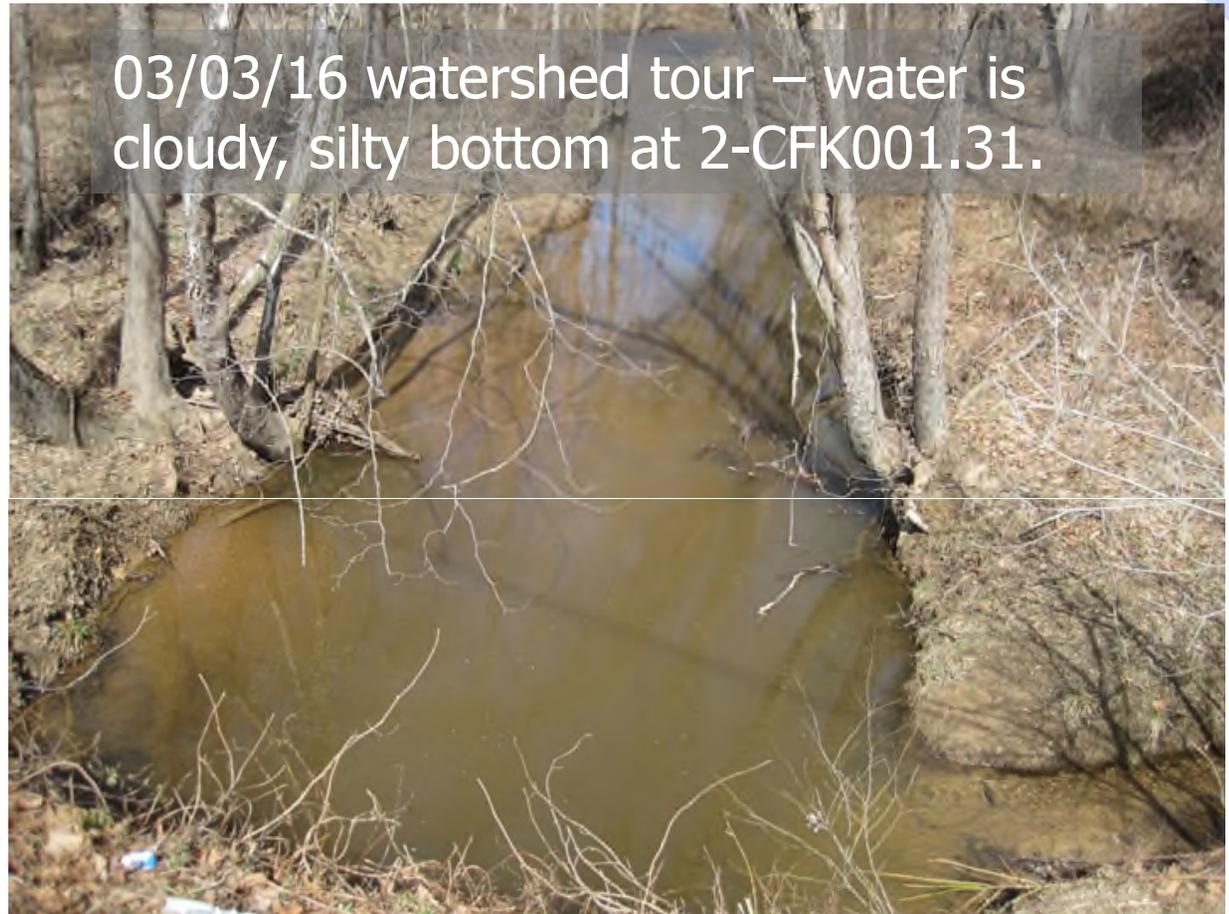
03/03/16 watershed tour – water is cloudy, silty bottom at 2-CFK001.31.

**Most probable stressor in 2012 and currently:**  
sediment from gully erosion near lake outlet, residential development, possibly some timber harvesting.

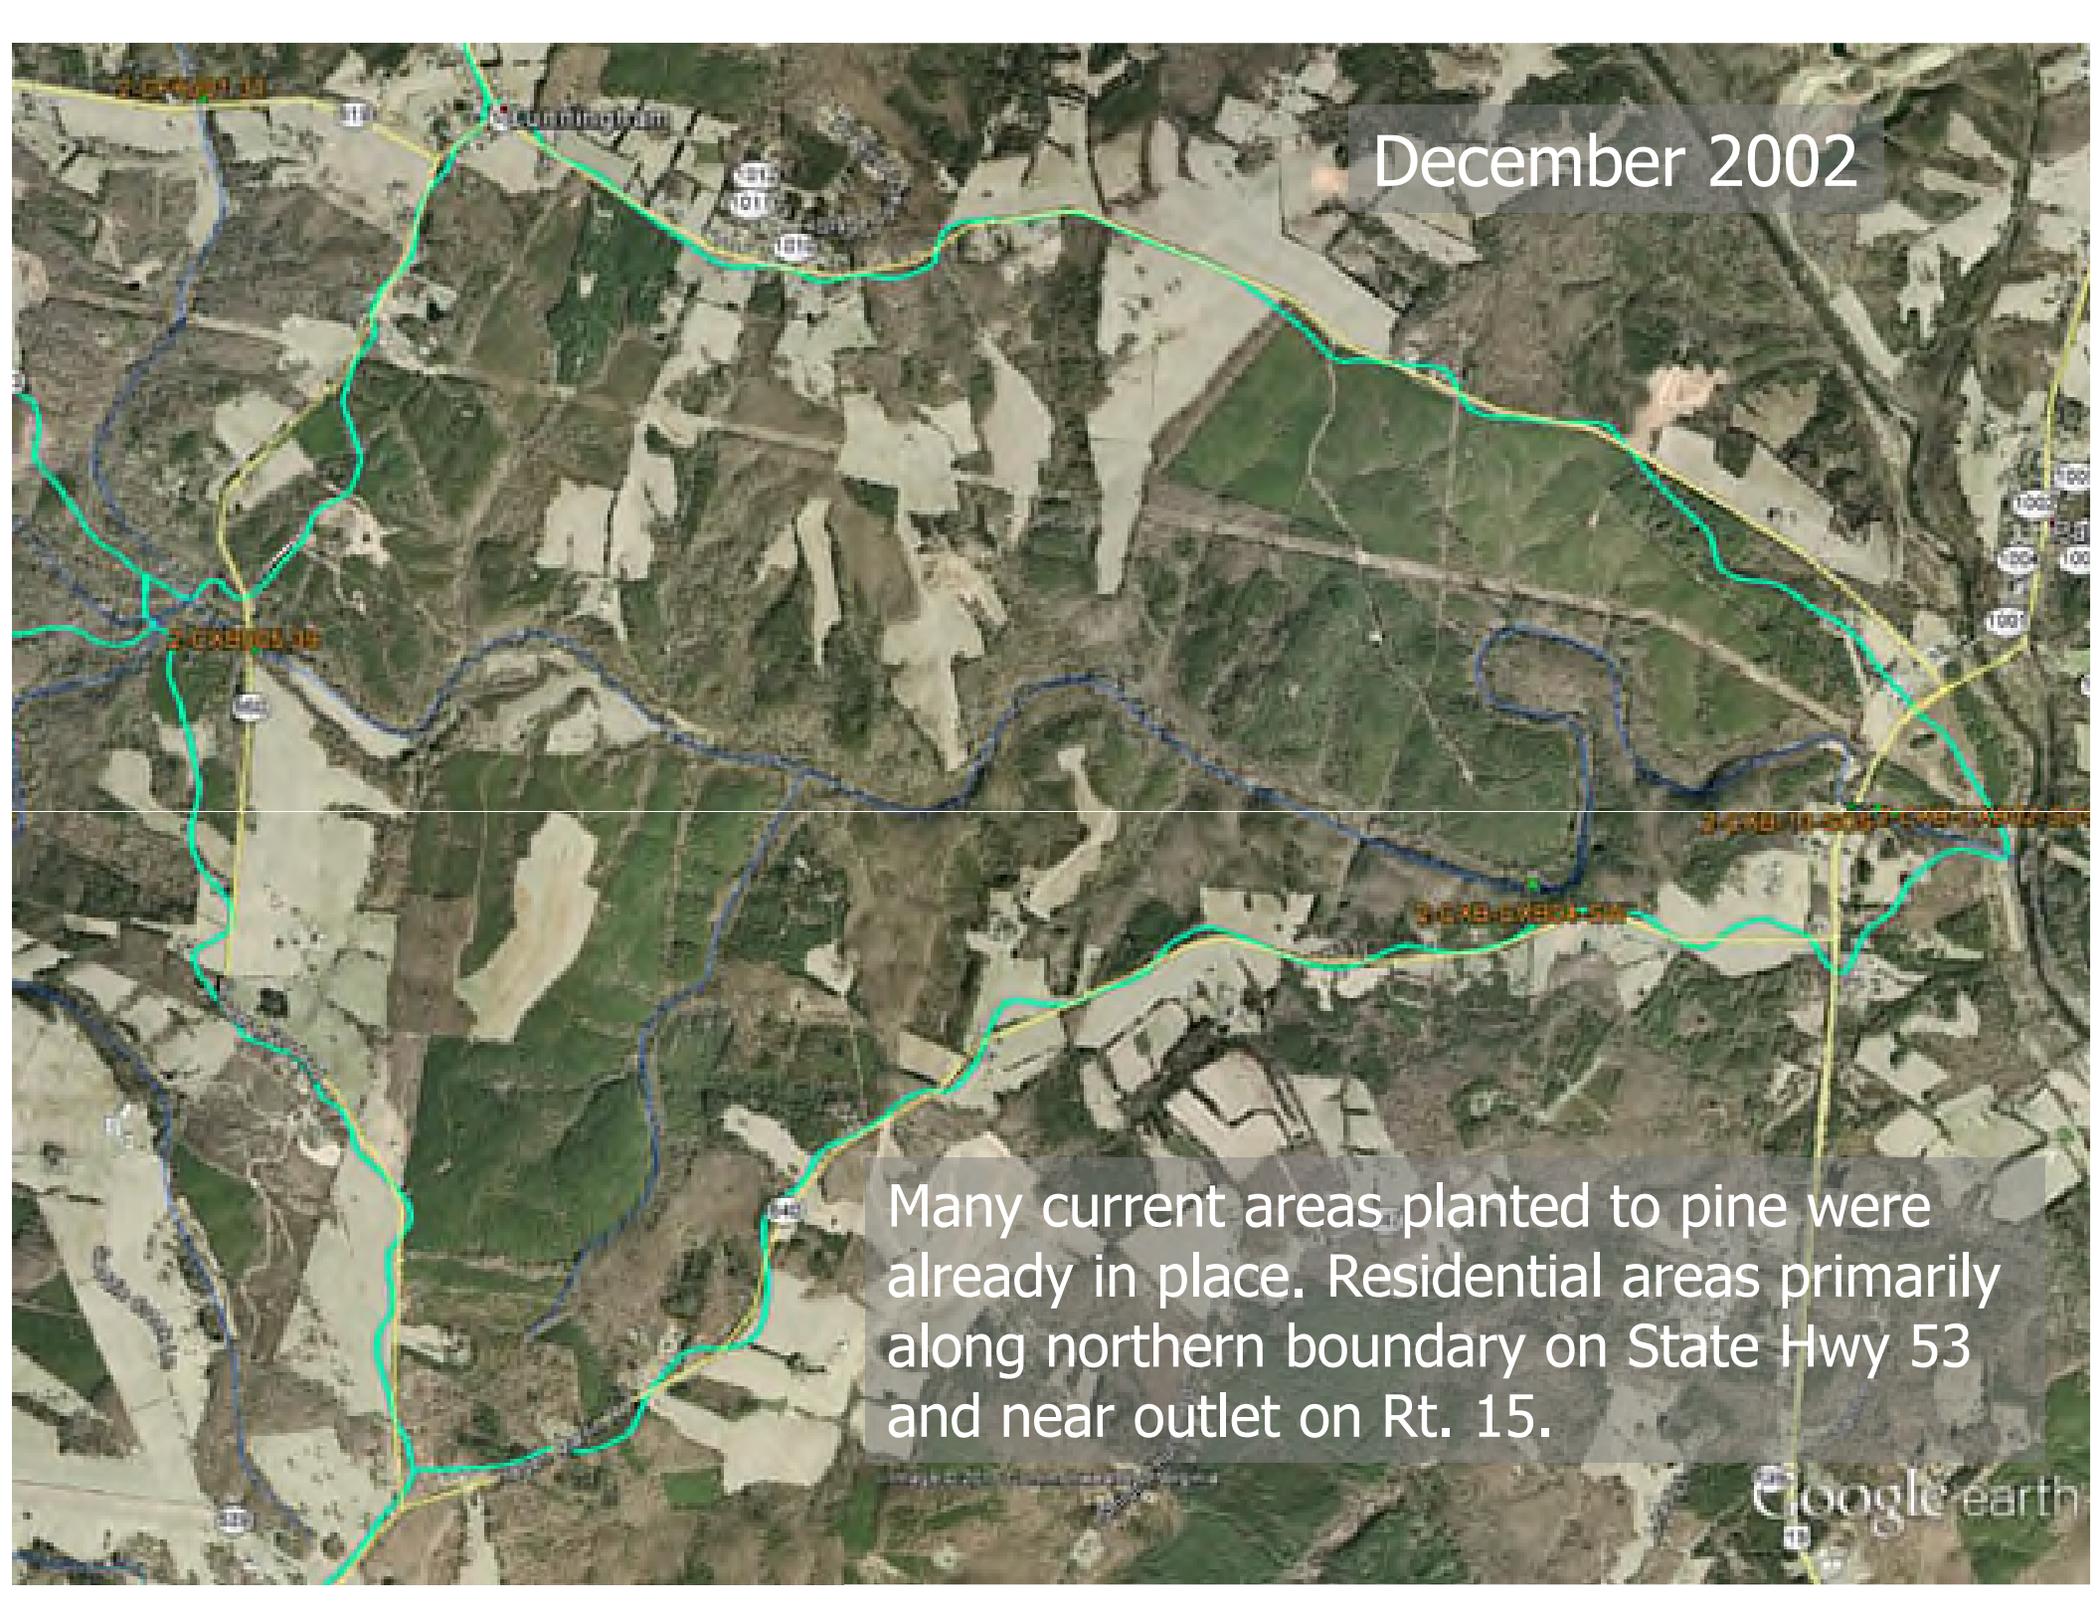
December 2002

Many current areas planted to pine were already in place. Residential areas primarily along northern boundary on State Hwy 53 and near outlet on Rt. 15.

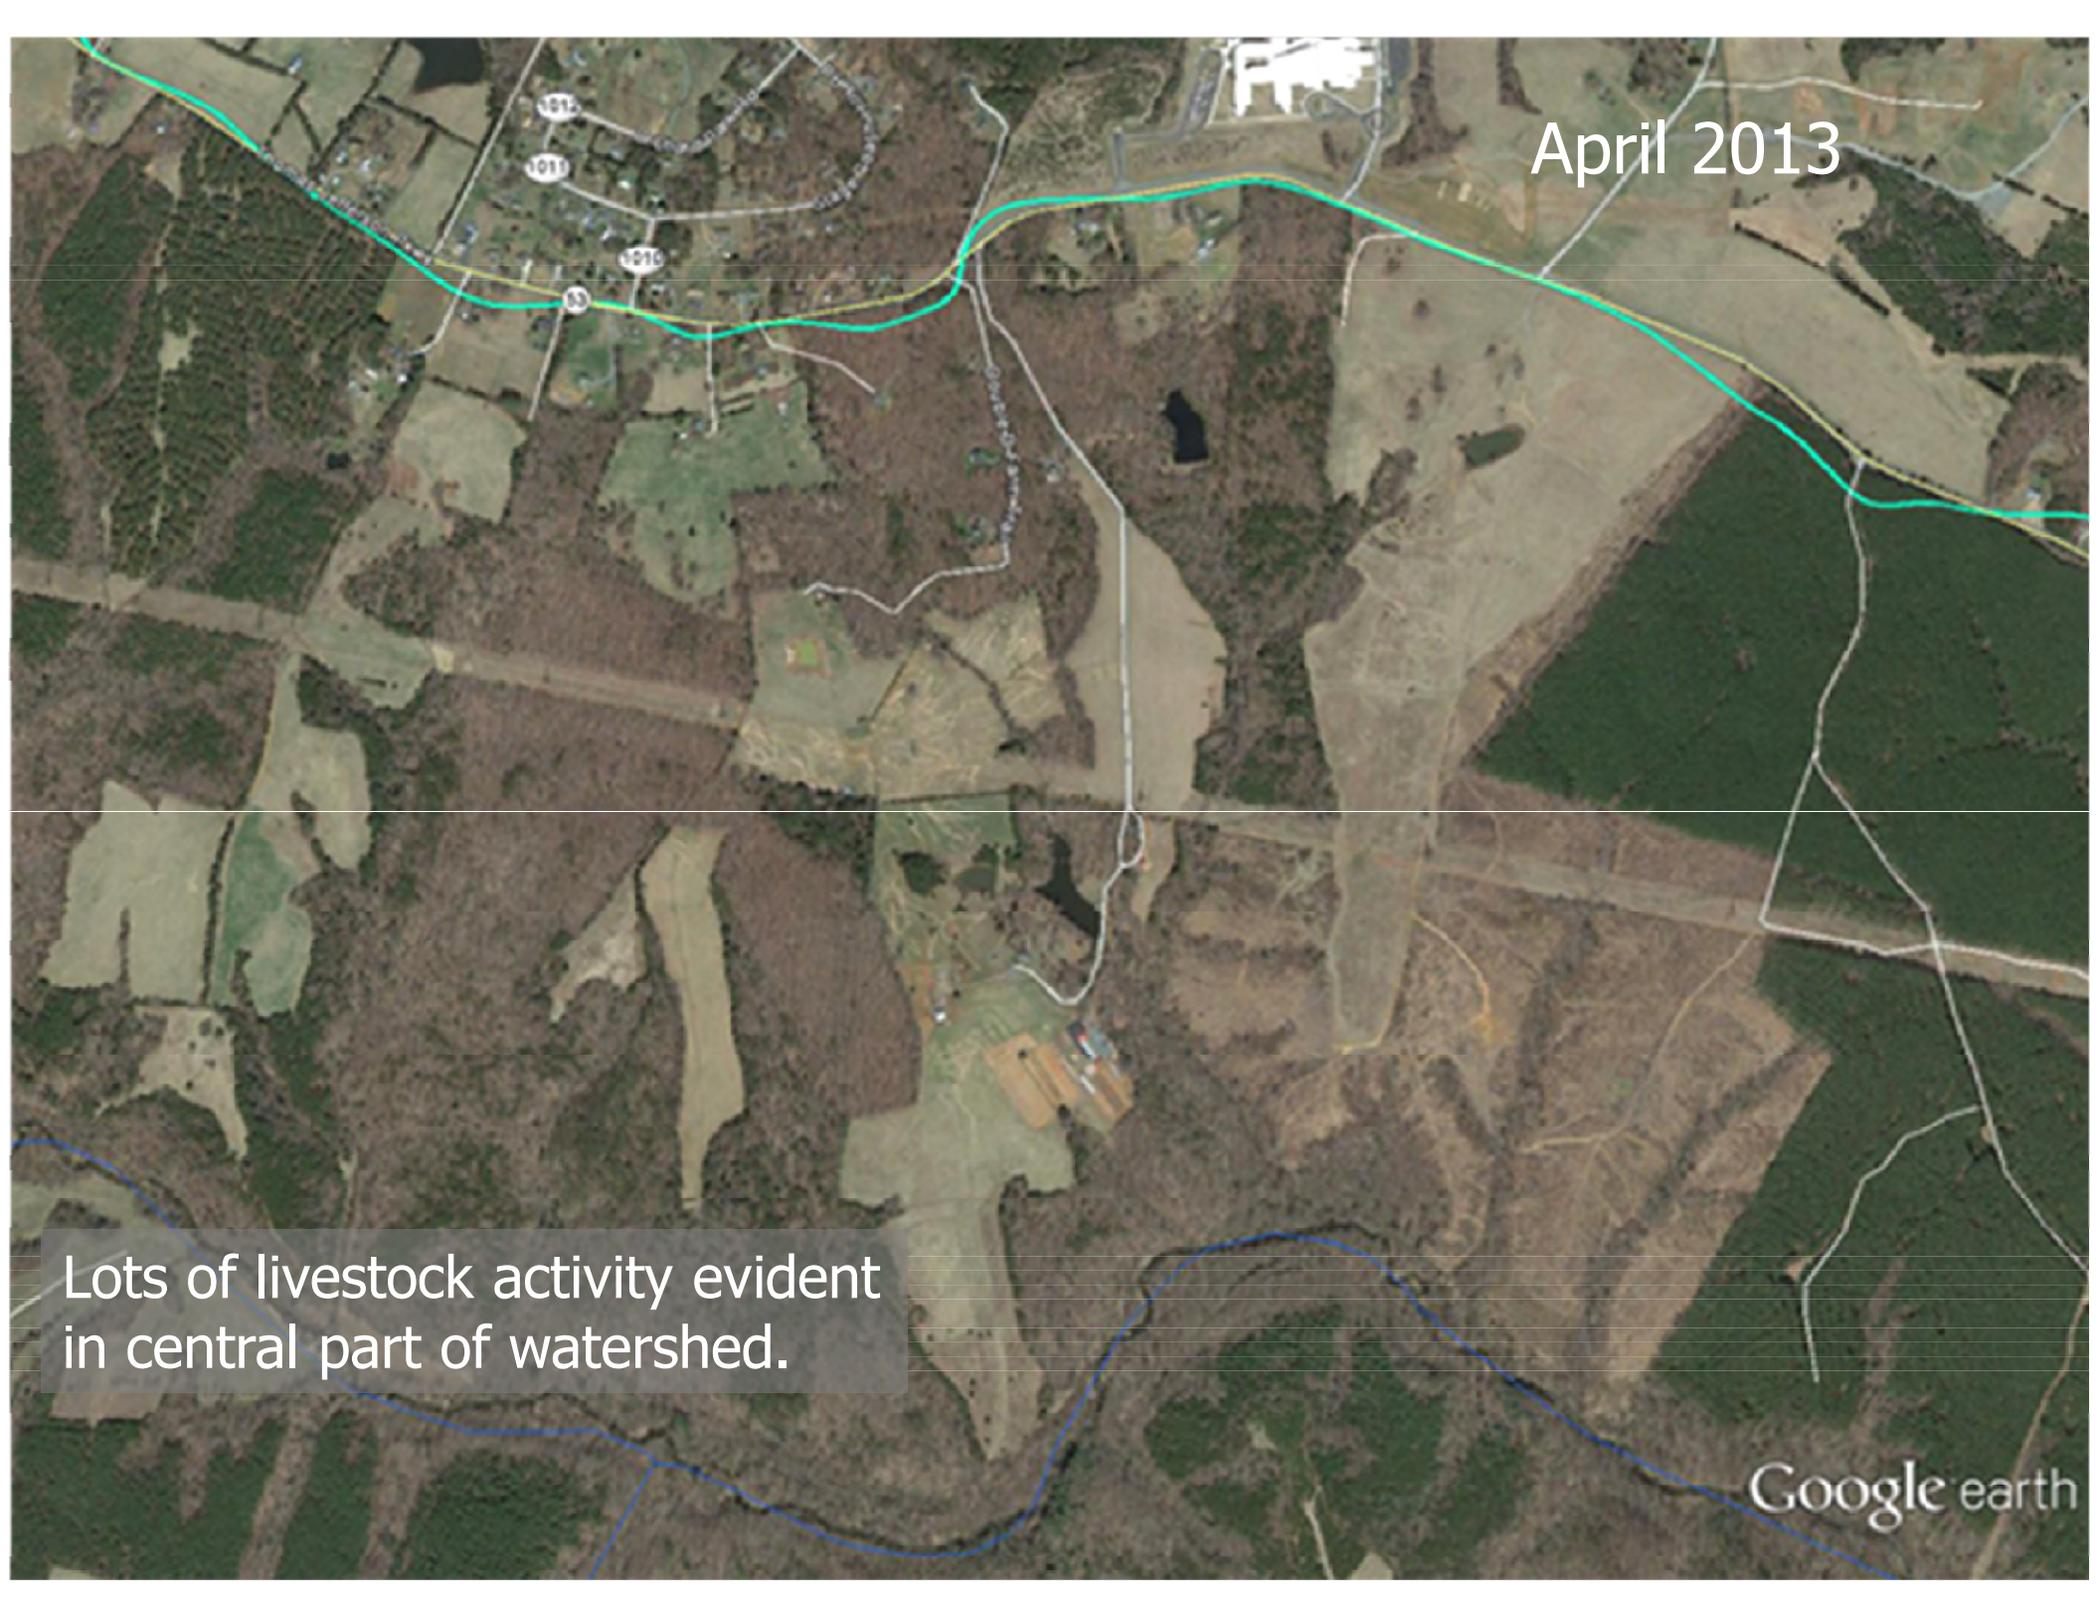
April 2013

Lots of livestock activity evident in central part of watershed.
