VWP FIELD INSPECTION CHECKLIST

Project Name	Mountain Valley Pipeline Spread H, Montgomery County	VWP Permit #	N/A	Inspection Date	6/26/2018
Inspector Name	Nathan Hughes; Matt Grant	Phone # & Email Address	(804) 698-4026; Nathan.Hughes@deq.virginia.gov (804) 418-9874; Matthew.Grant@deq.virginia.gov		
Address or lat/long (if no permit no.)	Catawba Road; 37°15'53.6"N, 80°18'30.8"W Stream Crossing #39 and #40	Others Present During Inspection	N/A		
Project Phase	Land Clearing; Grading	Reason for Inspection	Complaint		
PERMIT / REGULATORY REQUIREMENT		Yes/ No/ NA	Location, Description and Other Notes		
Unauthorized impacts to surface waters, including wetlands, or upland preservation areas have occurred .* <i>(This includes sedimentation impacts due to inadequate or failed erosion controls.)</i>		Yes	Approximately 2,200 linear feet (comprising 2 separate streams) have been impacted by sedimentation		
Non-impacted wetlands, streams and preservation areas within 50 feet of construction are clearly marked to prevent unpermitted impacts.		N/A	Impacted streams are located greater than 50 feet from project's LOD

Site Name: Mountain Valley Pipeline_Spread H south of Catawba Road

Date: 6/26/2

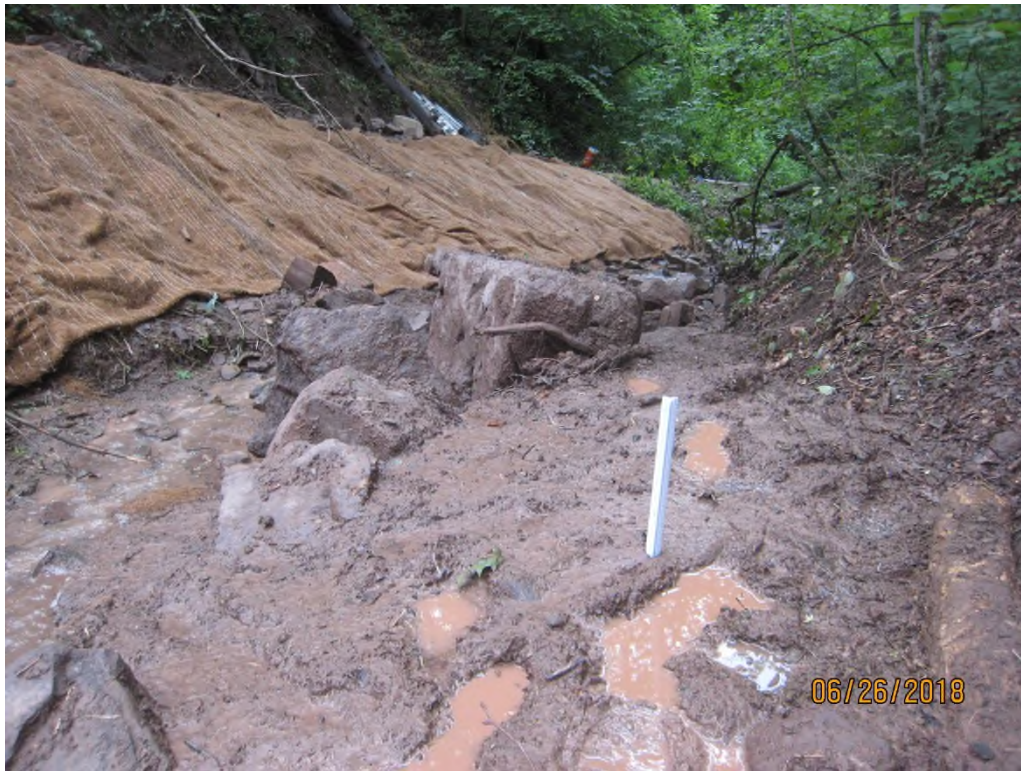
Approximately 2,200 linear feet of stream channel contained sediment ranging from 1-inch to a maximum depth of 5-inches was observed. Sediment within the stream's thalweg was generally <1-3 inches in depth; sediment bars and pool deposition was generally 1.5-5 inches in depth.

Photo 1: Sedimentation within "Stream 39" ~25' downstream of LOD
Orientation: Downstream

1. Repair erosion and sediment controls in areas where needed;
2. Stabilize all slopes above and below perimeter controls;
3. Remove sediment from impacted stream channels using hand removal methods (buckets and shovels) and stabilize with appropriate seed mix where applicable.

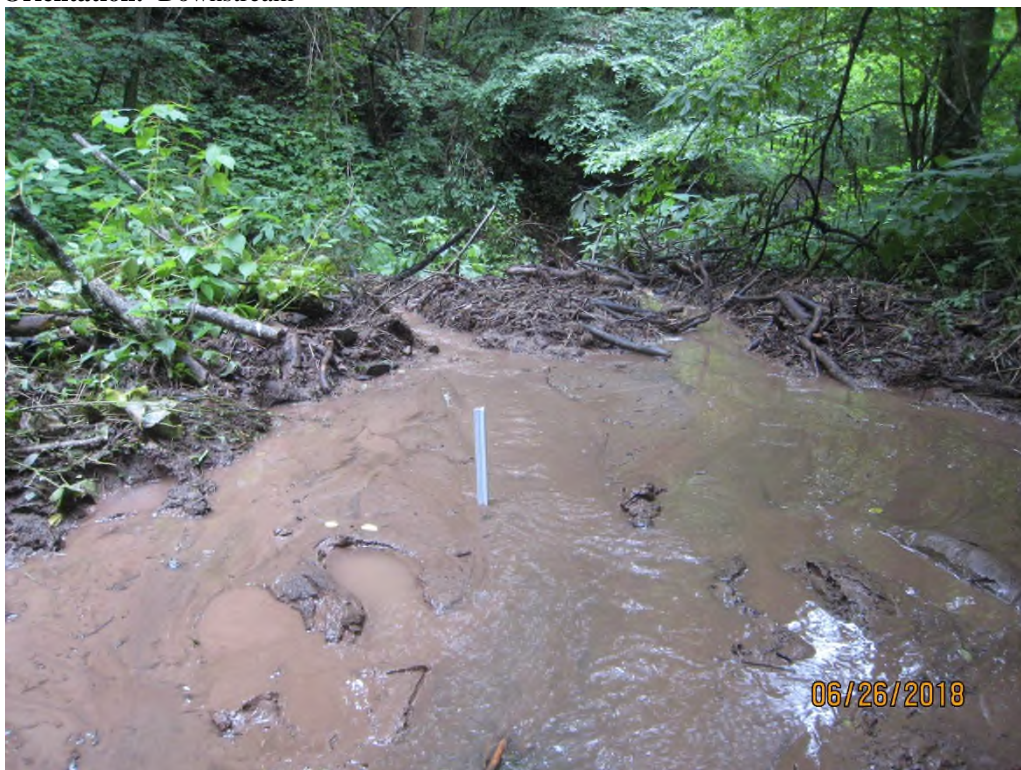
Photo 2: 4.5' of sediment at debris dam ~210' from Photo 1
Orientation: Downstream

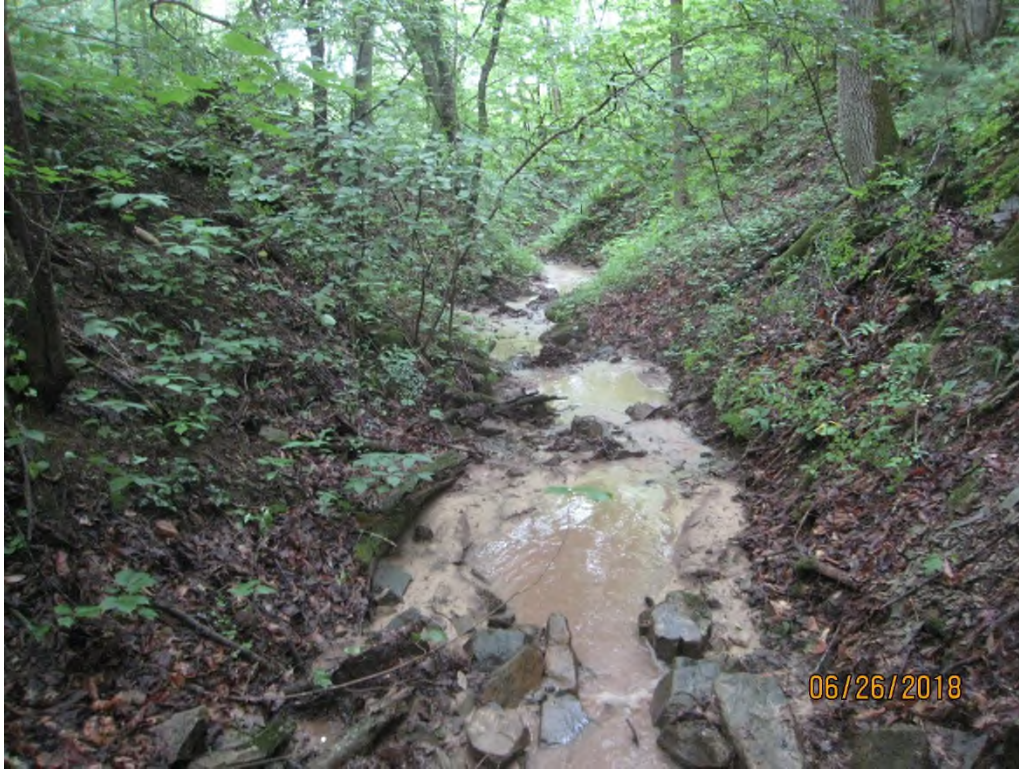
Photo 3: Sediment in stream at confluence with "Stream 40" ~265' downstream of Photo 1
Orientation: Downstream

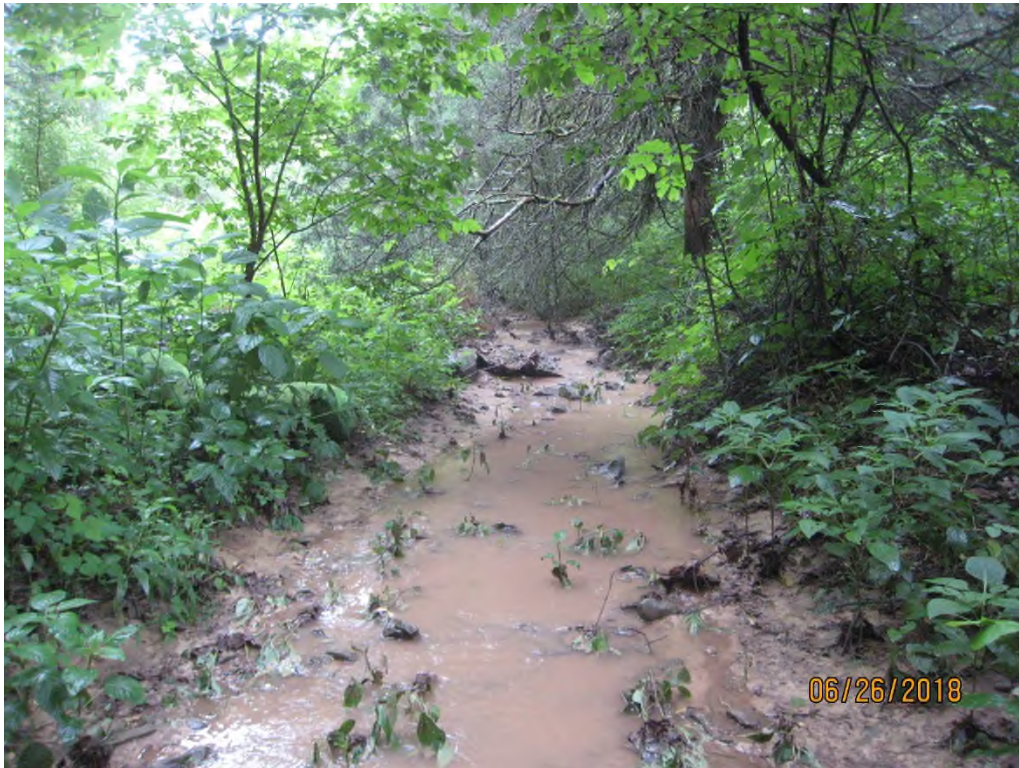
Photo 4: Sediment in stream ~1,325' from Photo 1
Orientation: Upstream
