APPENDIX H

Seep Investigation Photograph Log

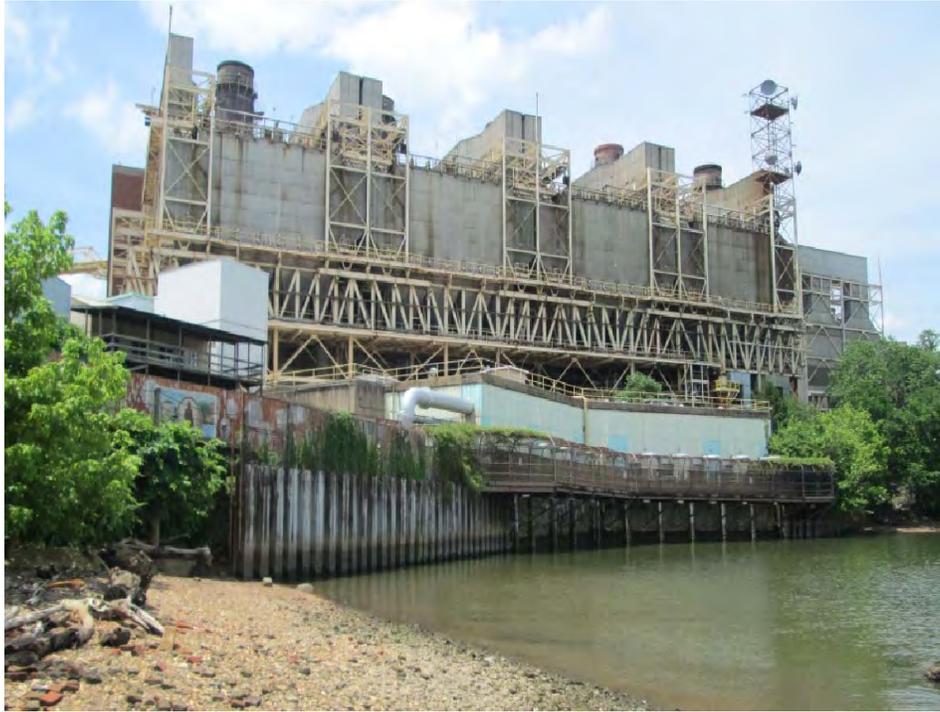
Picture 1.- View of PRGS sheet-pile bulkhead from south beach area facing north

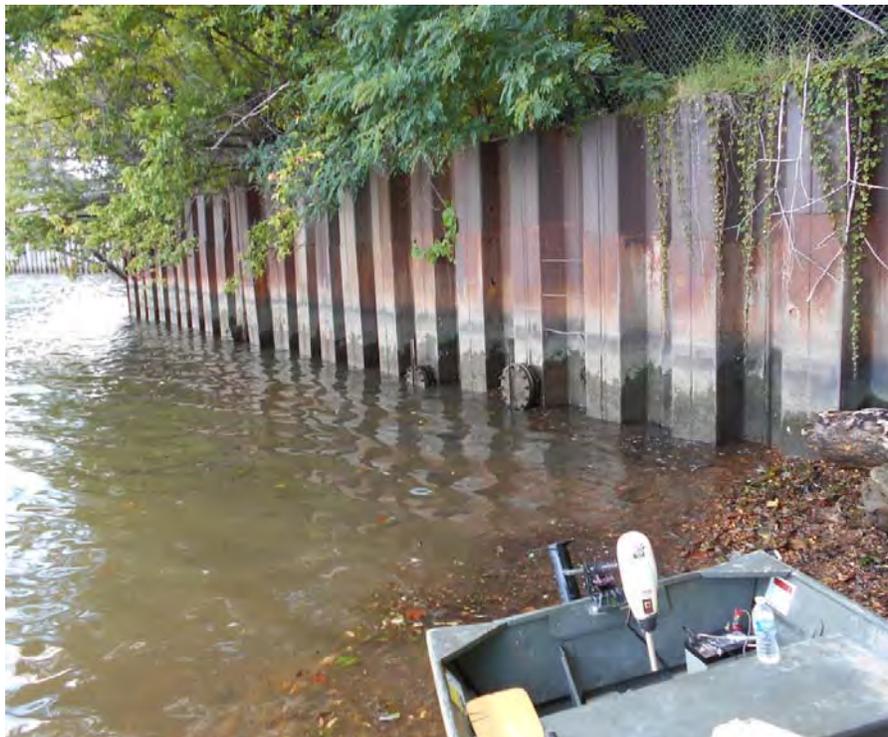
Picture 2. - View of PRGS sheet-pile bulkhead from north beach area facing south

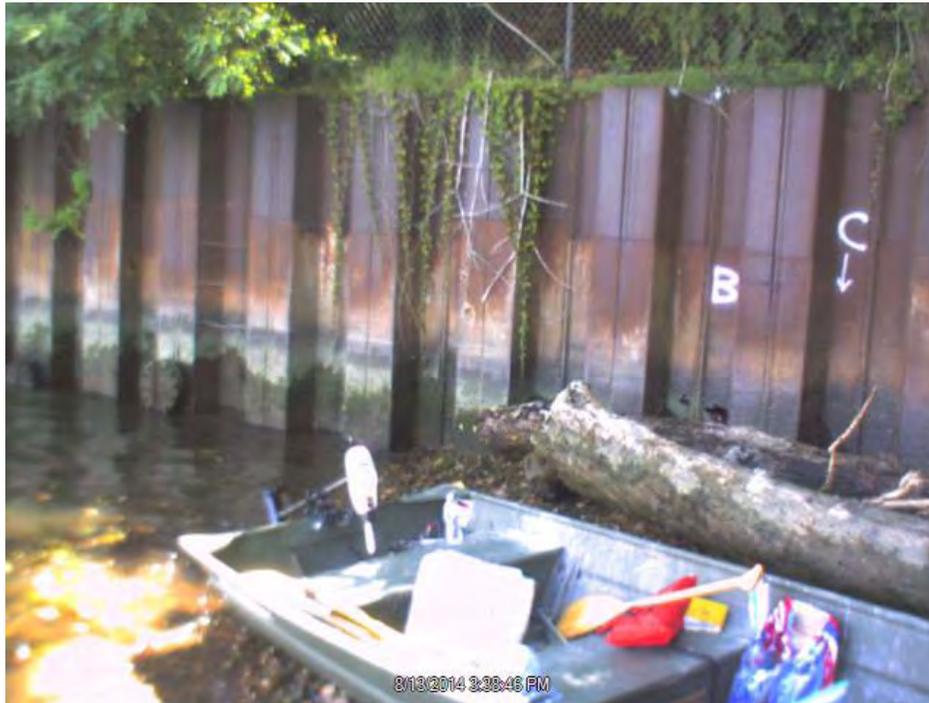
Picture 3. - View of PRGS sheet-pile bulkhead noting position of Seep B and Seep C

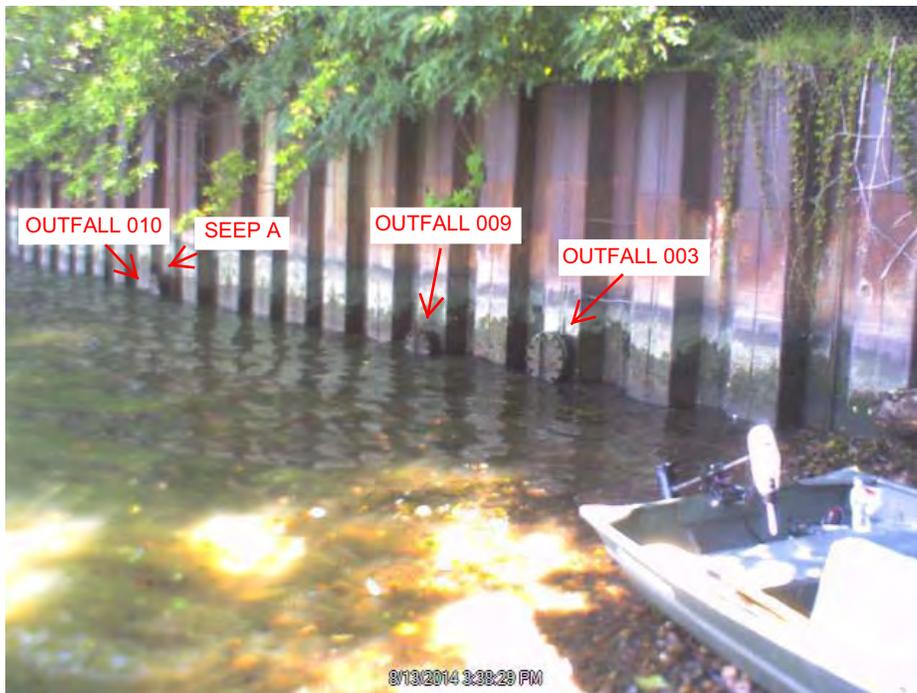
Picture 4. - View of north-side PRGS sheet-pile bulkhead noting position of Outfalls 003, 009, 010 and Seep A locations

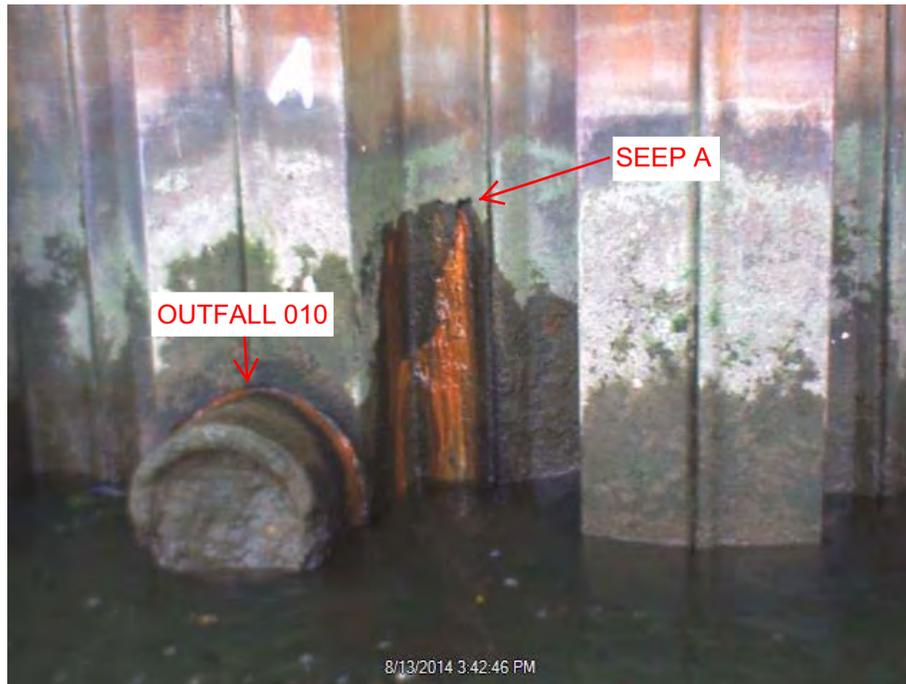
Picture 5. - View of Outfall 010 and adjacent Seep A

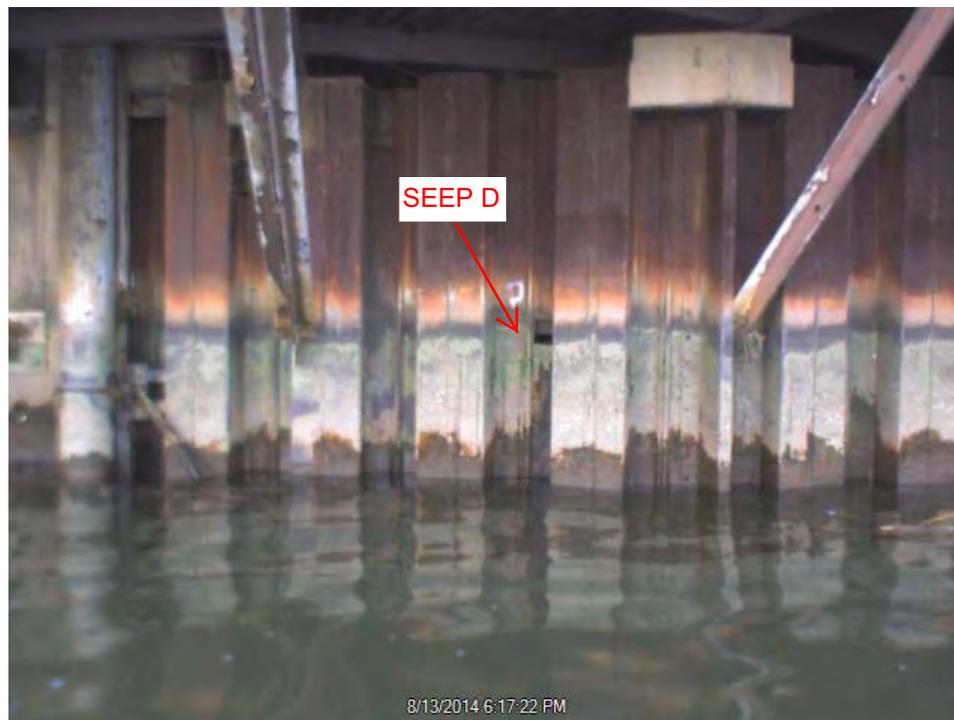
Picture 6. - View of Seep D located on north-side bulkhead section approaching concrete wall of Screen House

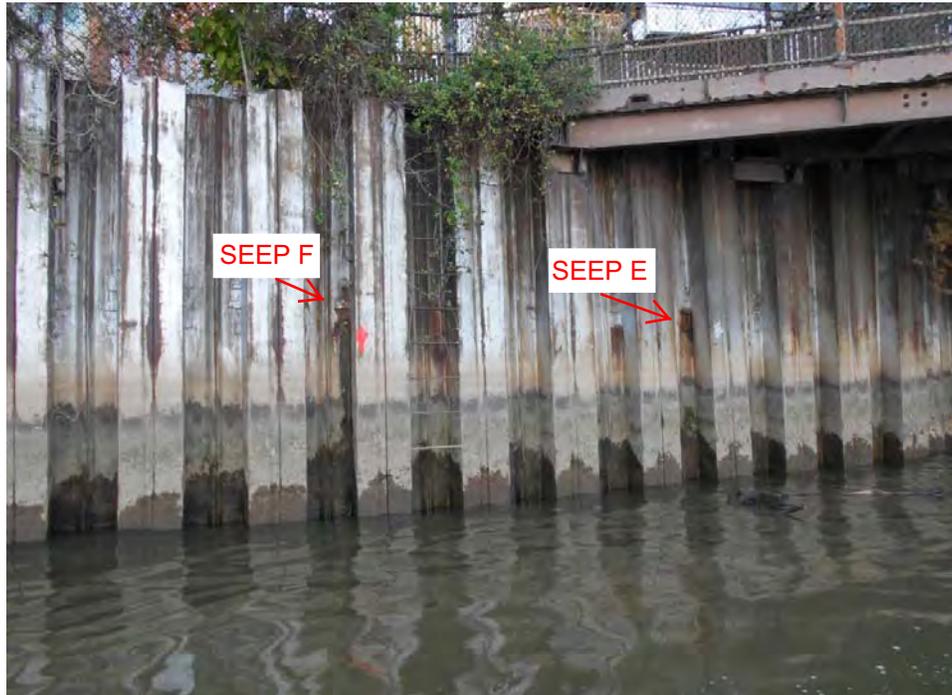
Picture 7.- View of south-section of PRGS sheet-pile bulkhead facing north, noting position of Seep E and Seep F.

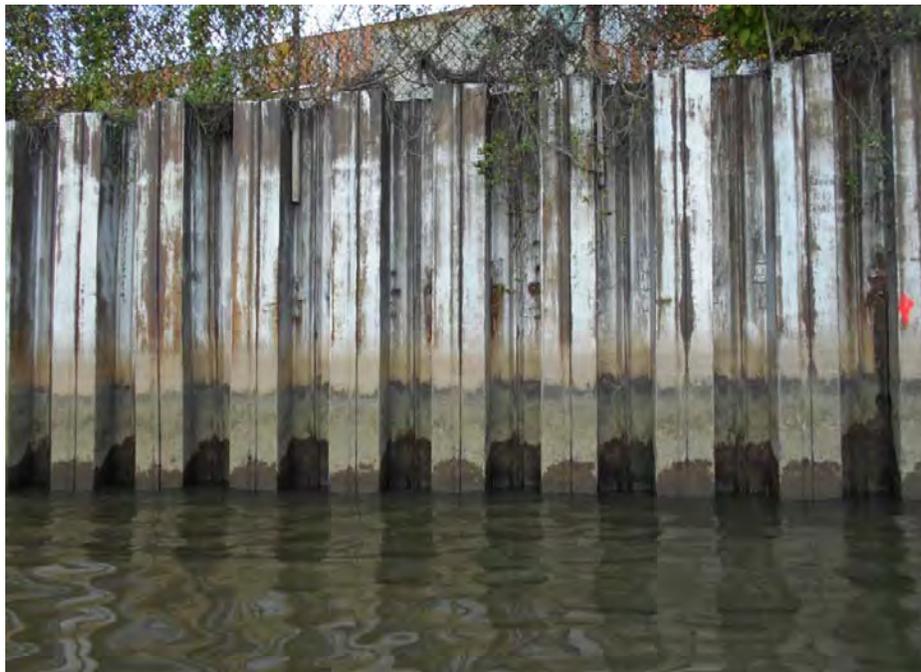
Picture 8.- View of south-section of PRGS sheet-pile bulkhead, noting area south Seep F approaching south beach area.

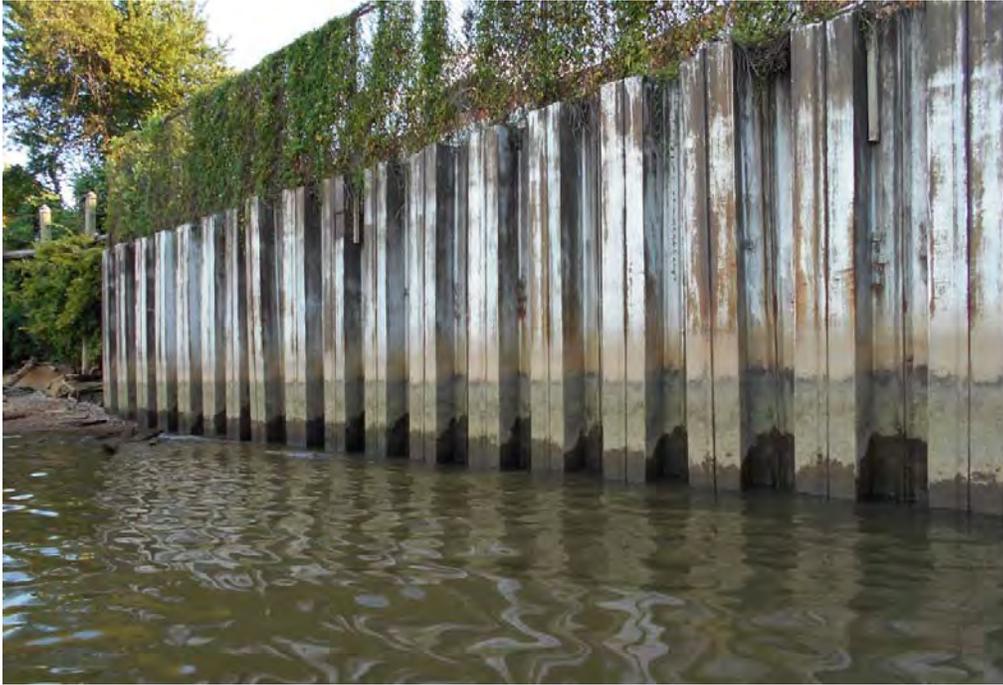
Picture 9.- View of south-section of PRGS sheet-pile bulkhead toward south beach area.

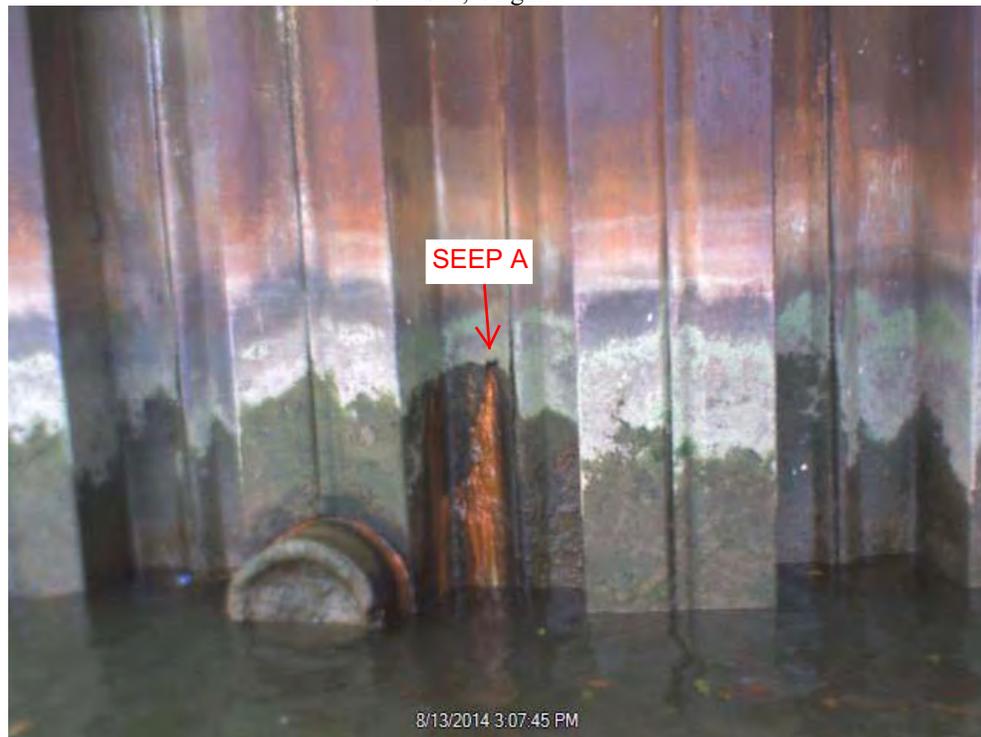
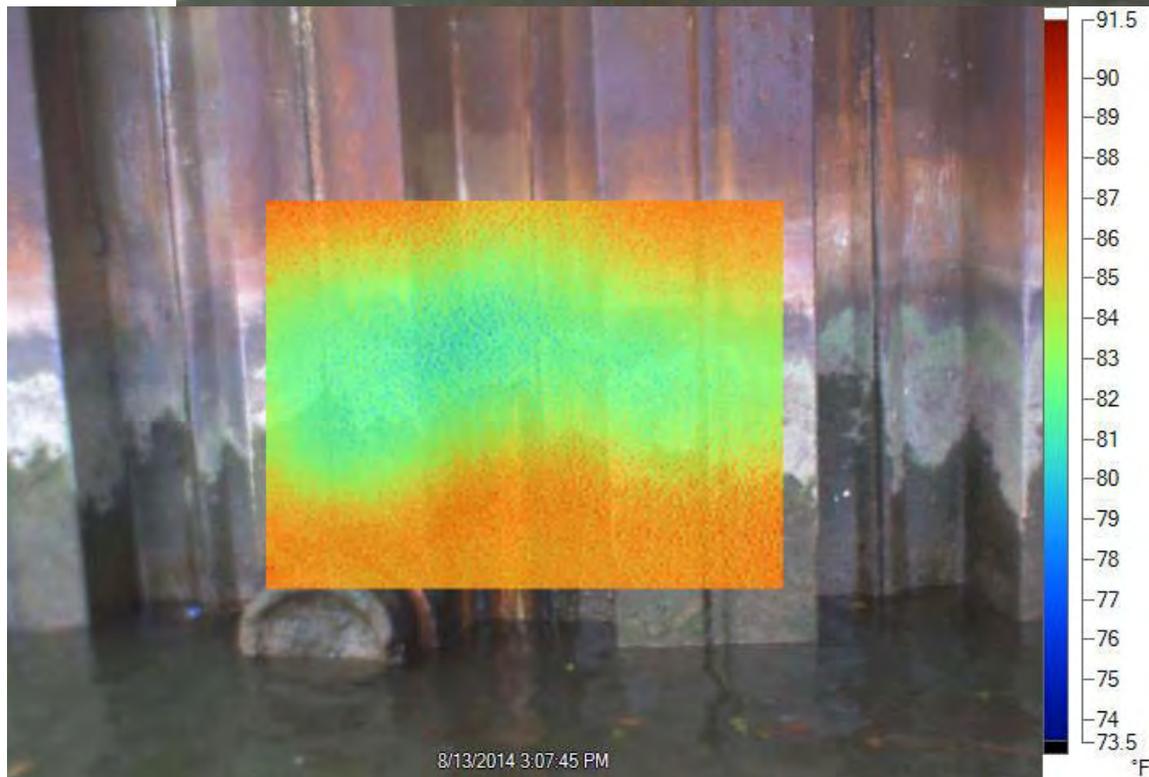
Picture 10: Seep A, with and without thermal imaging

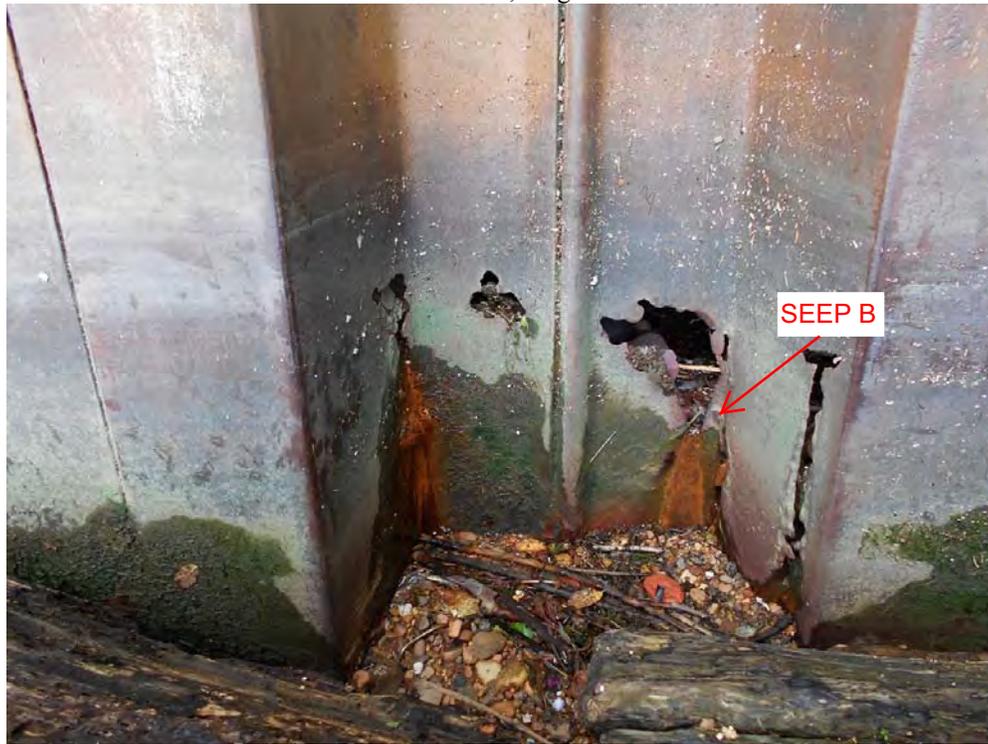
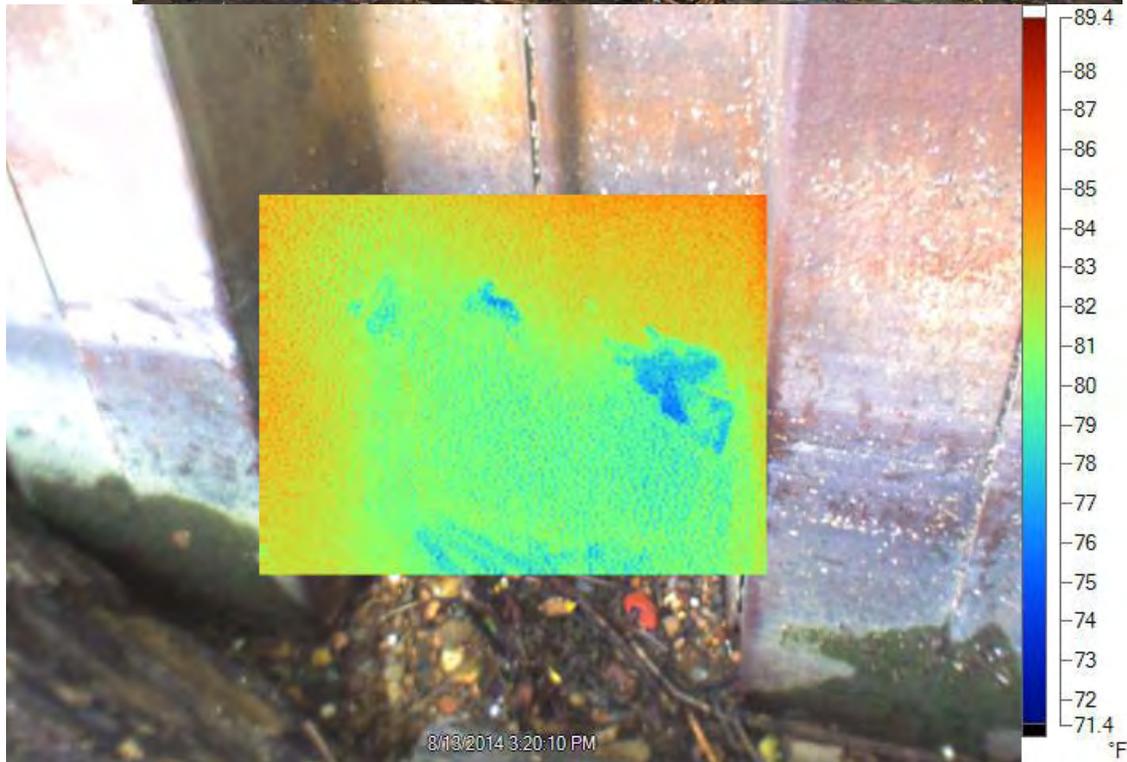
Picture 11: Seep B, with and without thermal imaging

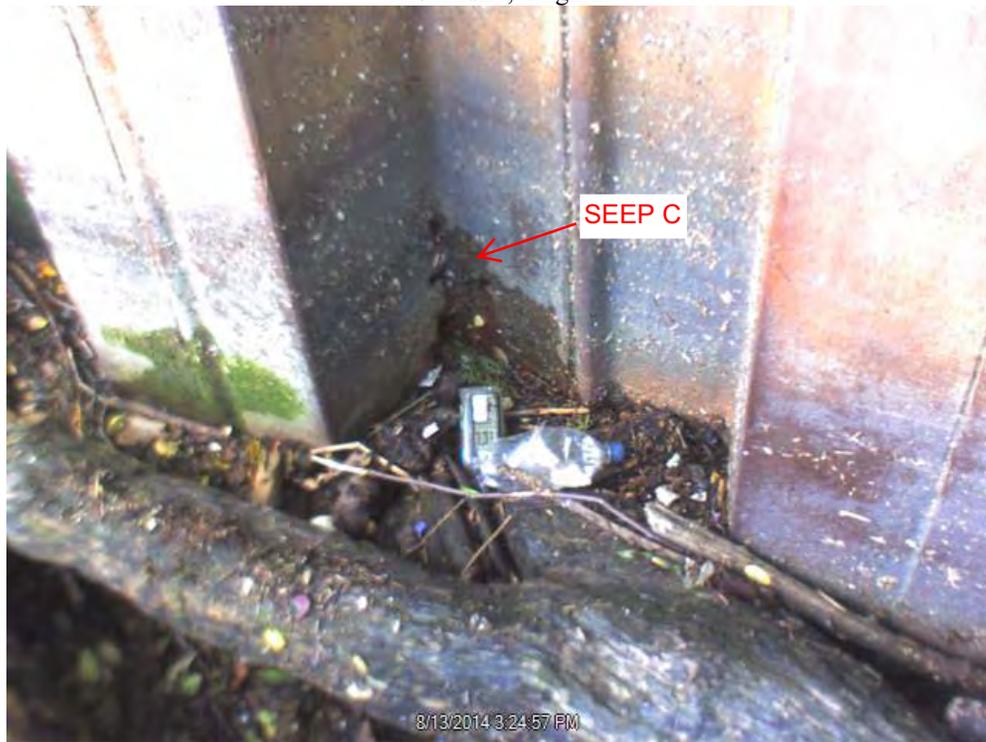
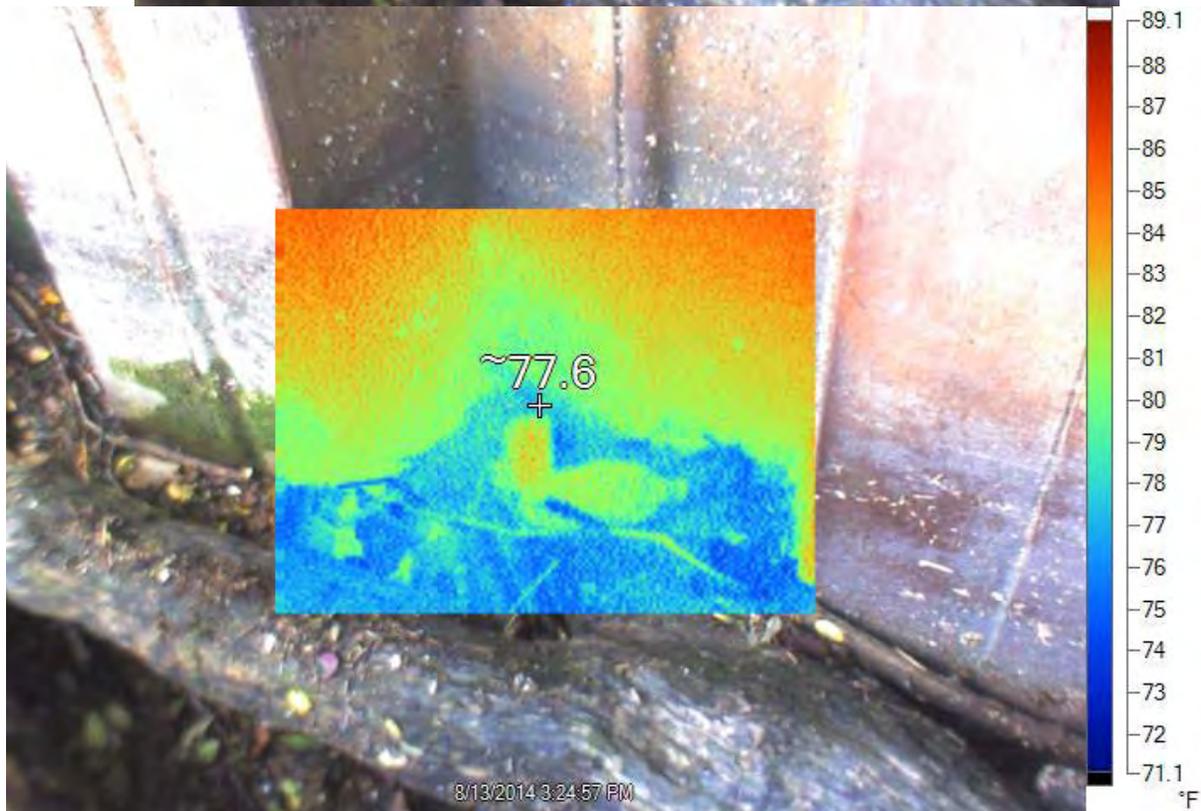
Picture 12: Seep C, with and without thermal imaging

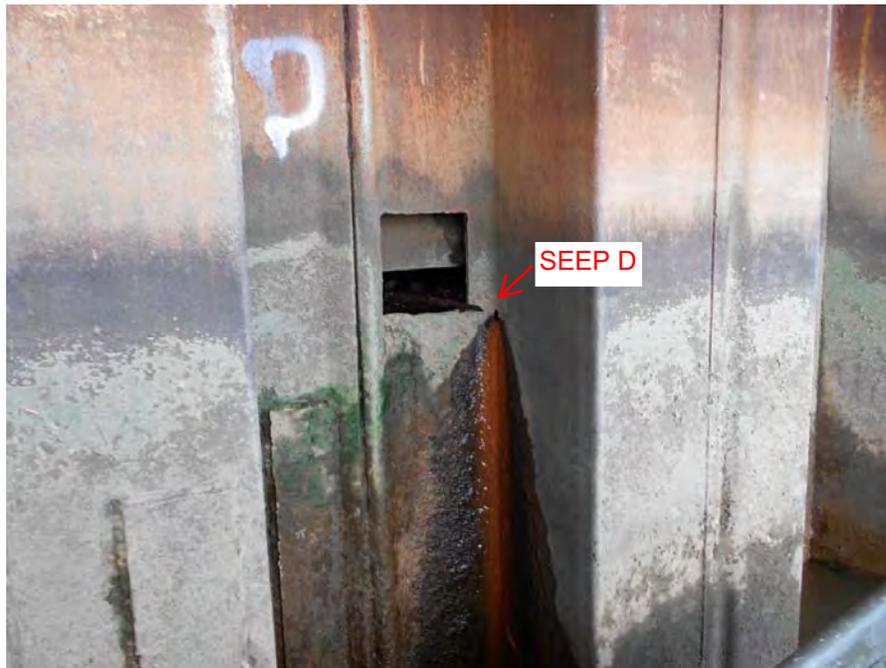
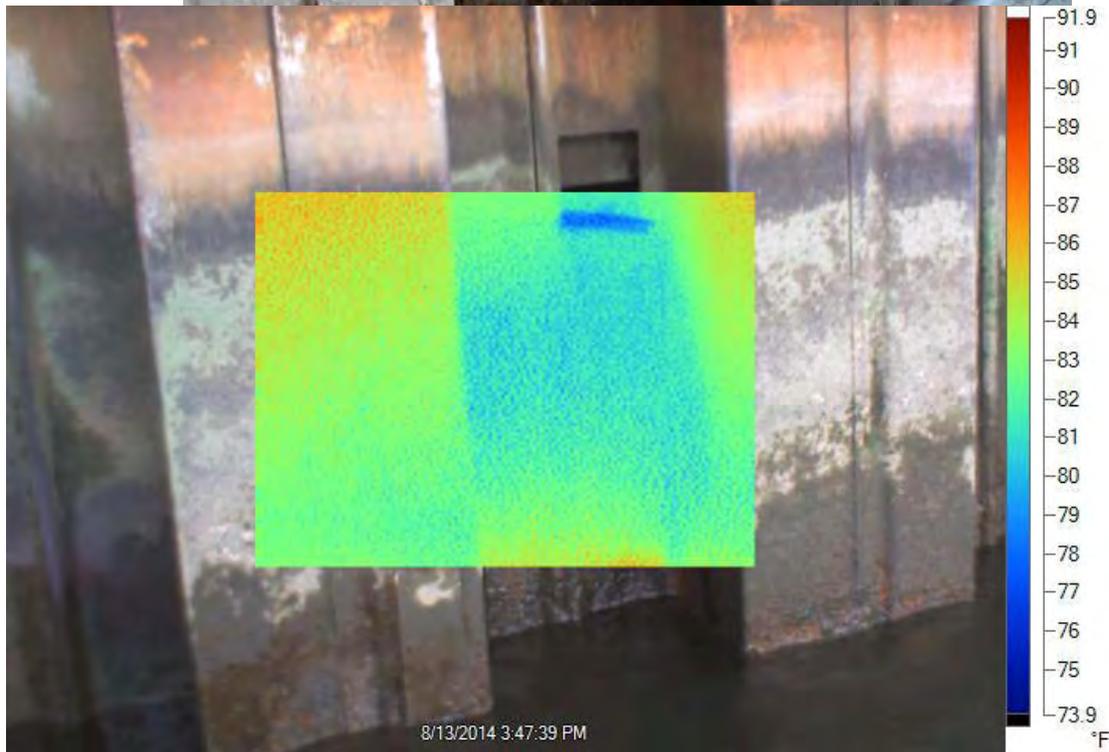
Picture 13: Seep D, with and without thermal imaging

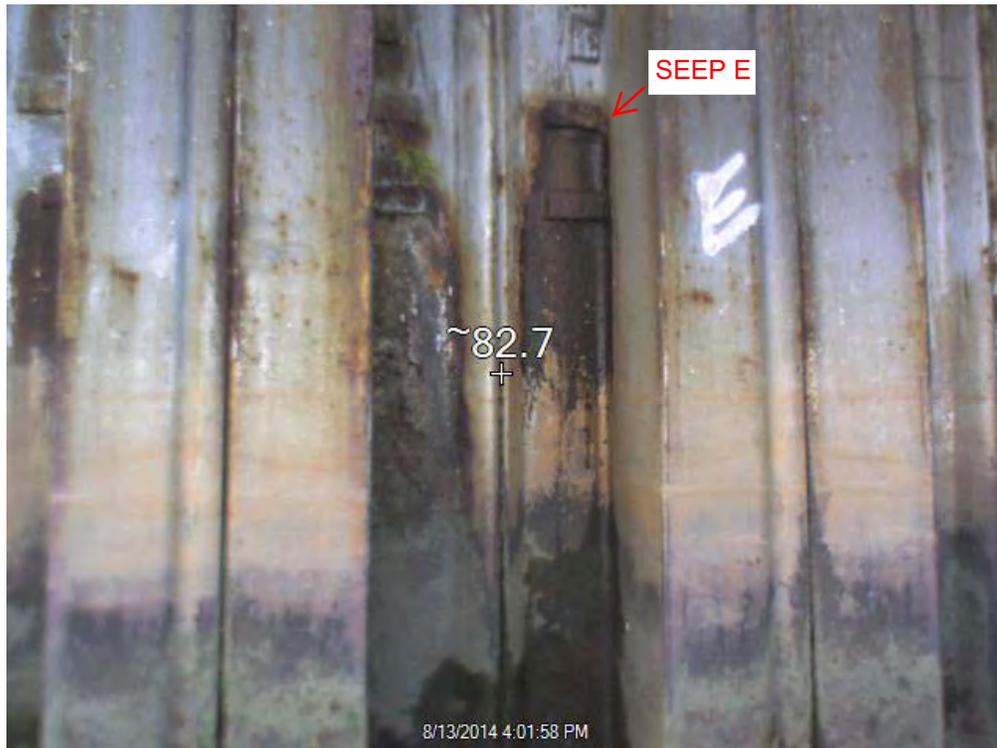
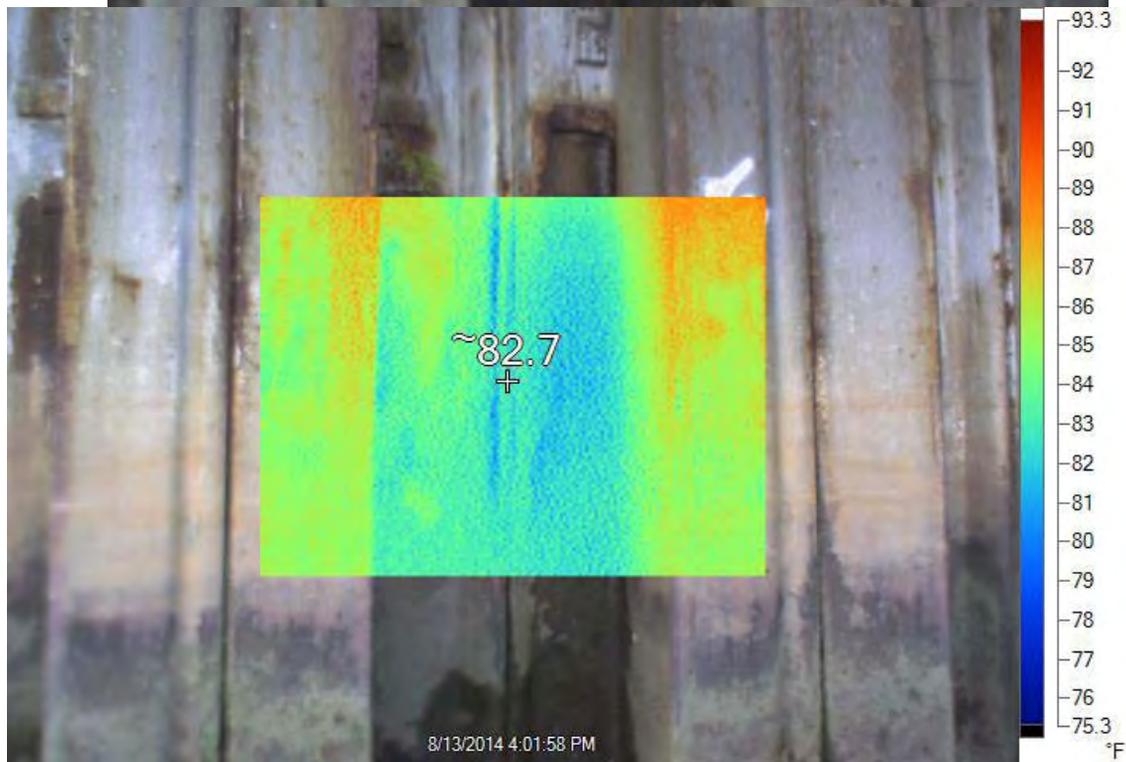
Picture 14: Seep E, with and without thermal imaging

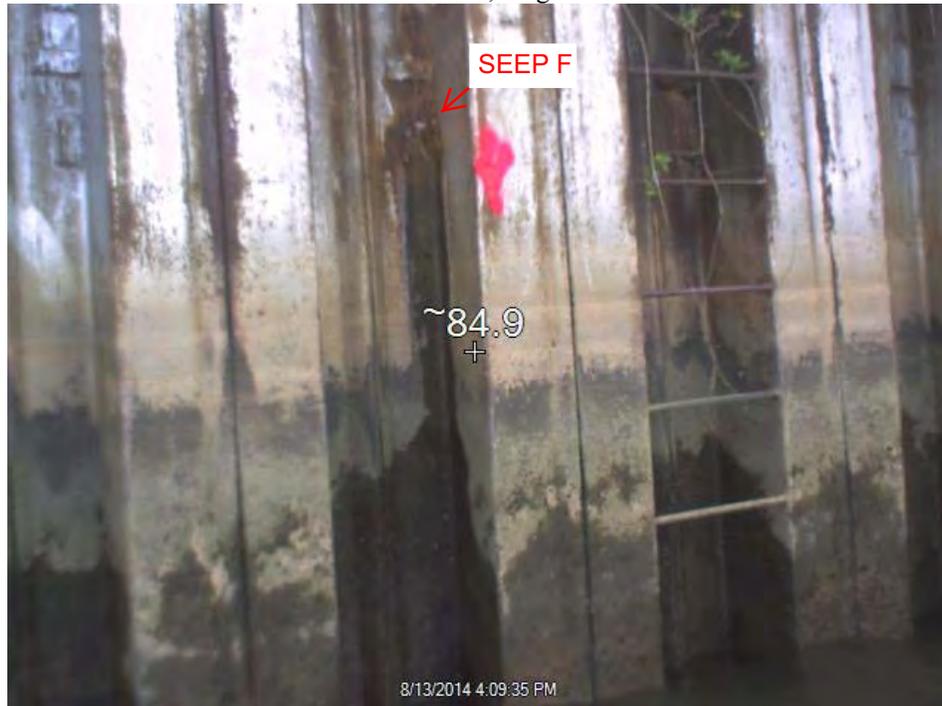
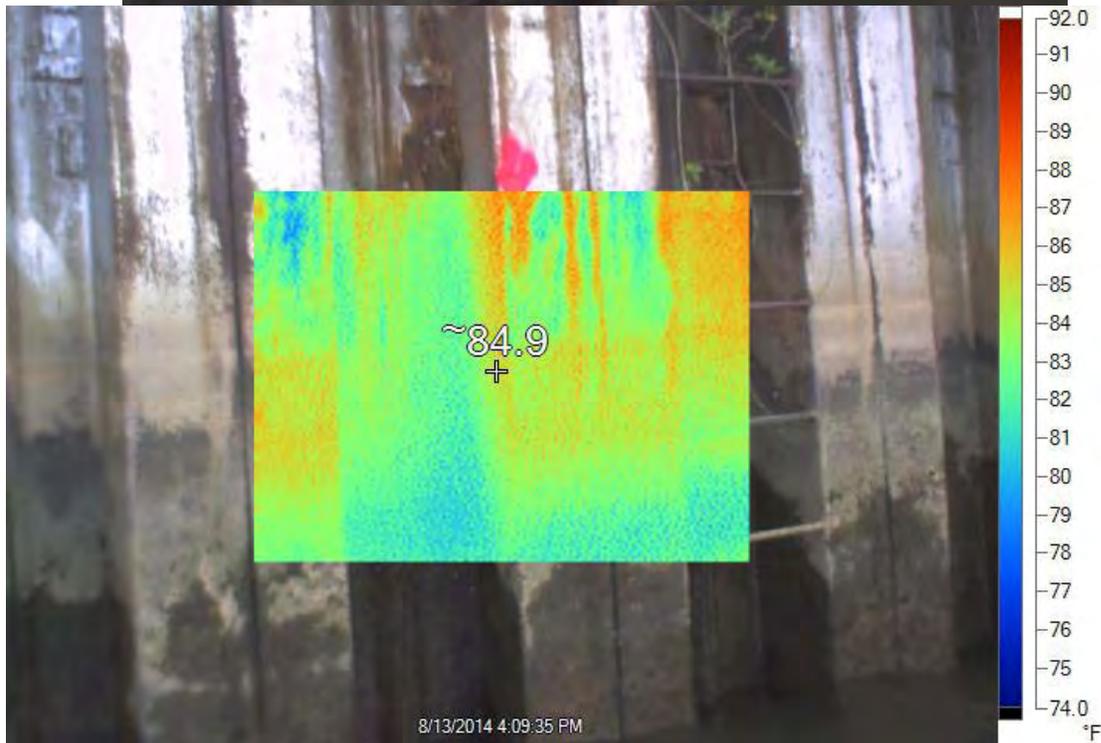
Picture 15: Seep F, with and without thermal imaging
