COMPLAINT INSPECTION REPORT

Project Name:	Mountain Valley Pipeline	Inspector:	Marshall Willis
Inspection Date:	Monday, January 13, 2020	Project Contact:	Brian Clauto, Cory Chalmers
Spread G: Montgomery County	STA 11972+00 – 11989+00 ATWS 1157A & ATWS 1157 MVP-MN-266	Weather (Wet/Dry/Rain):	Wet

FIELD INSPECTION PHOTO LOG

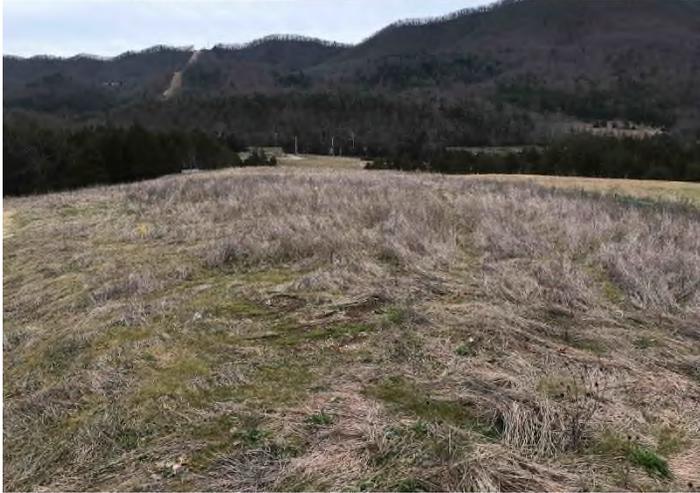
Fig. 1: **STA 11979+00** – Controls in place. Area stabilized with vegetative cover. No erosion evident.

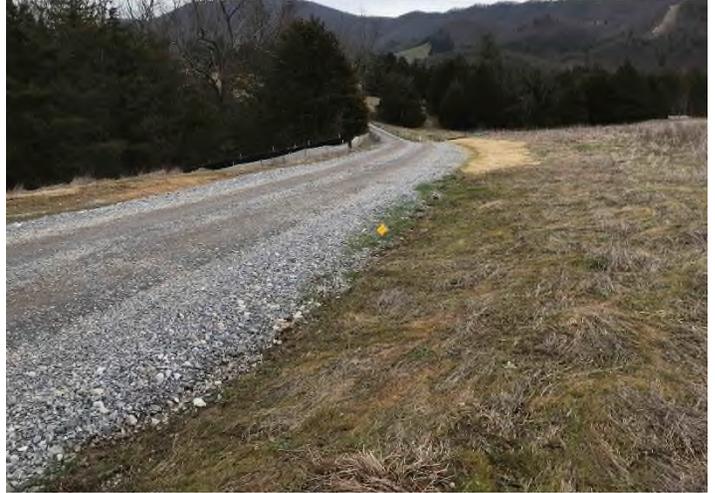
Fig. 2: **MVP-MN-266** – Controls in place along access road. Area stabilized with vegetative cover. No erosion evident.

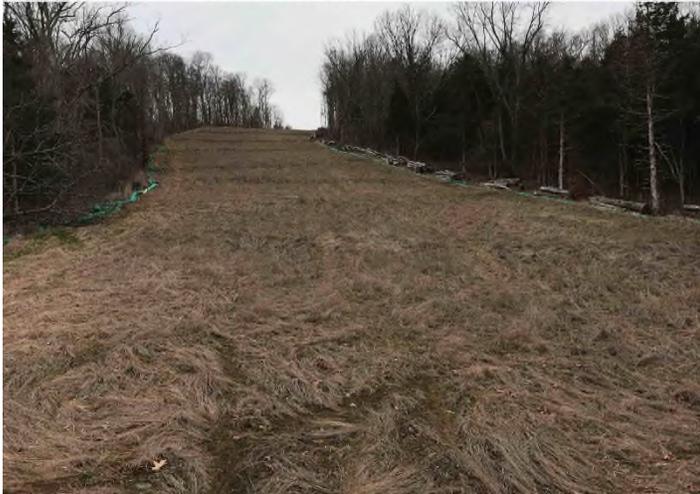
- Observations:**
1. Underground gravel filter bed is located approximately at STA 11975+60. See Figure 3.
 2. At the time of inspection, there was no evidence of sediment discharge from the MVP ROW.

Fig. 3: **STA 11977+00** – Looking north towards underground gravel filter bed. Controls in place. Area stabilized with vegetative cover. No erosion evident.

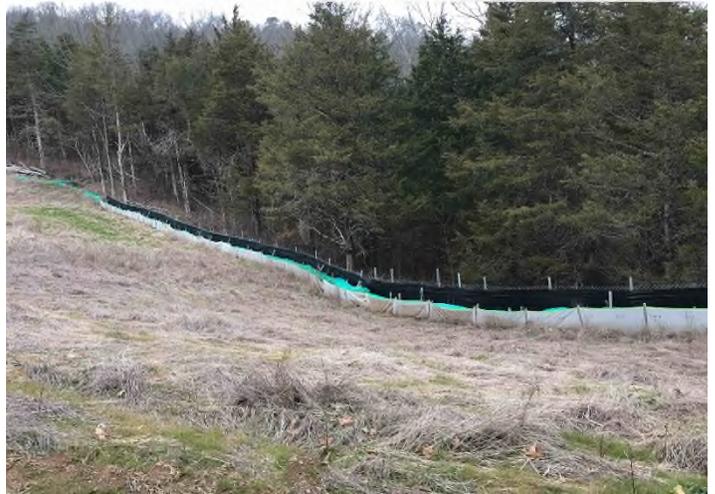
Fig. 4: **STA 11978+00** – Controls in place above karst feature on the east of ROW. Area stabilized with vegetative cover. No erosion evident.

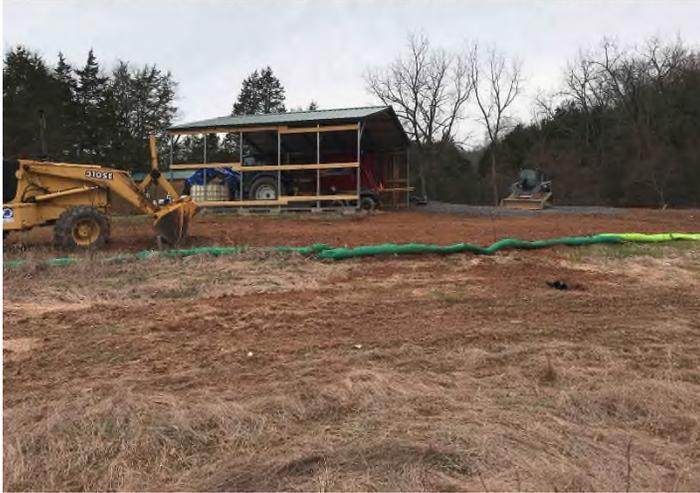
5. Continued land disturbing activities not associated with the project were noted off-ROW during the inspection near STA 11976+00 and along MVP-MN-266. LDA is located west of MVP ROW and upslope of potential sinkhole. See Figures 5-8.

Fig. 5: STA 11978+00 – Land disturbance not associated with MVP project. Adjacent to approx. STA 11976+00 to STA 11978+00.

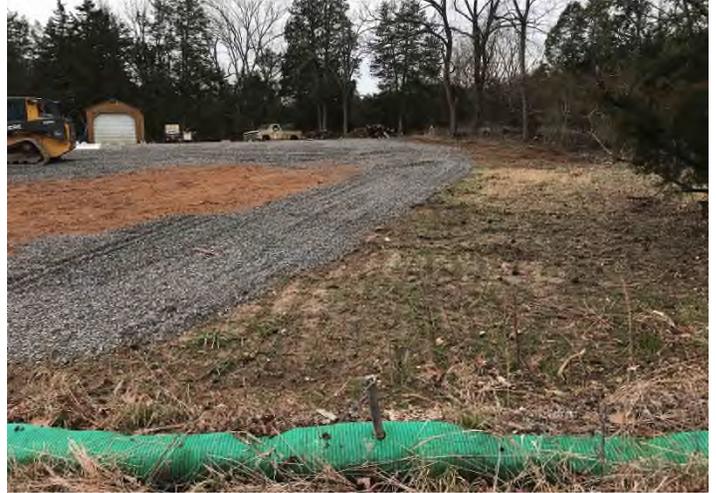
Fig. 6: STA 11977+00 – Land disturbance not associated with MVP project. Adjacent to approx. STA 11976+00 to STA 11978+00.

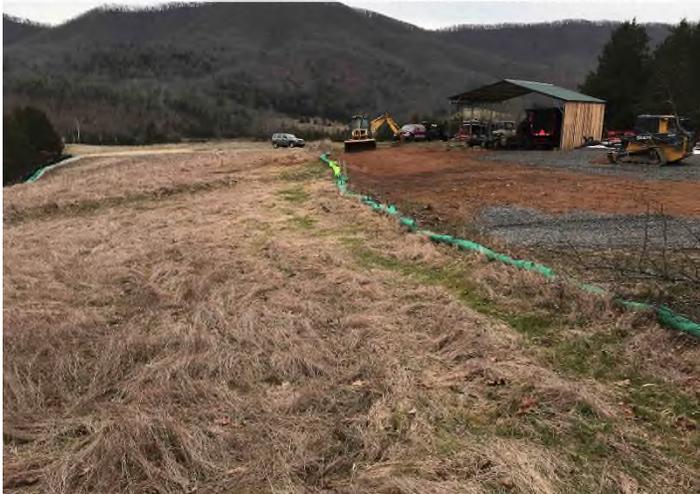
Fig. 7: STA 11976+00 – Land disturbance not associated with MVP project. Adjacent to approx. STA 11976+00 to STA 11978+00.

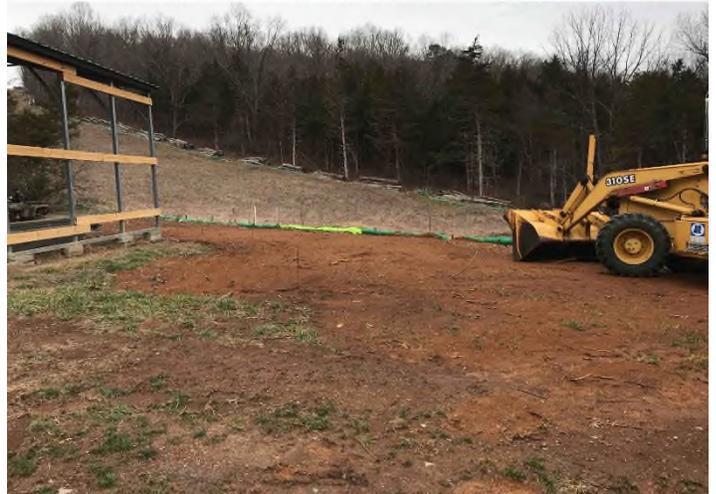
Fig. 8: MVP-MN-266 – Land disturbance not associated with MVP project. Adjacent to approx. STA 11976+00 to STA 11978+00.

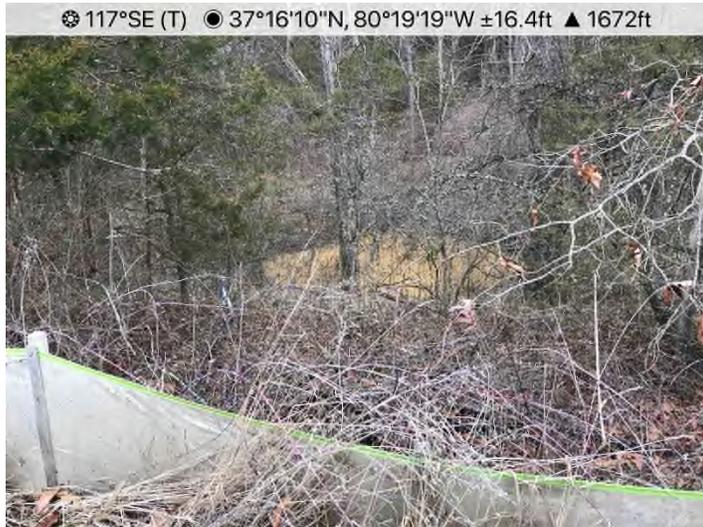
6. Ponded turbid water was observed in a karst feature off ROW along MVP-MN-266, north of MVP ROW. Muddy landowner access road was observed above feature. See Figures 9 and 10.

Fig. 9: **MVP-MN-266** – Turbid water pooled in sinkhole off east side of ROW, north of MN-266.

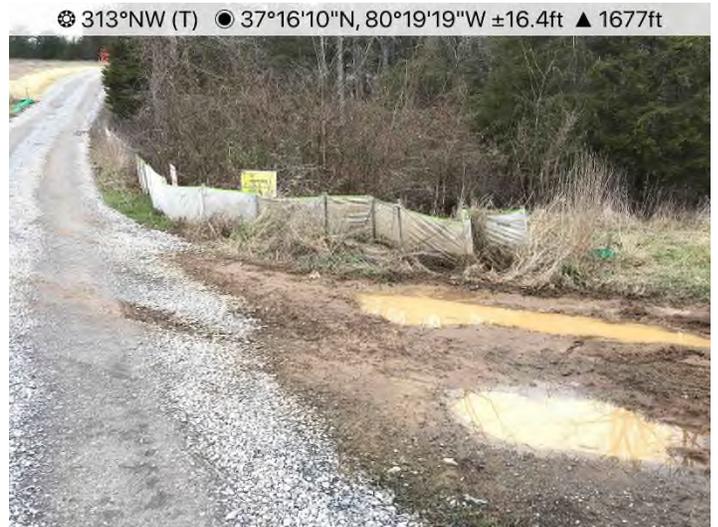
Fig. 10: **MVP-MN-266** – Muddy landowner access road above turbid sinkhole (Figure 9).

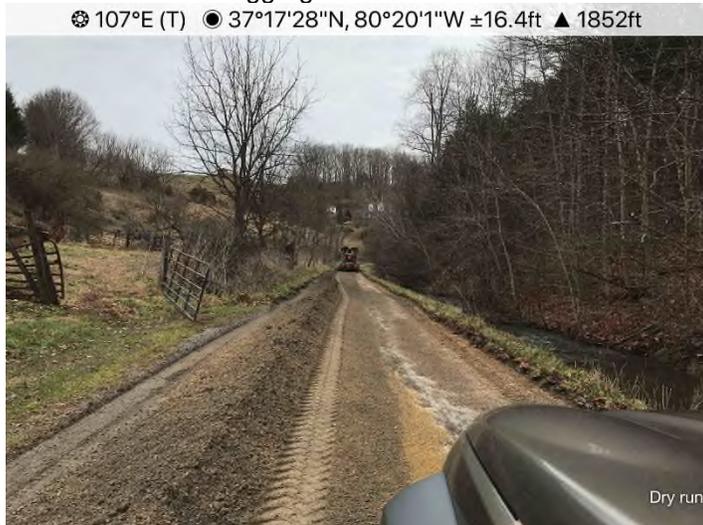
7. Dry Run Road significantly impacted by erosion and high flow conditions of Dry Run. VDOT actively regrading and adding stone to road at the time of inspection. See Figure 11.

Fig. 11: **Dry Run Road** – VDOT repairing Dry Run Road from Catawba Rd. to Mt. Tabor Rd. Rain event caused significant erosion to road along Dry Run depositing sediment and road aggregate into stream.

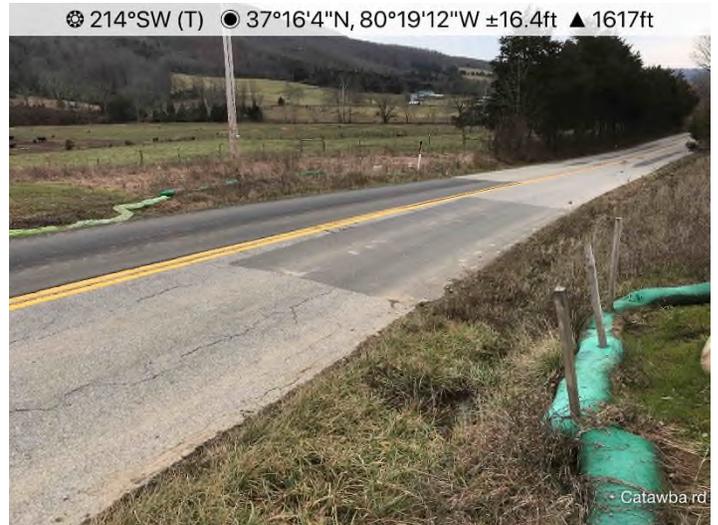
Fig. 12: **Catawba Road Crossing** – Controls in place and functioning at Catawba Road.
