Complaint Investigation

Project Name:	Mountain Valley Pipeline	Inspector:	Matthew Grant
Inspection Date:	Wednesday, November 20, 2019	Project Contact:	Brian Clauto
Spread: Craig Co. MP217.2- 214.4 ATWS 1370 MLV 25 Giles Co. ATWS 1464 AR GI 249.02	Spread G	Weather (Wet/Dry/Rain):	Dry

FIELD INSPECTION PHOTO LOG

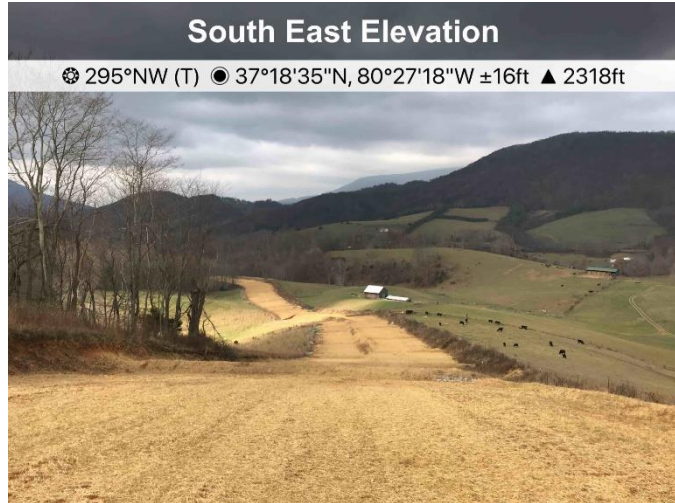
Fig. 1 Near MP 215.7 area has had stabilization applied.

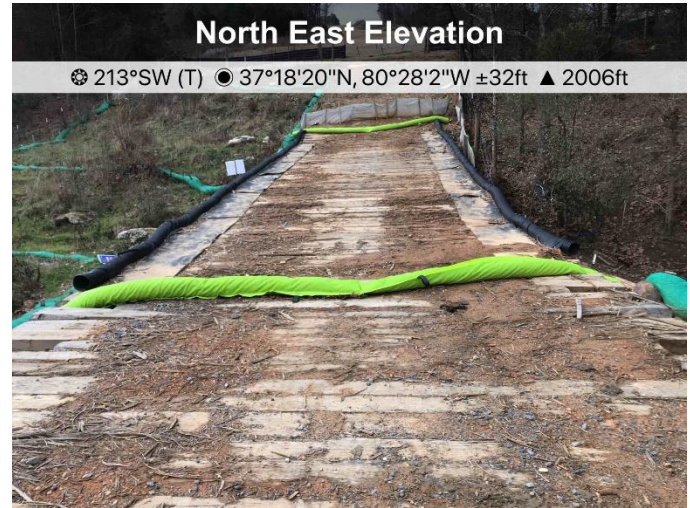
Fig. 2 Designated steam S-NN11, ECD's in place and functioning.

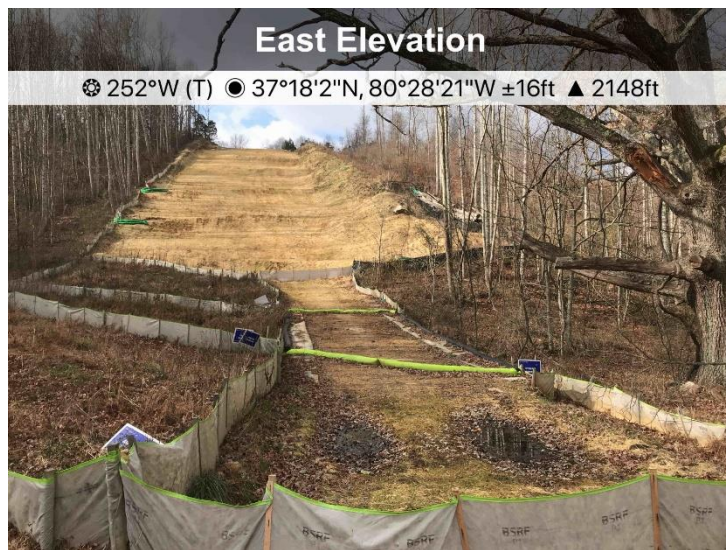
Fig. 3 Designated steam S-NN12, ECD's in place and functioning.

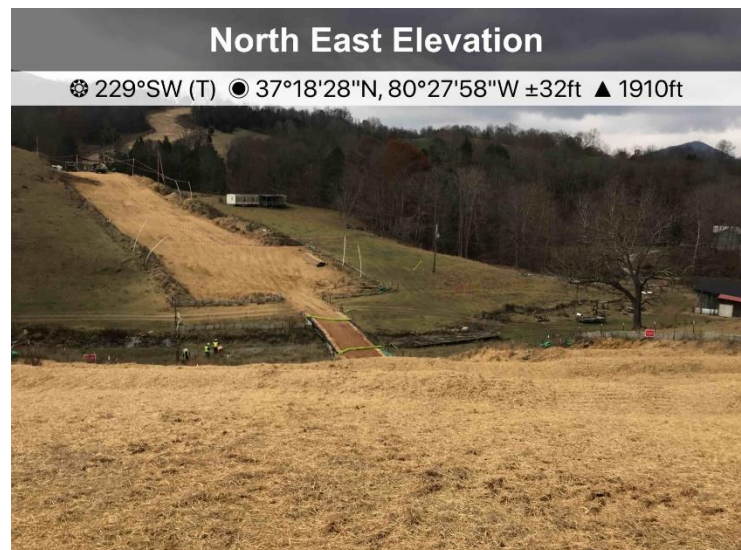
Fig. 4 Above designated stream S-KL43, ECD's in place and stabilization has been applied.
