COMPLAINT INSPECTION REPORT

Project Name:	Mountain Valley Pipeline	Inspector:	Marshall Willis
Inspection Date:	Tuesday, December 3, 2019	Project Contact:	Brian Clauto, Cory Chalmers
Spread G: Montgomery County	STA 11929+47 – 12008+53 ATWS 473A, ATWS 473, ATWS 1157A & ATWS 1157 MVP-MN-266/268	Weather (Wet/Dry/Rain):	Wet

Background: This investigation was conducted in response to an email received on December 02, 2019 for the Catawba Road area. The complaint describes contamination of Bottom Spring from “construction runoff into an improperly installed gravel filter bed that does not filter the sediment out of water that is sinking into the pipeline trench”. The complaint also describes a connection to the location of the installed gravel filter bed within the MVP ROW as a drainage feature to Bottom Creek via karst features.

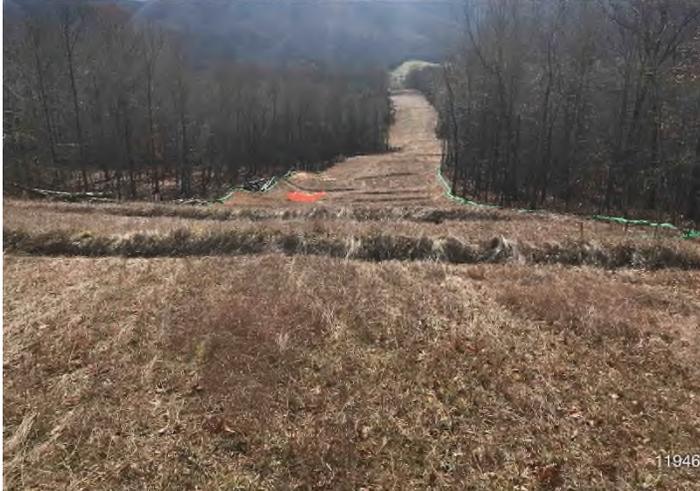
11946

Fig. 1: **STA 11946+00** – Controls in place and functioning. Area stabilized with vegetative cover.

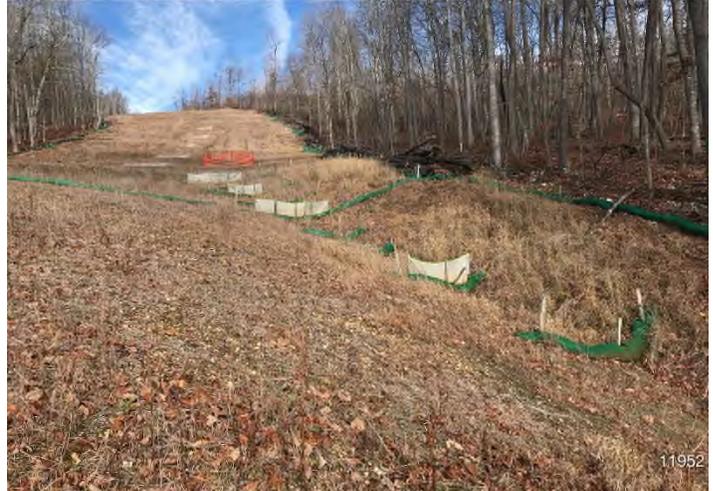
11952

Fig. 2: **STA 11952+00** – Controls in place and functioning. Area stabilized with vegetative cover.

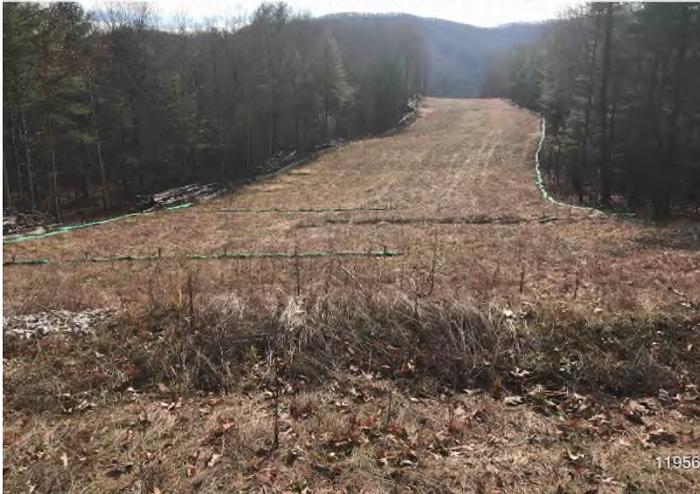
11956

Fig. 3: **STA 11956+00** – Controls in place and functioning. Area stabilized with vegetative cover.

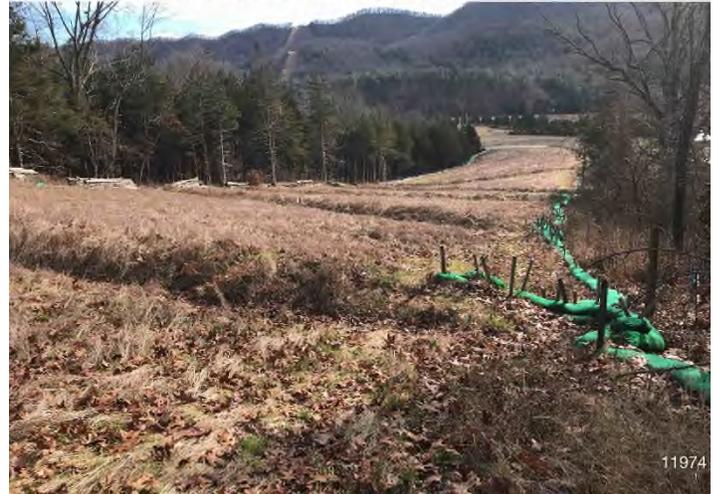
11974

1. Underground gravel filter bed is located approximately at STA 11975+60. See Figures 4, 5, 6, 7 and 8.
2. At the time of inspection, there was no evidence of sediment discharge from MVP ROW.
3. ECDs within the MVP LOD were installed per the approved plans and appeared to be functioning as designed.
4. ROW in this area is currently stabilized with vegetative cover and no significant erosion was evident within the LOD.
5. Land disturbing activities not associated with the project were noted off-ROW during the inspection near STA 11976+00 along MVP-MN-266. See Figures 9-12.

Fig. 4: **STA 11974+00** – Controls in place and functioning. Area stabilized with vegetative cover. No erosion evident.

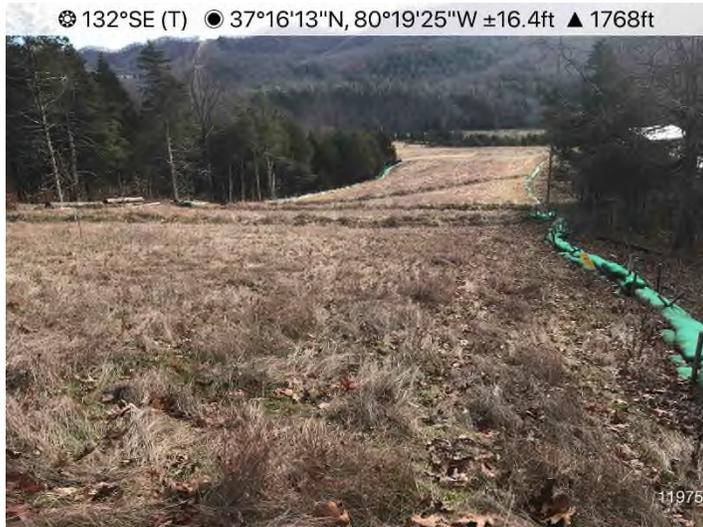
Fig. 5: **STA 11975+00** – Controls in place. Area stabilized with vegetative cover. No erosion evident.

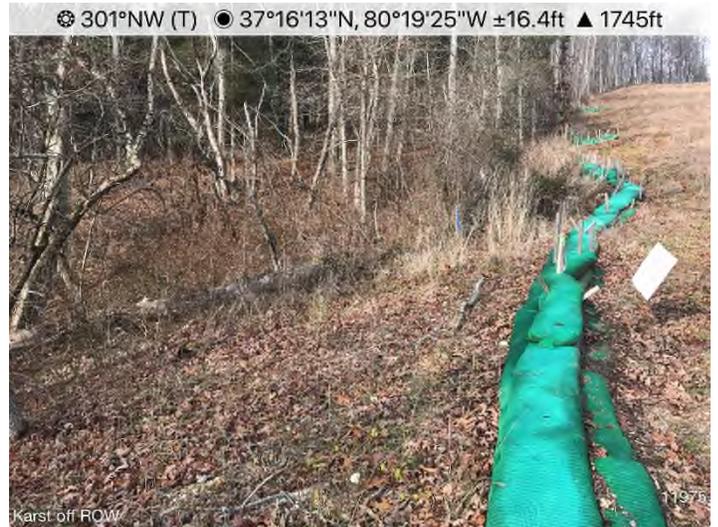
Fig. 6: **STA 11975+00** – Controls in place. Area stabilized with vegetative cover. No erosion evident.

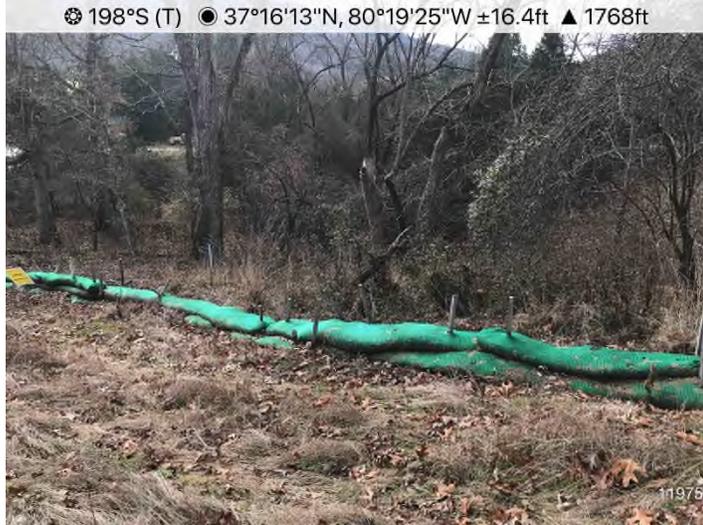
Fig. 7: **STA 11975+00** – Looking south towards offsite karst feature. Controls in place. Area stabilized with vegetative cover. No erosion evident.

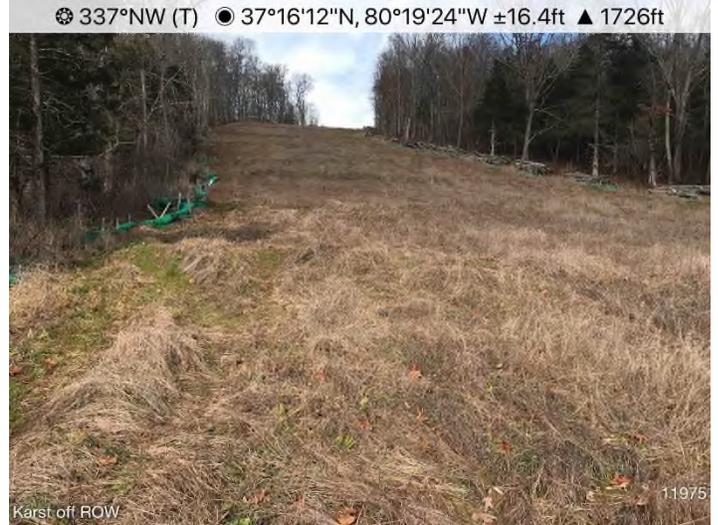
Fig. 8: **STA 11975+00** – Controls in place. Area stabilized with vegetative cover. No erosion evident.

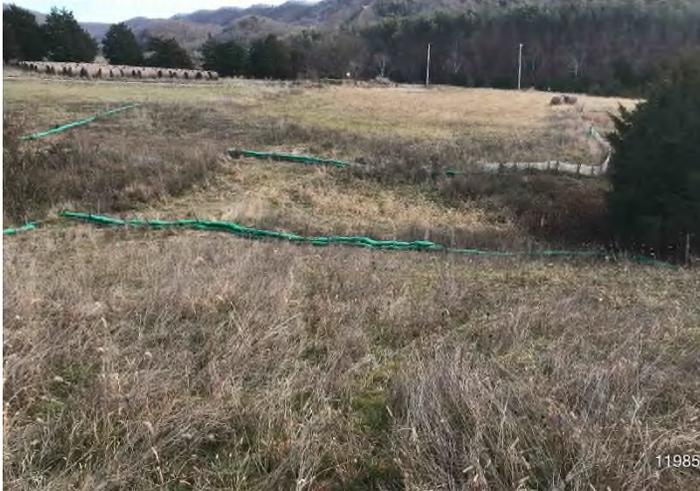
Fig. 13: **STA 11985+00** – Controls in place and functioning. Area stabilized with vegetative cover.

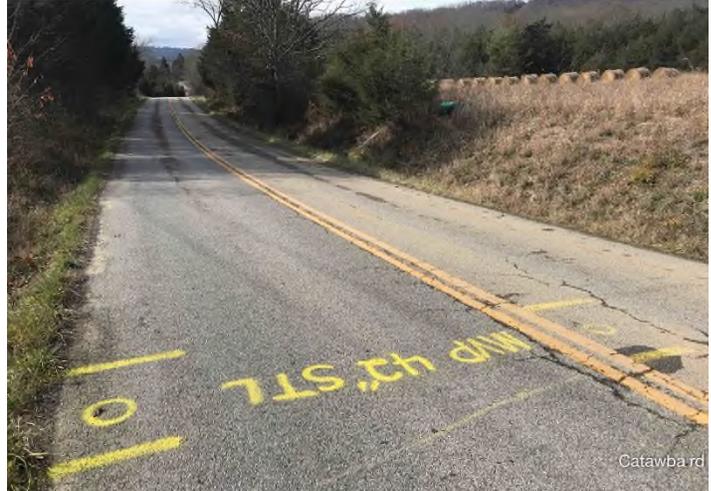
Fig. 14: **STA 11989+05** – Catawba Road crossing.

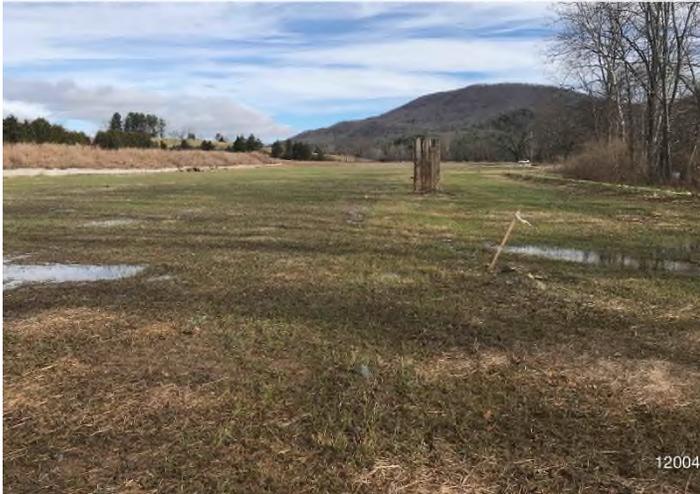
Fig. 15: **STA 12004+00** – Controls in place and functioning. Area stabilized.

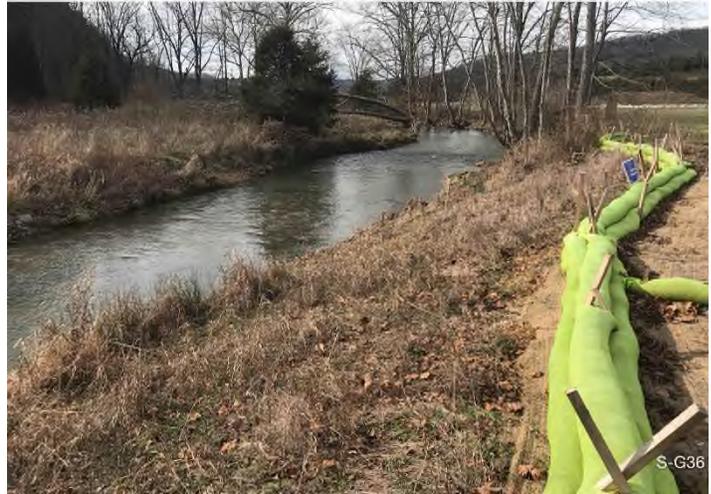
Fig. 16: **Stream S-G36** – Controls in place and functioning at North Fork Roanoke River crossing.
