## COMPLAINT INSPECTION REPORT

<b>Project Name:</b>	Mountain Valley Pipeline	<b>Inspector:</b>	John McCutcheon
<b>Inspection Date:</b>	Wednesday, July 17, 2019	<b>Project Contact:</b>	Brian Clauto, Brian Shields
<b>Spread:</b>	Spread G	<b>Weather (Wet/Dry/Rain):</b>	Dry

## FIELD INSPECTION PHOTO LOG

**Project Name:** Mountain Valley Pipeline

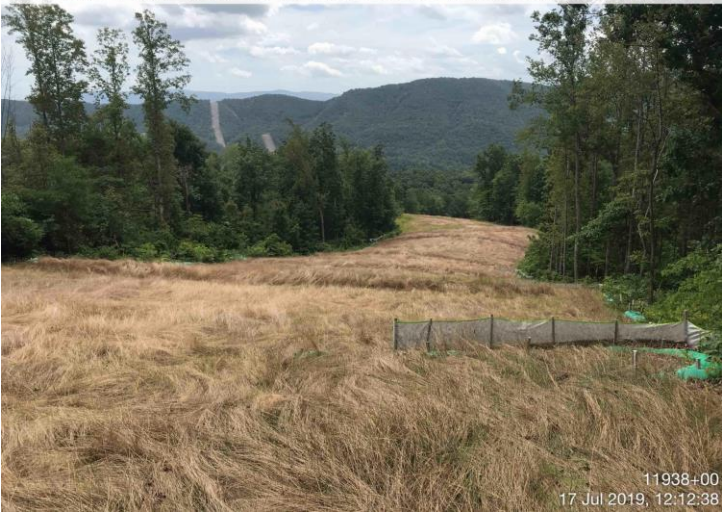
<p><b>Comment 1.</b>  <span style="font-size: small;">☉ 140°SE (T) ● 37°18'19"N, 80°16'33"W ±36041.8ft ▲ 2146ft</span></p>

<p style="text-align: right; font-size: x-small;">11938+00 17 Jul 2019, 12:12:38</p> <p><b>ROW well-stabilized with vegetative cover.</b></p>	<p><b>Comment 2.</b>  <span style="font-size: small;">☉ 182°S (T) ● 37°16'43"N, 80°19'39"W ±16.4ft ▲ 2227ft</span></p>

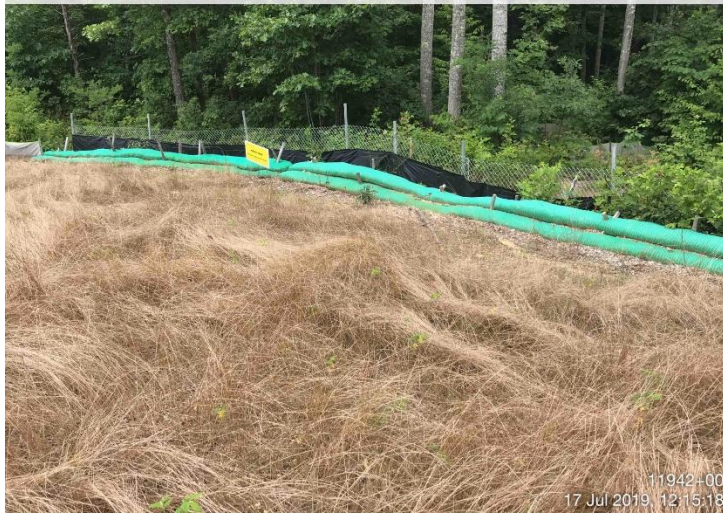
<p style="text-align: right; font-size: x-small;">11942+00 17 Jul 2019, 12:15:18</p> <p><b>Perimeter controls in good condition.</b></p>
<p><b>Comment 3</b>  <span style="font-size: small;">☉ 227°SW (T) ● 37°16'23"N, 80°19'31"W ±16.4ft ▲ 1968ft</span></p>

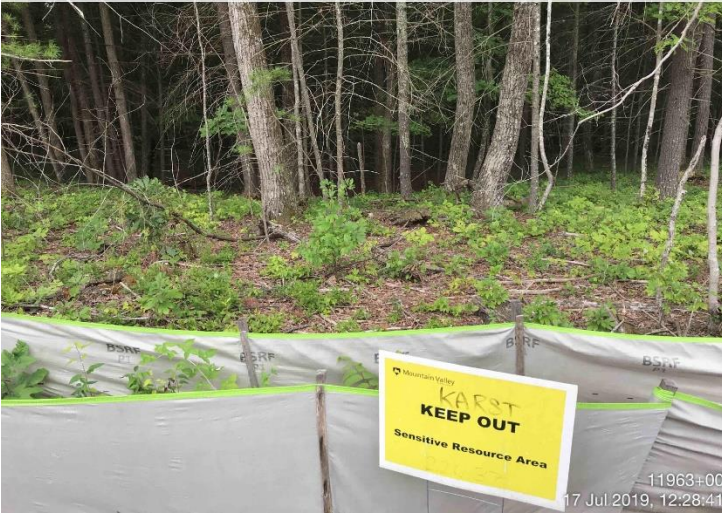
<p style="text-align: right; font-size: x-small;">11963+00 17 Jul 2019, 12:28:41</p> <p><b>Resource protection signage in place and in good condition.</b></p>	<p><b>Comment 4.</b>  <span style="font-size: small;">☉ 183°S (T) ● 37°16'13"N, 80°19'25"W ±16.4ft ▲ 1713ft</span></p>

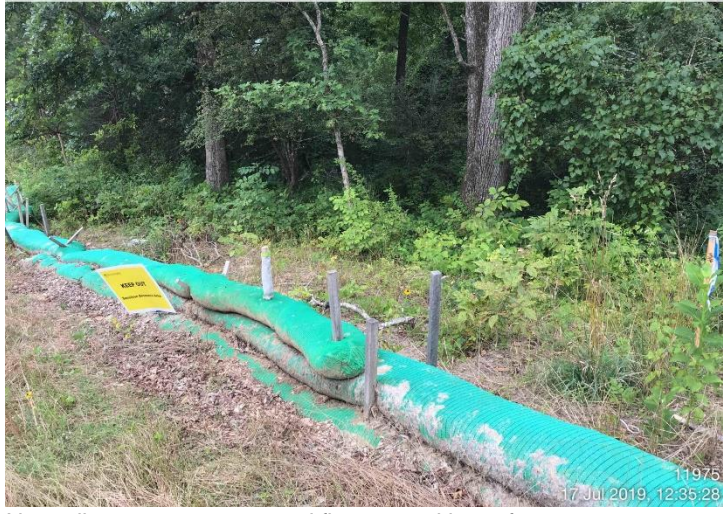
<p style="text-align: right; font-size: x-small;">11975 17 Jul 2019, 12:35:28</p> <p><b>No sediment or concentrated flow toward karst feature.</b></p>
