COMPLAINT INSPECTION REPORT

Project Name:	Mountain Valley Pipeline	Inspector:	Marshall Willis
Inspection Date:	Wednesday, July 17, 2019	Project Contact:	Brian Clauto
Spread G: Giles County	STA 11353+67 – 11471+52	Weather (Wet/Dry/Rain):	Dry

FIELD INSPECTION PHOTO LOG

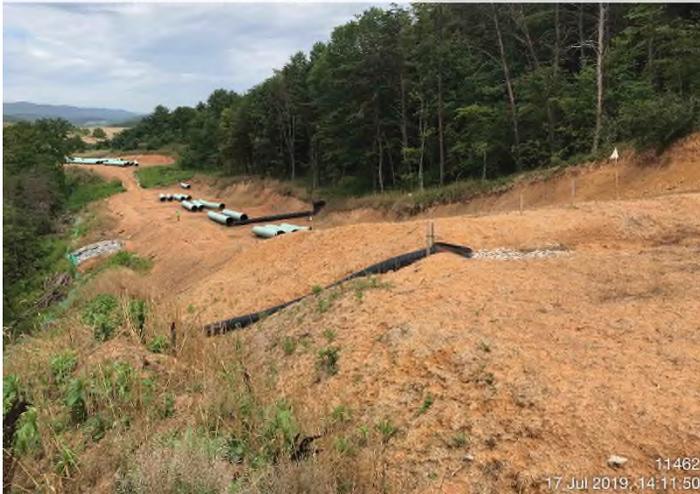
Fig. 1: **STA 11462+00** – Controls in place and functioning properly. Mobilization for re-stabilization occurring in the area.

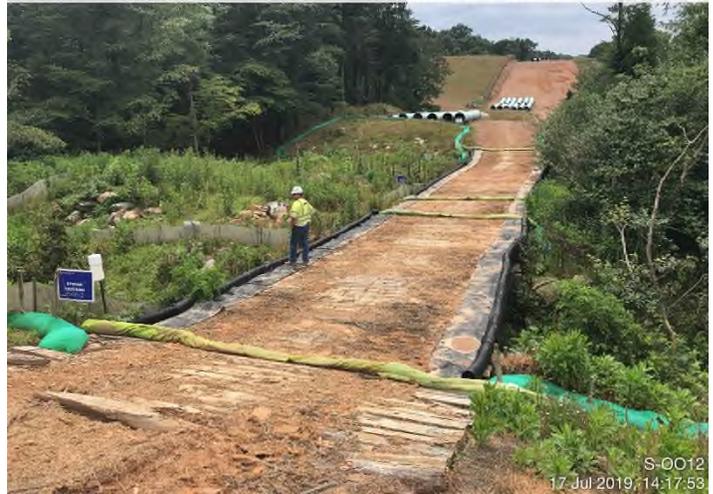
Fig. 2: **Stream S-0012** – Controls in place. Bridge clean with functioning sideboards and waddles.

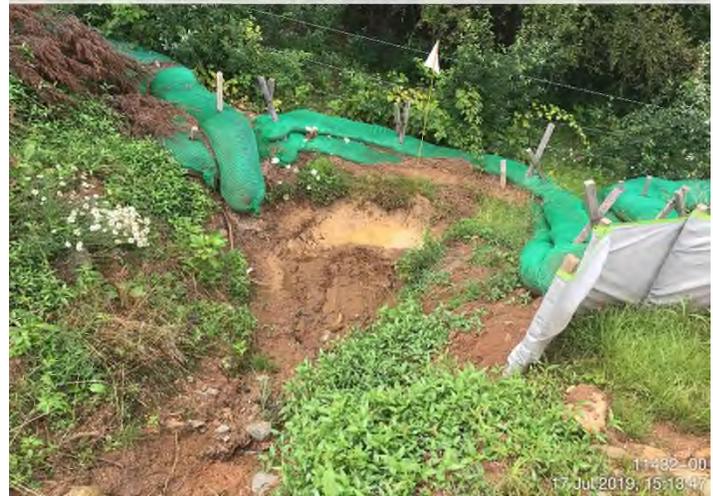
Fig. 4: **STA 11432+00** – Sump maintenance needed.

Recommended Corrective Action: Adequately re-stabilize ROW. Maintain and install all controls per the approved plan and specs.
