COMPLAINT INSPECTION REPORT

Project Name:	Mountain Valley Pipeline	Inspector:	Marshall Willis
Inspection Date:	Monday, October 28, 2019	Project Contact:	Brian Clauto
Spread H: Montgomery County	STA 12544+27 – 12540+00 MVP-MN-278.01	Weather (Wet/Dry/Rain):	Wet

FIELD INSPECTION PHOTO LOG

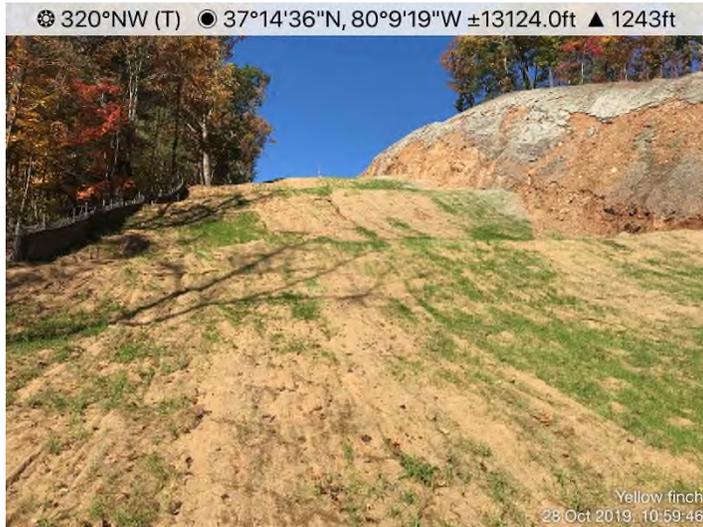
Fig. 1: **STA 12544+00** – Area stabilized with erosion matting. Controls in place and functioning at the time of inspection.

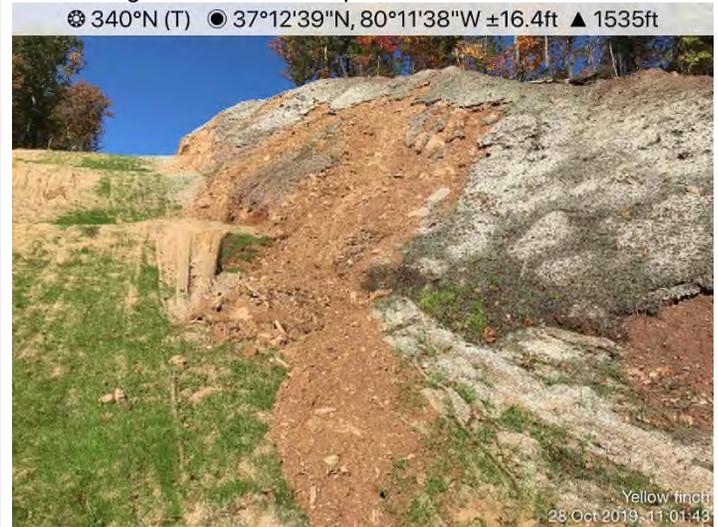
1. At the time of inspection, there was no evidence of sediment discharge from MVP ROW onto Yellow Finch Lane or into S-EF20a.
2. ECDs within the MVP LOD were installed per the approved plans and appeared to be functioning as designed.
3. Soil stockpile at STA 12541+00 – 12543+00 is eroding onto ROW and depositing sediment within waterbar throat. Item was identified by MVP inspectors on 10/20/2019 and is currently extended due to wet conditions on the ROW.

Fig. 2: **STA 12543+00** – Stockpile slipping onto ROW. Item identified by MVP on 10/20/2019. Repair extended due to wet ROW conditions. Controls in place and functioning at the time of inspection.

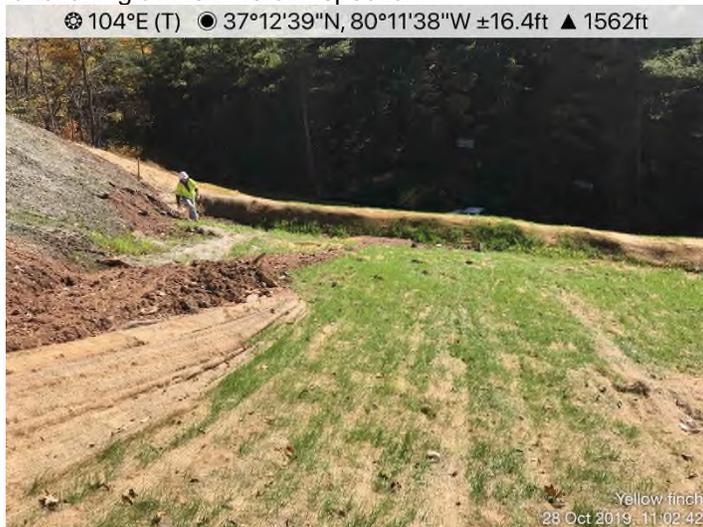
Fig. 3: **STA 12541+00** – Stockpile slipping onto ROW. Item identified by MVP on 10/20/2019. Repair extended due to wet ROW conditions. Controls in place and functioning at the time of inspection.

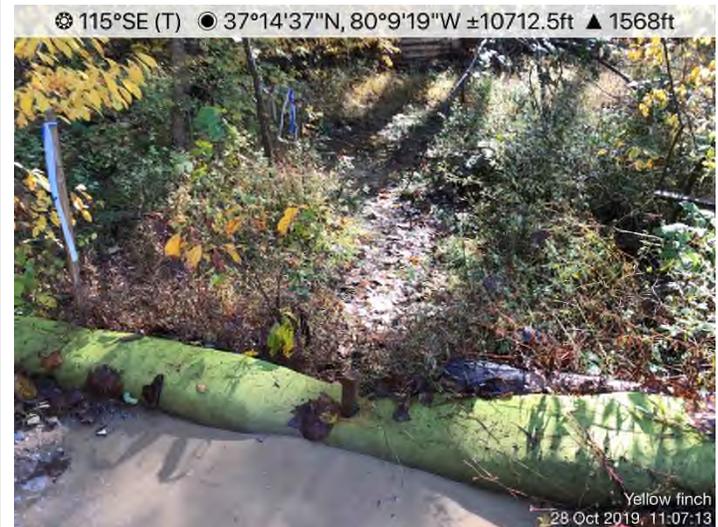
Fig. 4: **MVP-MN-278.01** – Yellow Finch Lane. CFS installed correctly and functioning properly at the time of inspection.
