COMPLAINT INVESTIGATION REPORT

Project Name:	Mountain Valley Pipeline	Inspector:	Matthew Grant
Inspection Date:	Tuesday, February 18, 2020	Project Contact:	Brian Clauto
Spread H: Montgomery County	AR MN-278.01 MP 237.4-237.2	Weather:	Rainy

FIELD INSPECTION PHOTO LOG

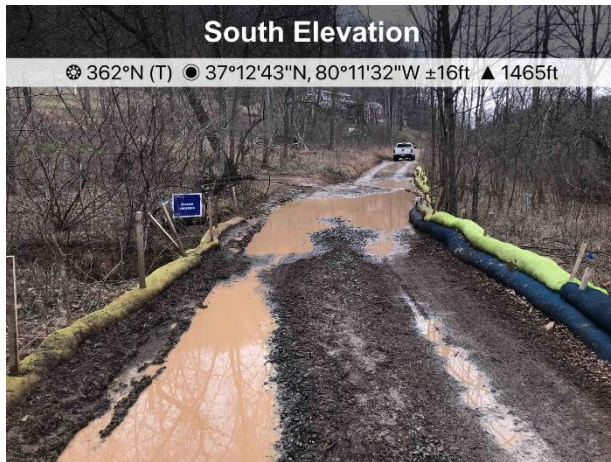
Figure 1: ECD's are installed and functioning along access road MN 278.01 and designated stream S-EF54A.

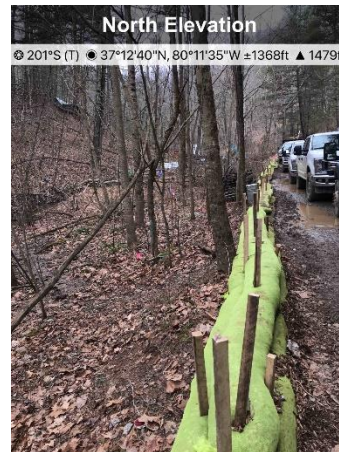
Figure 2: ECD's are installed and functioning along access road MN278.01, designated wetland W-EF5-PFO and designated stream S-EF20a.

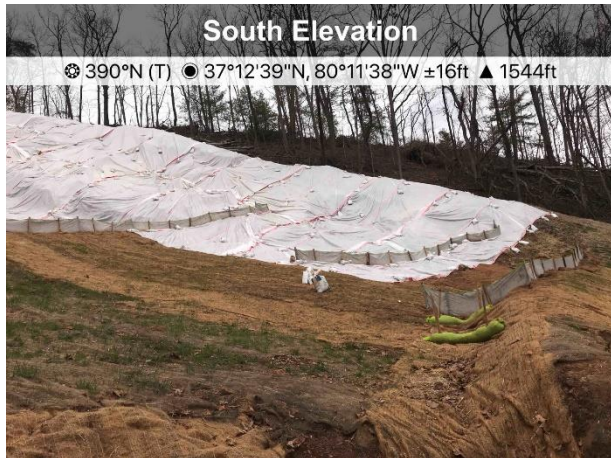
1. At the time of inspection, there was no evidence of sediment discharge from MVP ROW.
2. ECDs within the MVP access road and the LOD were installed per the approved plans and appeared to be functioning as designed.
3. Due to site conditions, plastic sheeting was installed on the hillside stockpile, additional stabilization will be applied when site conditions improve.
4. ROW in this area is currently stabilized with blanket matting, vegetation and plastic sheeting. No significant erosion was evident within the LOD.

Figure 3: Near St12544+00 the stockpile slope has temporarily been stabilized with plastic sheeting, the remaining slope has been stabilized with blanket matting.

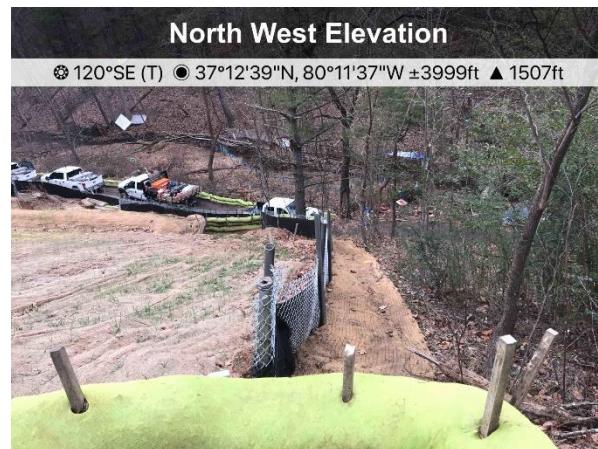
Figure 4: ECD's including sumps, and SSF are installed and appear to be functioning.
