COMPLAINT INVESTIGATION REPORT

Project Name:	Mountain Valley Pipeline	Inspector:	Marshall Willis
Inspection Date:	Thursday, April 16, 2020	Project Contact:	Brian Clauto, Cory Chalmers
Spread H: Montgomery County	STA 12445+19 – 12544+06 MVP-MN-278.01	Weather:	Dry

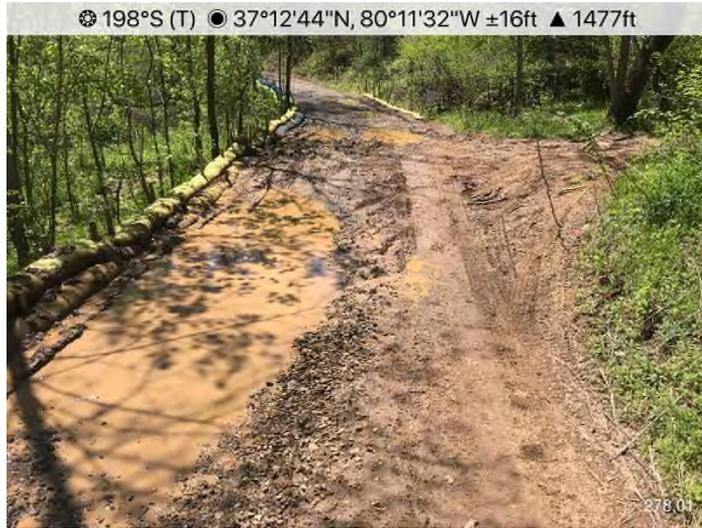
1. Approximately 2.8” precipitation accumulation on 4/12 and 4/13 recorded in the area prior to inspection.
2. Several maintenance items were noted during the inspection.
3. MVP has not completed installation of access road MVP-MN-278.01 to date. Roadway previously damaged by access to logging operation up slope of the MVP ROW.
4. 3x CFS along MVP-MN-278.01 was damaged/overwhelmed during 4/13 rain event allowing sediment and run-on from upslope area to discharge off the roadway.
5. Sediment discharged off ROW cause by breach/failure of controls along roadway. Sediment source appears to be from roadway as well as landowner access adjacent to breach.

Figure 1: MVP-MN-278.01 – Maintain access road to prevent sediment discharge from roadway. Rutting, water ponding and sediment deposition evident. Sediment source to roadway likely from erosion of landowner access adjacent to road.

- MVP-MN-278.01: Maintain access road.
- STA 13533+00: Re-stabilize area between CFS and rock check dam.

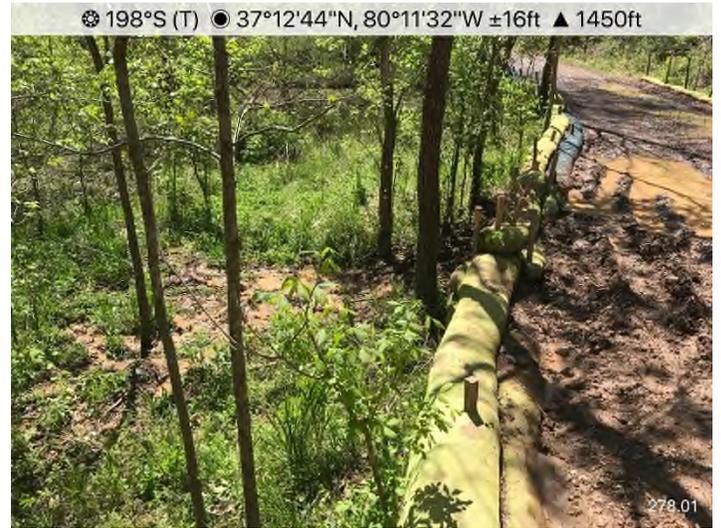
Figure 2: MVP-MN-278.01 – Stabilize sediment deposited within ROW due to CFS control overtopped/damaged from private road.

- MVP-MN-278.01: Stabilize sediment deposited within ROW.
- MVP-MN-278.01: Sediment off ROW due to CFS failure.
- STA 13533+00: CFS at capacity.

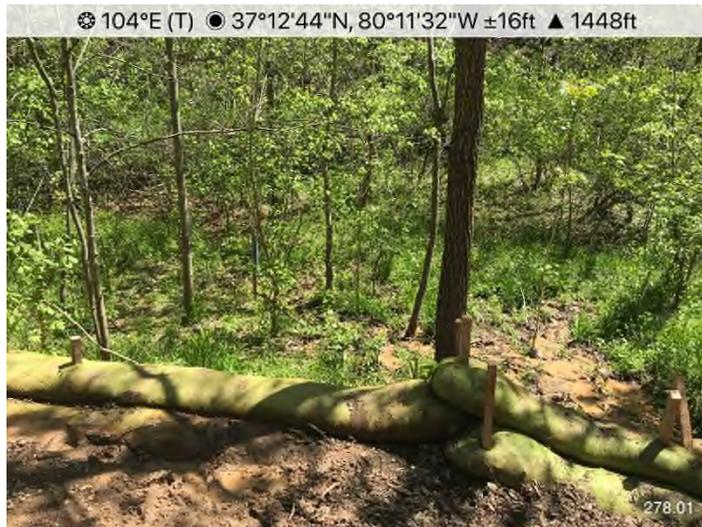
Figure 3: MVP-MN-278.01 – Sediment off ROW due to CFS control overtopped/damaged from private road. Retrieve measureable sediment and stabilize.

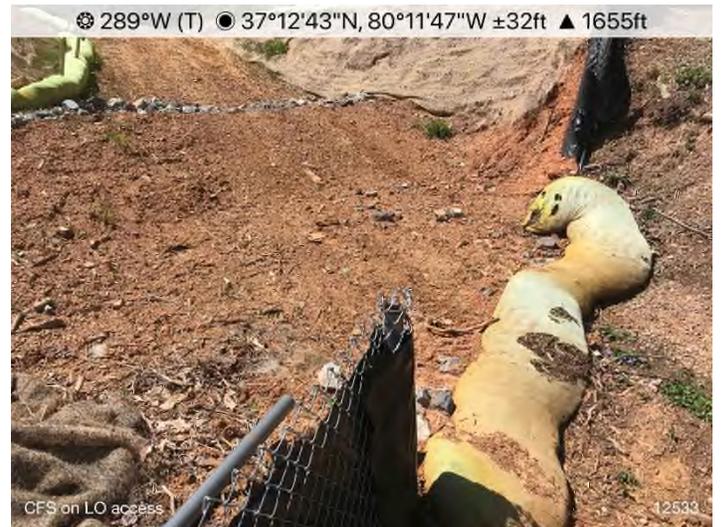
Figure 4: STA 12533+00 – CFS Maintenance needed. Sock at capacity and torn from landowner access.

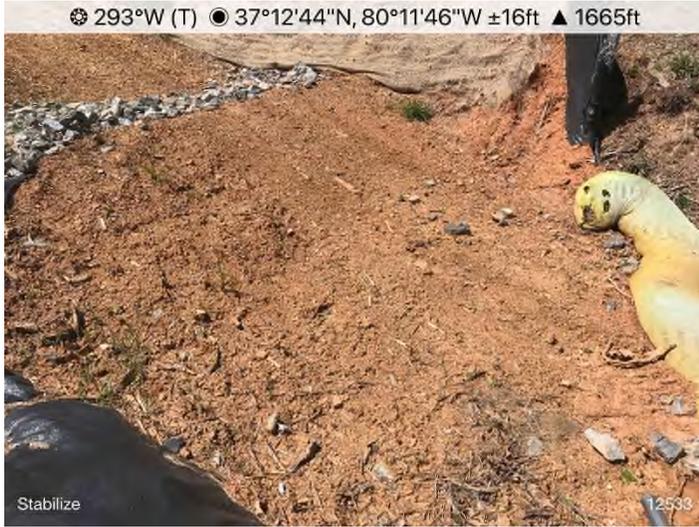
Figure 5: **STA 12533+00** – Re-stabilize denuded area for landowner access below checkdam.
