## COMPLAINT INSPECTION REPORT

<b>Project Name:</b>	Mountain Valley Pipeline	<b>Inspector:</b>	Marshall Willis
<b>Inspection Date:</b>	Tuesday, July 2, 2019	<b>Project Contact:</b>	Brian Clauto
<b>Spread H: Montgomery County</b>	STA 12190+85 – 12200+00 ATWS 1446 & 1375	<b>Weather (Wet/Dry/Rain):</b>	Dry

# FIELD INSPECTION PHOTO LOG

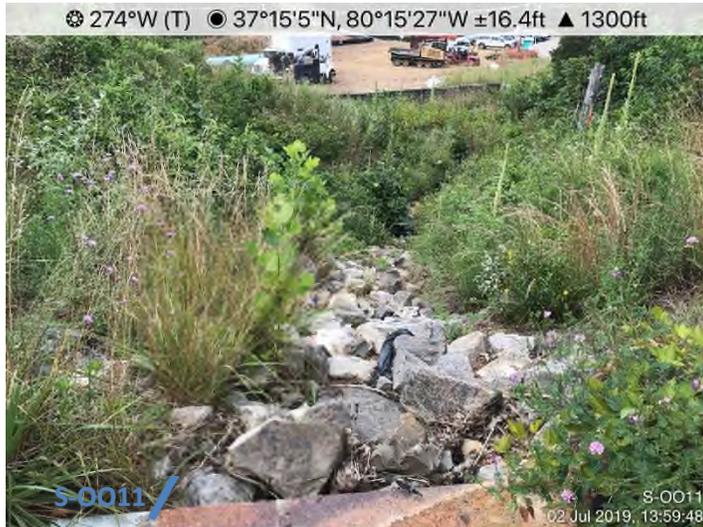
**Fig. 1: Photo Location "A"** – Stream S-0011 on the west side of Norfolk Southern ROW.

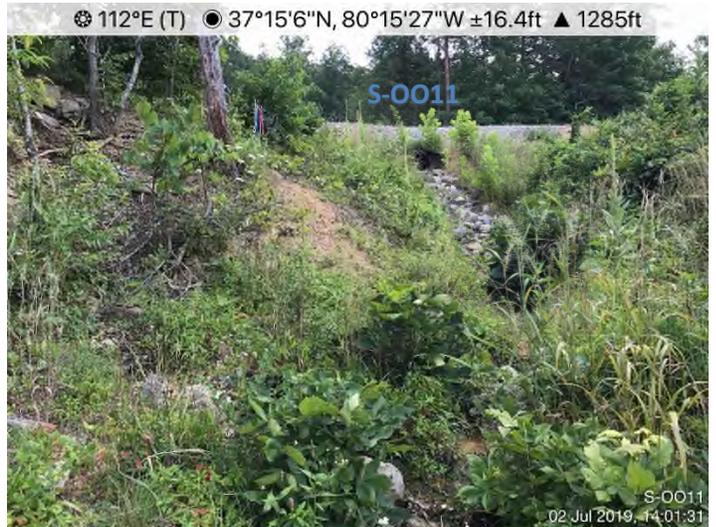
**Fig. 2: Photo Location "B"** – Sediment discharge from west side of Norfolk Southern ROW towards Stream S-0011.

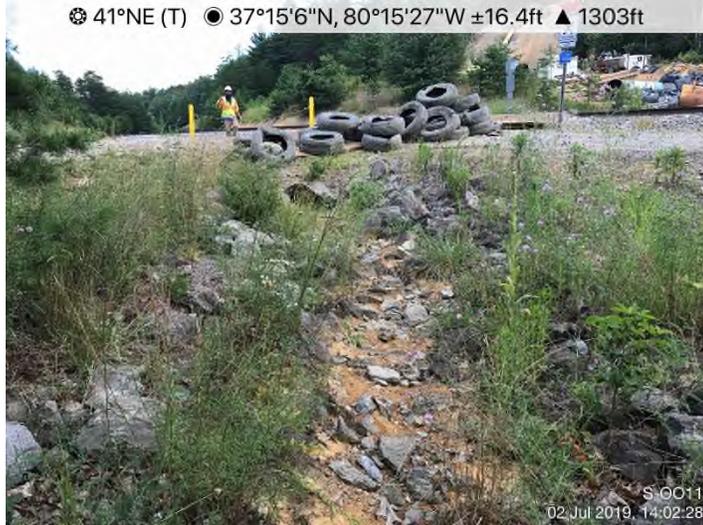
**Fig. 3: Photo Location "C"** – Sediment discharge from west side of Norfolk Southern ROW towards Stream S-0011.

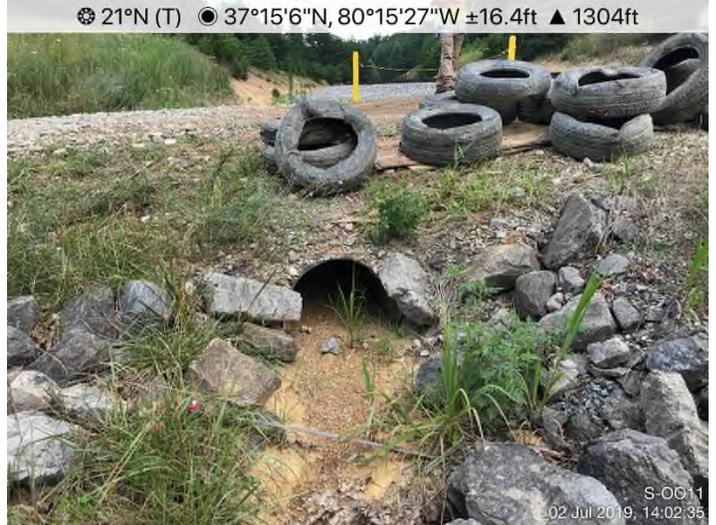
**Fig. 4: Photo Location "D"** – Sediment discharge from west side of Norfolk Southern ROW towards Stream S-0011.

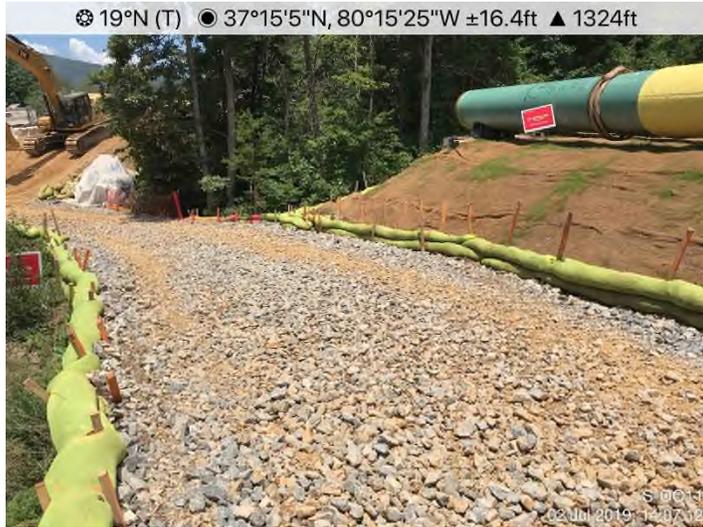
Fig. 13: **ATWS 1375** – Controls in place above Stream S-OO11 (UNT to Bradshaw Creek).

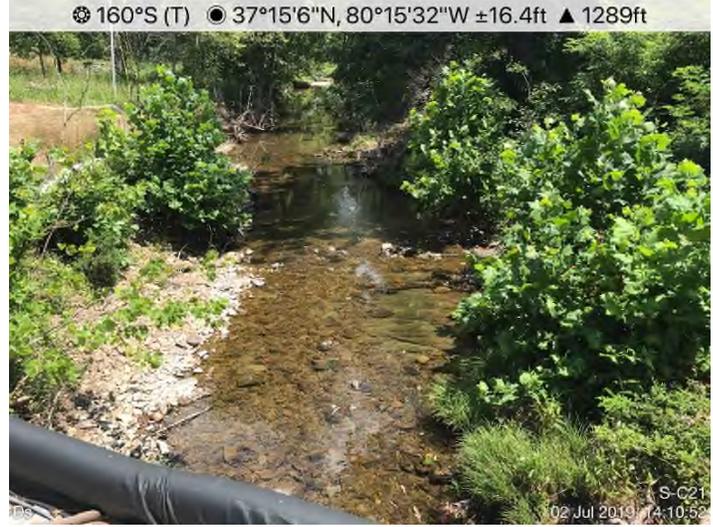
Fig. 14: **Stream S-C21** – Downstream view of Bradshaw Creek. Controls in place. (STA 12192+50)

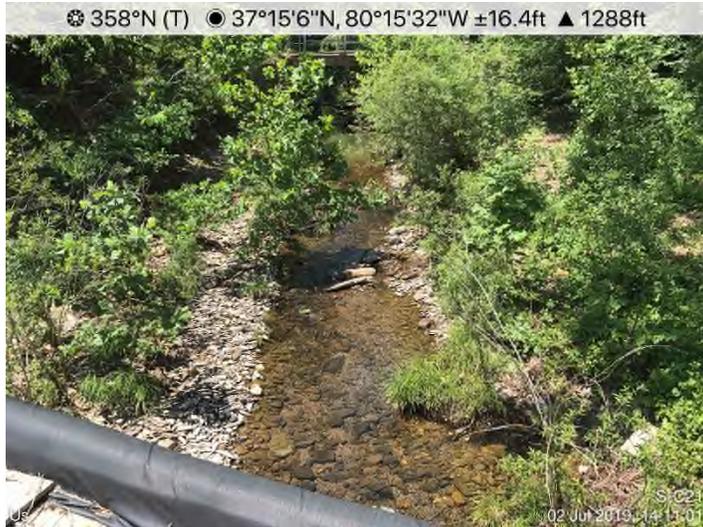
Fig. 15: **Stream S-C21** – Upstream view of Bradshaw Creek. Controls in place. (STA 12192+50)
