COMPLAINT INSPECTION REPORT

Project Name:	Mountain Valley Pipeline	Inspector:	Marshall Willis
Inspection Date:	Wednesday, July 31, 2019	Project Contact:	Brian Clauto
Spread H: Montgomery County	STA 12180+00 – 12200+00 ATWS 703, ATWS 704A, ATWS 1446 & ATWS 1375 MVP-MN-275/274	Weather (Wet/Dry/Rain):	Wet

Background: This investigation was conducted in response to a complaint (IR#: 291656) received on July 30, 2019 for the Bradshaw Creek area. The complaint describes sediment runoff below MVP ROW on Bradshaw Road and into Bradshaw Creek. The complainant also described the condition of Bradshaw Creek as “clear upstream but has high turbidity near pipeline ROW.”

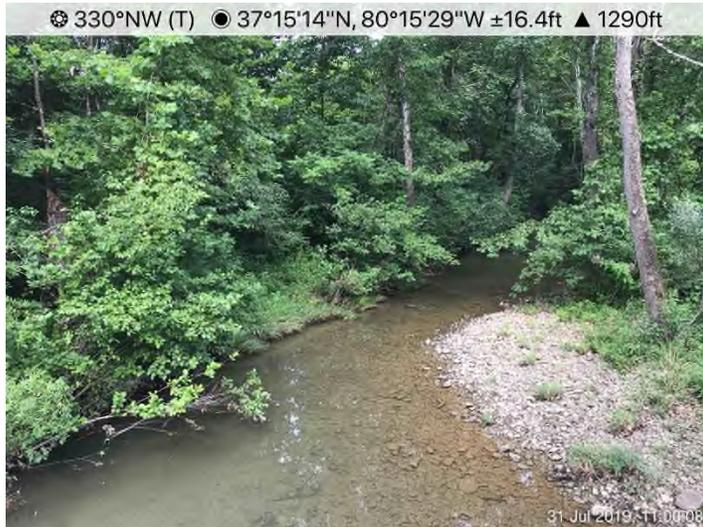
4. There was no evidence of high turbidity upstream or downstream of the MVP crossing of Bradshaw Creek (S-C21). See Figures 1, 5, 7, 8 and 12.
5. Minor sedimentation was observed deposited in the riprap channel of Stream S-OO11 starting at STA 12197+73. Source of the sediment is likely a combination of turbid water discharged through MVP ECDs during high intensity rainfall events and previous runoff from the Roanoke Valley Resource Authority (RVRA) property (See Figures 13, 14, 15, 16 & 17).

Fig. 1: Upstream Bradshaw Creek – 0.2 miles north of MVP ROW on Bradshaw Road.

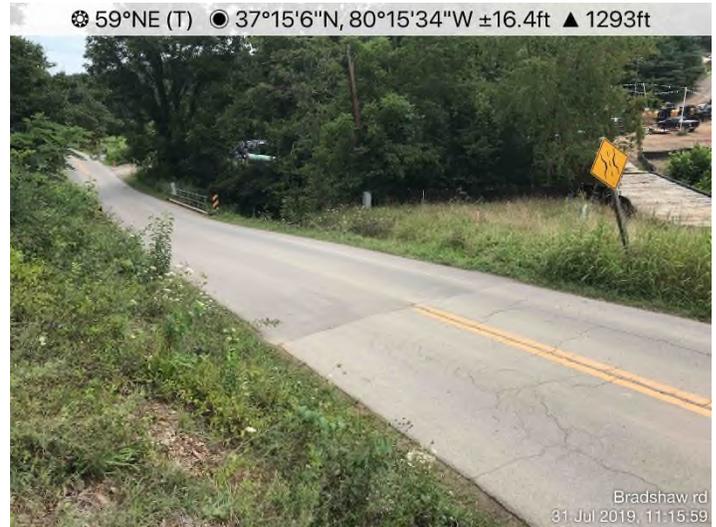
1. At the time of inspection, there was no evidence of sediment discharge from MVP ROW onto Bradshaw Road or into Bradshaw Creek. See Figures 2, 3, 4 & 5.

Fig. 2: STA 12190+75 – Bradshaw Road crossing. No evidence of sediment discharge from ROW.

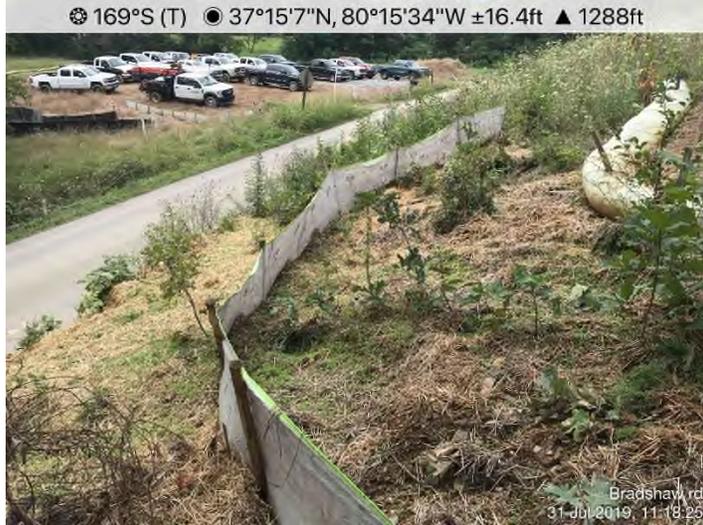
Fig. 3: STA 12190+75 – Bradshaw Road crossing. No evidence of sediment discharge from ROW. Controls functioning and area stabilized.

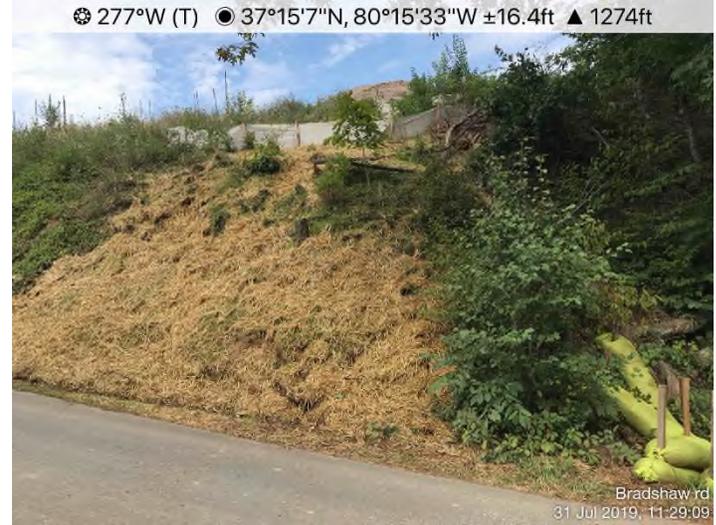
Fig. 4: STA 12190+95 – Bradshaw Road crossing. No evidence of sediment discharge from ROW. Slope stabilized.

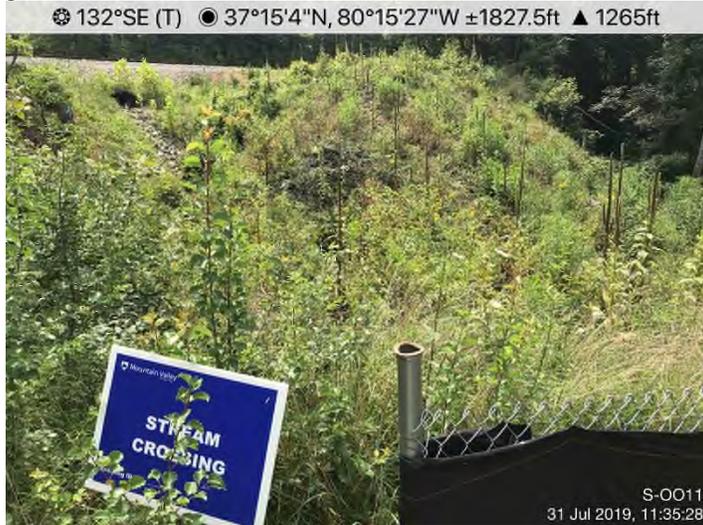
Fig. 9: **STA 12195+50** – Stream S-OO11 on the west side of Roanoke Valley Resource Authority (RVRA) tracks. No ground disturbance.

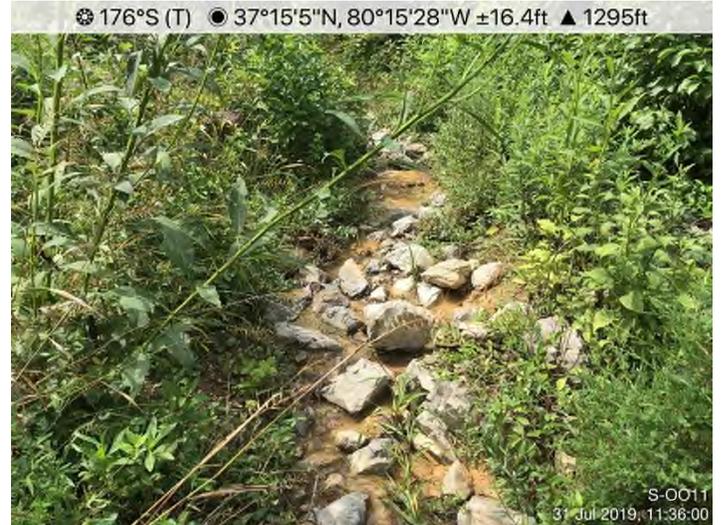
Fig. 10: **Stream S-OO11** – Sediment deposition in riprap channel of S-OO11 on west side of RVRA tracks at approx. STA 12196+24.

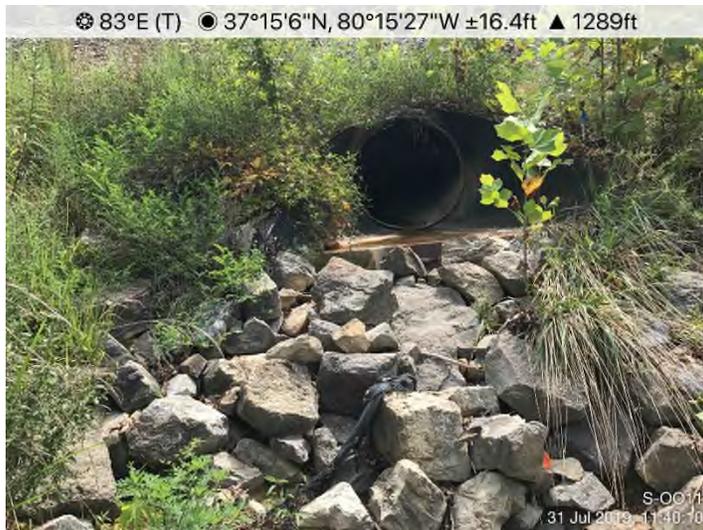
Fig. 11: **Stream S-OO11** – Outfall of S-OO11 on west side of RVRA tracks at approx. STA 12497+00

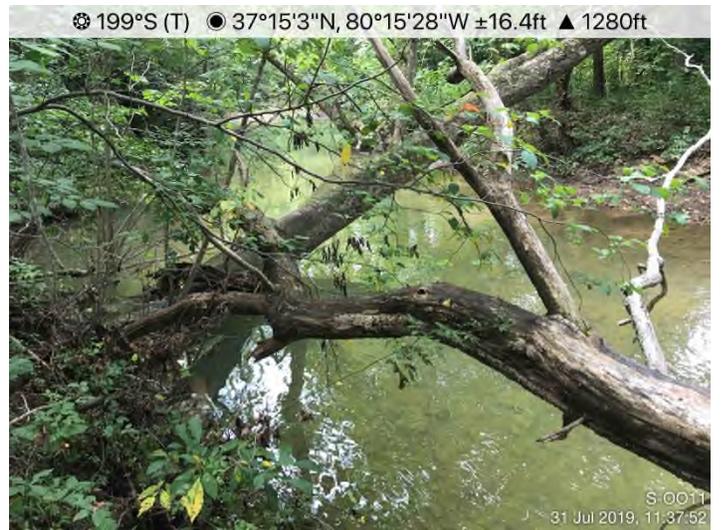
Fig. 12: **Bradshaw Creek** – Downstream of the confluence of S-OO11 and Bradshaw Creek. No increased turbidity from S-OO11.

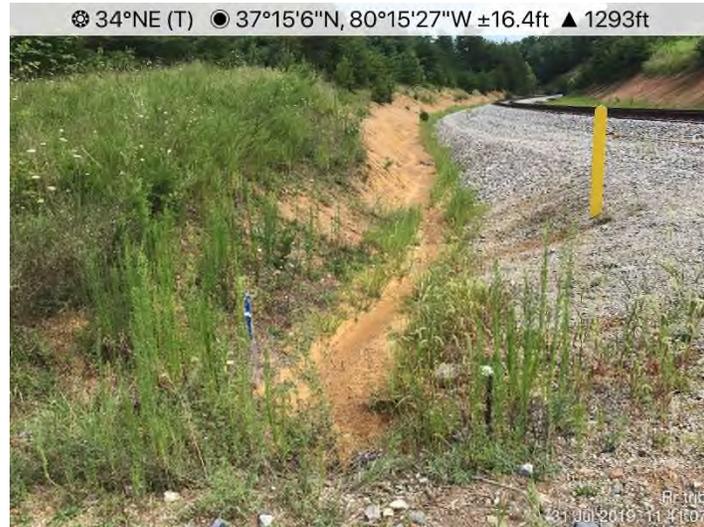
Fig. 13: **MVP-MN-275** – RVRA west track swale leading to S-OO11 north side of access road MVP-MN-275.

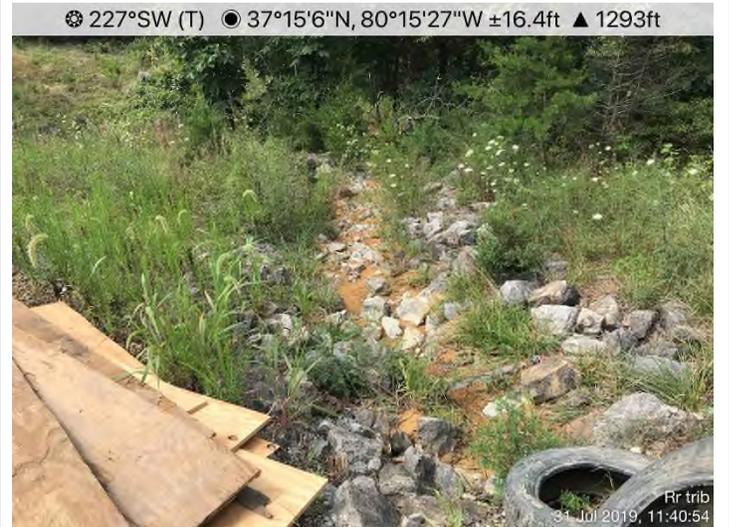
Fig. 14: **MVP-MN-275** – Minor sediment accumulation in RVRA west track swale leading to S-OO11 south side of access road MVP-MN-275.

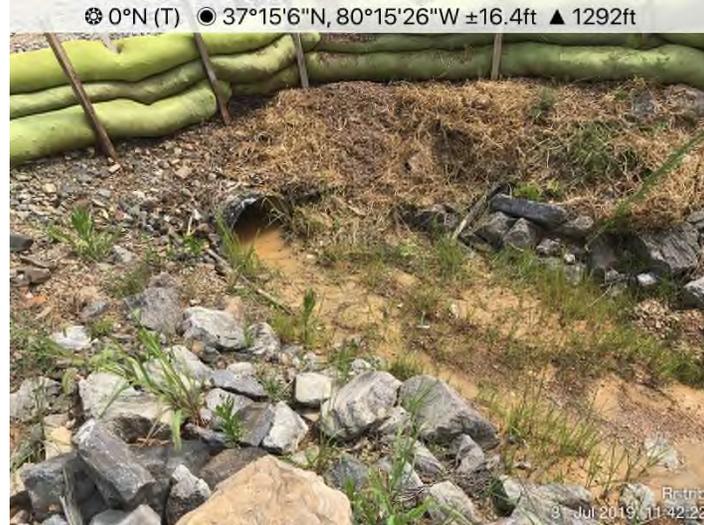
Fig. 15: **MVP-MN-275** – RVRA east track swale leading to S-OO11 south side of access road MVP-MN-275. Sediment accumulation evident in culvert and swale.

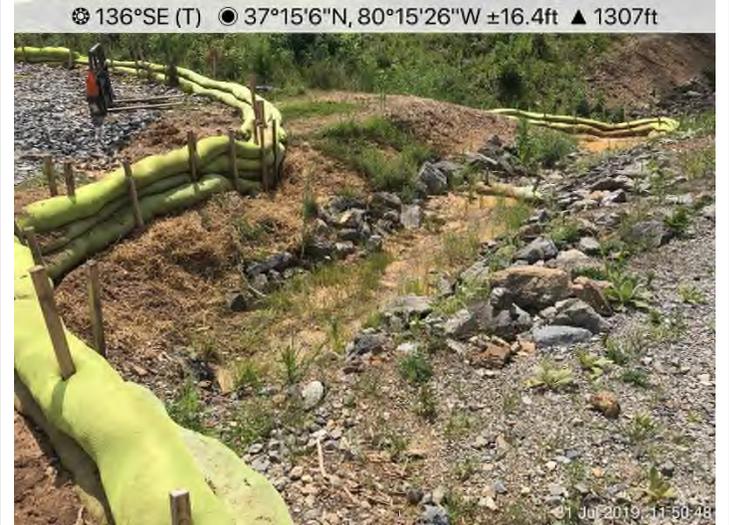
Fig. 16: **MVP-MN-275** – Sediment accumulation in RVRA east track swale leading to S-OO11 south side of access road MVP-MN-275.

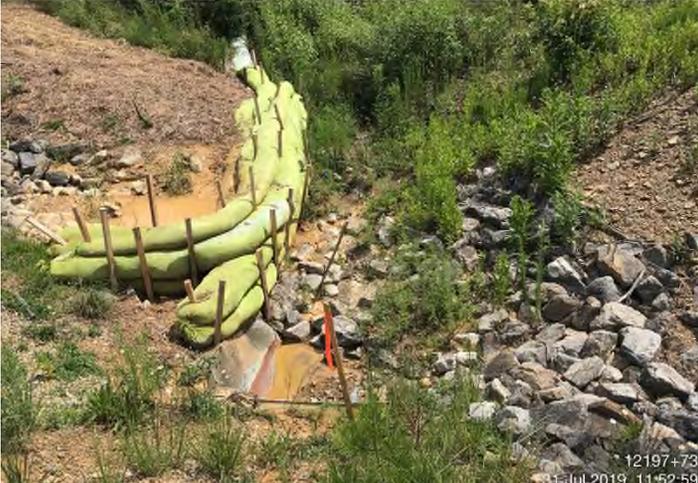
Fig. 17: **S-0011** – RVRA east track swale confluence with S-0011 south side of access road MVP-MN-275 at STA 12197+73. MVP controls in place and functioning. Minor sediment passing through ECDs into riprap of S-0011.

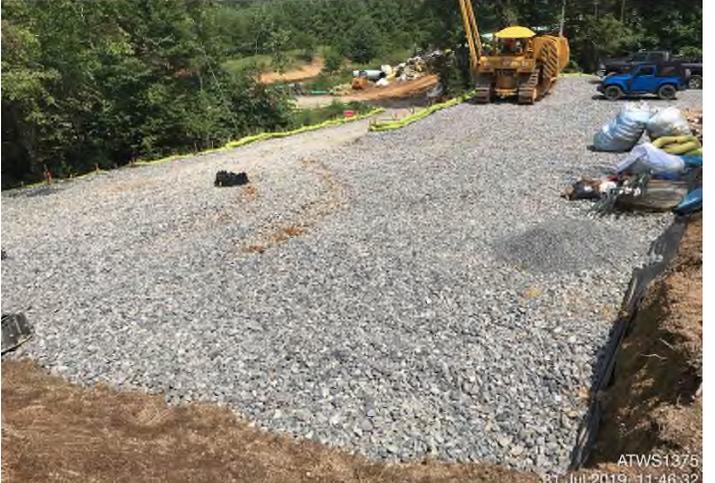
Fig. 18: **ATWS 1375** – Workspace stabilized with clean stone. Controls in place and functioning properly.

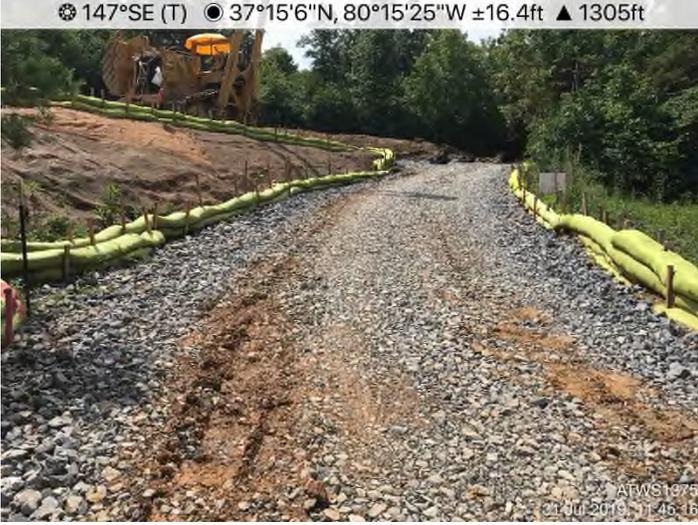
Fig. 19: **ATWS 1375** – Controls in place above S-0011 in ATWS 1375. Stone is clean and perimeter controls in place and functioning.

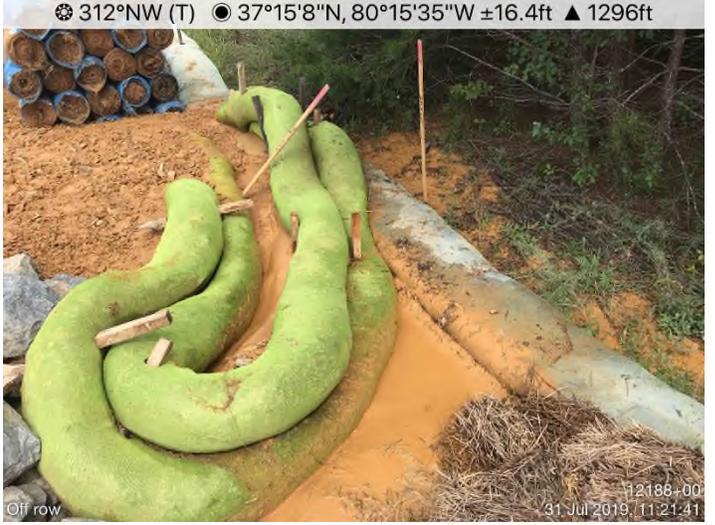
2. ECDs within the MVP LOD and along the resources were installed per the approved plans and appeared to be functioning as designed.
3. Sediment off ROW was found at STA 12188+00 (see Figure 20), however there were no impacts to Bradshaw Creek as a result.

STA 12188+00: Sediment off ROW.

Fig. 20: **STA 12188+00** – Sediment off ROW.

Recommended Corrective Action: Retrieve/stabilize sediment loss at STA 12188+00.
