COMPLAINT INSPECTION REPORT

Project Name:	Mountain Valley Pipeline	Inspector:	Marshall Willis
Inspection Date:	Monday, July 8, 2019	Project Contact:	Brian Clauto
Spread H: Montgomery County	STA 12180+00 – 12200+00 ATWS 703, ATWS 704A, ATWS 1446 & ATWS 1375 MVP-MN-275	Weather (Wet/Dry/Rain):	Dry

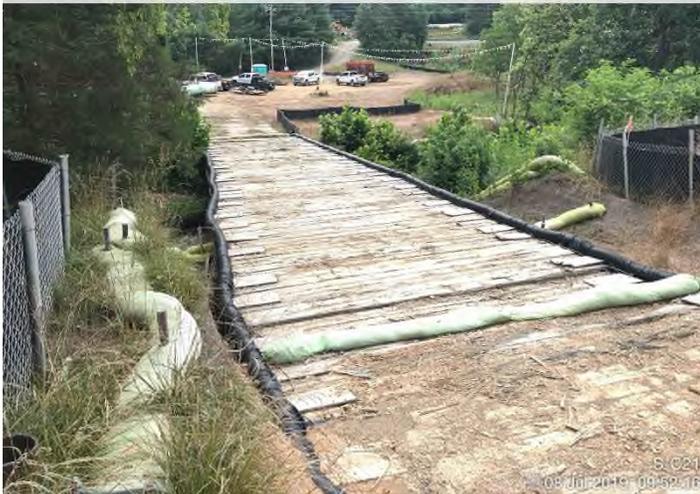
Fig. 1: **Stream S-C21** – Bradshaw Creek Crossing at approx. STA 12192+36. CFS and bridge waddles in place and in good condition. SSF installed correctly and functioning properly. Timber mat bridge clean and sideboards in appear in good condition.

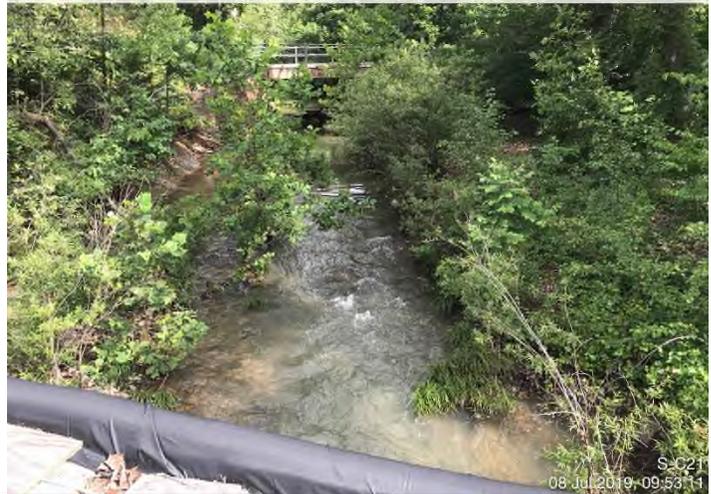
Fig. 2: **Stream S-C21** – Bradshaw Creek Crossing at approx. STA 12192+36. Looking upstream towards Bradshaw Road bridge.

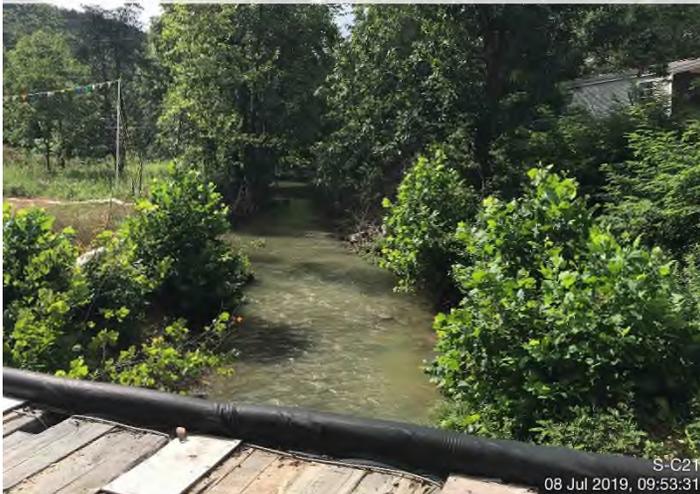
Fig. 3: **Stream S-C21** – Bradshaw Creek Crossing at approx. STA 12192+36. Looking downstream.

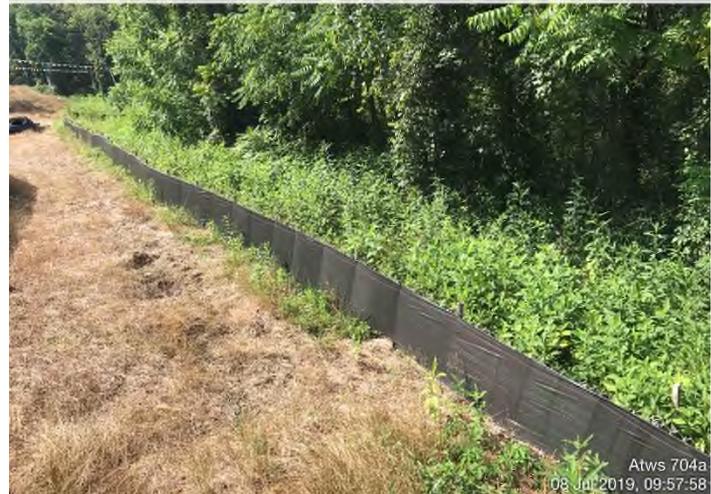
Fig. 4: **ATWS 704A** – Perimeter controls adjacent to S-C21 (Bradshaw Creek). SSF installed correctly and functioning properly. Dormant storage area within LOD stabilized with seed and straw.

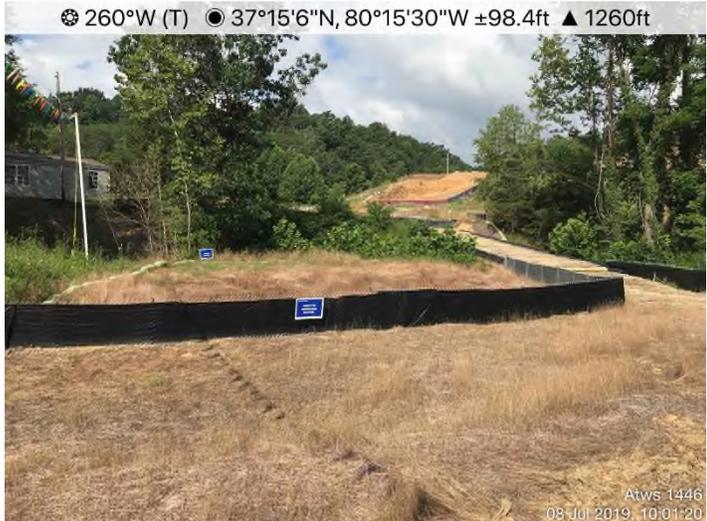
Fig. 5: STA 12194+23 – East side of S-C21 looking west at stream buffer area. SSF is installed correctly and in good condition. Stream buffer area protected and dormant construction areas stabilized with seed, straw and Earth-Guard.

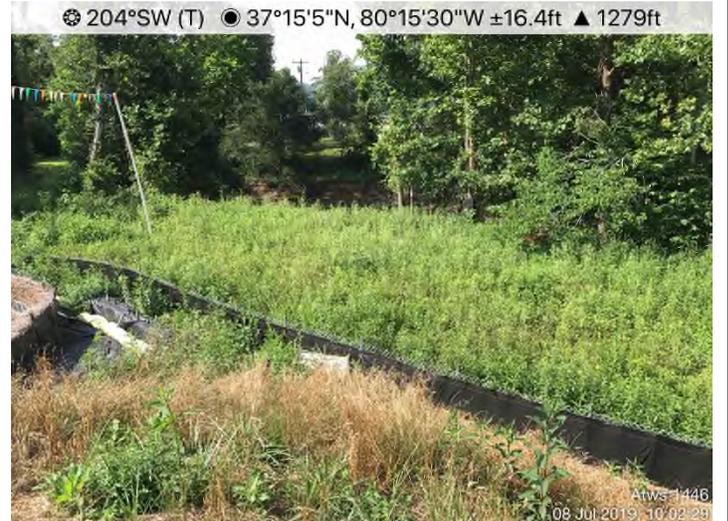
Fig. 6: ATWS 1446 – Looking west at perimeter controls adjacent to S-C21 (Bradshaw Creek). SSF installed correctly and functioning properly. Dormant storage area within LOD stabilized with seed and straw.

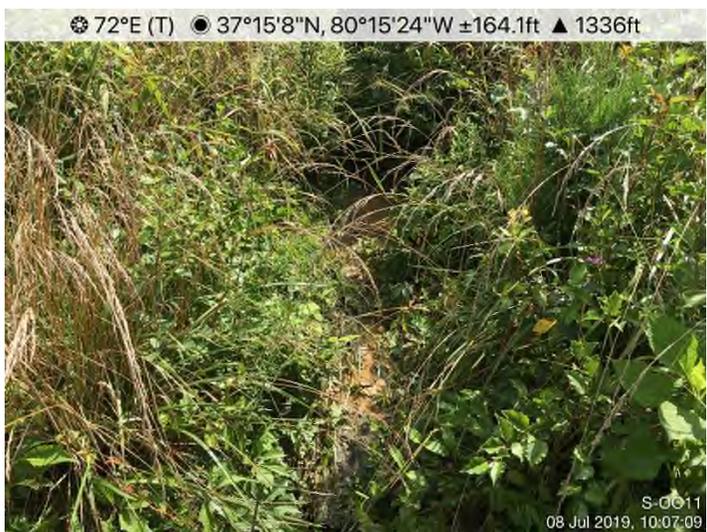
During the inspection, Stream S-OO11 (UNT to Bradshaw Creek) was found to be impacted from denuded banks from within the Norfolk Western ROW. These impacts were discovered and documented during a previous investigation by DEQ inspectors on July 02, 2019. See Photo Log Figures 7, 9 and 10 below.

Fig. 7: Stream S-0011 – Sediment impacting S-0011 (UNT to Bradshaw Creek) at approx. STA 12196+24.

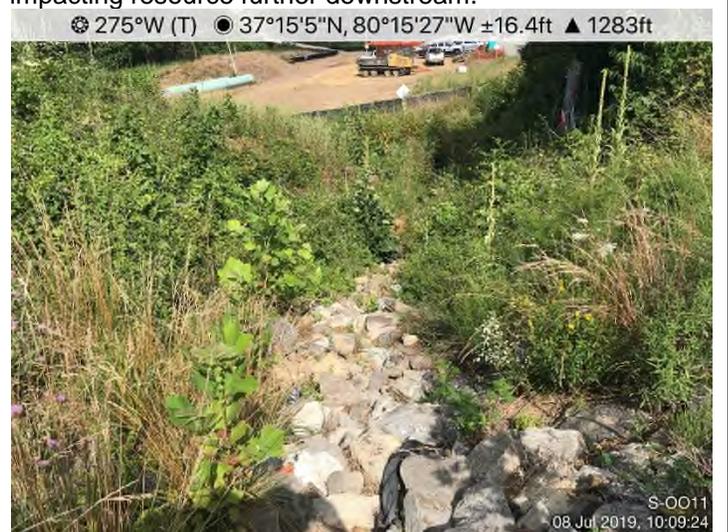
Fig. 8: Stream S-0011 – Riprap outfall channel of S-0011 culvert on west side of Norfolk Western railroad tracks. Riprap appeared to be clean and free of sediment found impacting resource further downstream.

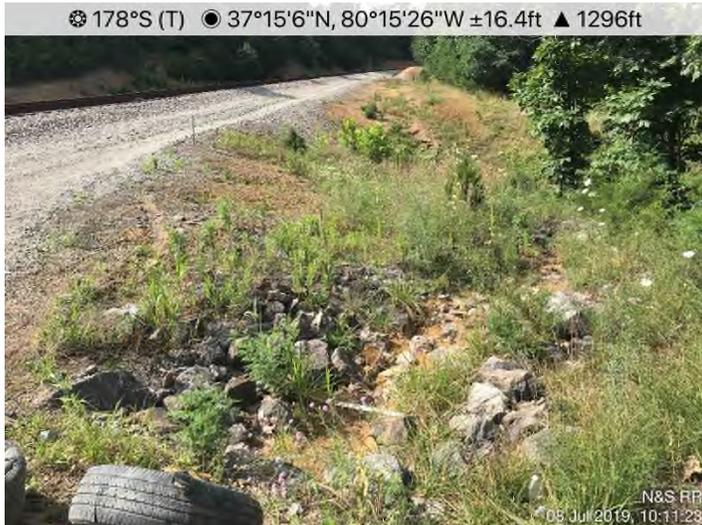
Fig. 9: Access Road MVP-MN-275 – Looking south from MVP-MN-275. Sediment laden riprap outfall from road culvert flowing towards stream S-OO11.

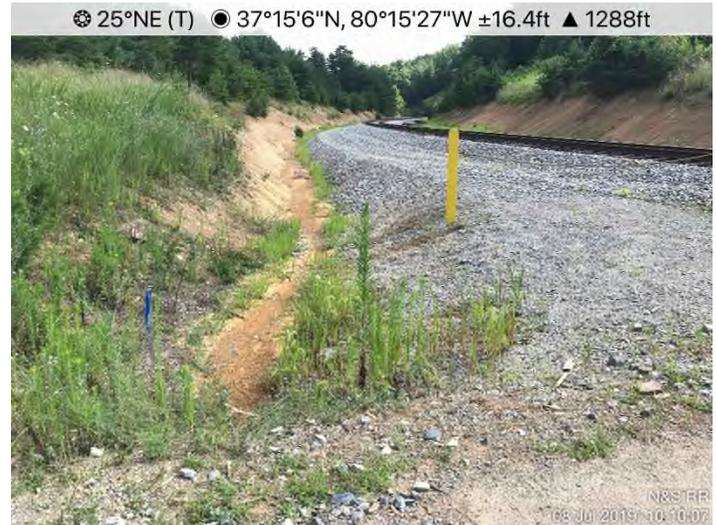
Fig. 10: Access Road MVP-MN-275 – Source of sediment impacting stream S-OO11 off MVP ROW on north side of MVP-MN-275.

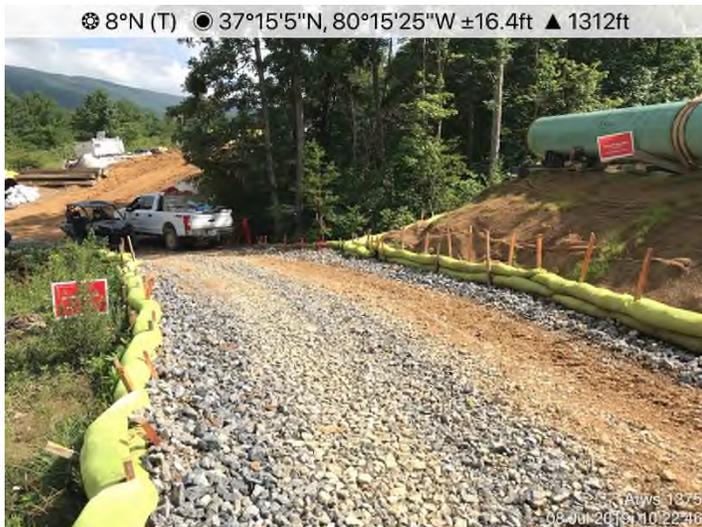
Fig. 11: ATWS 1375 – Looking north from ATWS 1375 towards stream S-OO11. CFS is in good condition. Dormant areas stabilized with seed, straw and fabric.

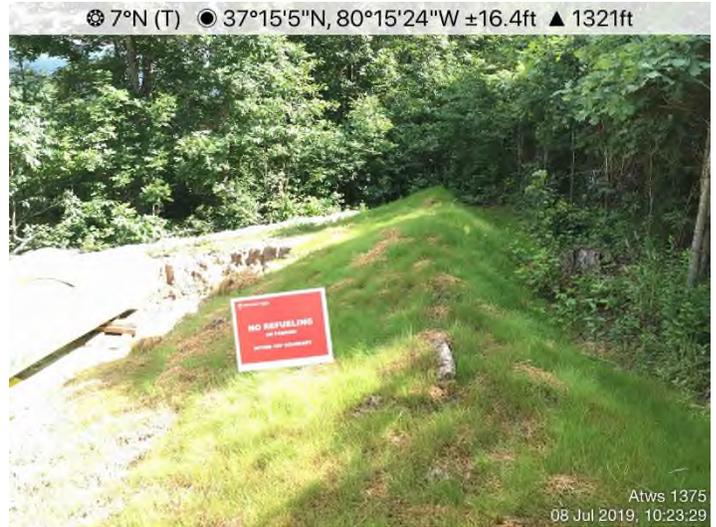
Fig. 12: ATWS 1375 – Looking north from ATWS 1375 towards stream S-OO11. Perimeter diversions berm stabilized with seed and straw.
