## COMPLAINT INSPECTION REPORT

<b>Project Name:</b>	Mountain Valley Pipeline	<b>Inspector:</b>	Marshall Willis
<b>Inspection Date:</b>	Tuesday, July 2, 2019	<b>Project Contact:</b>	Brian Clauto
<b>Spread I: Franklin County</b>	STA 13840+00 – 13892+45	<b>Weather (Wet/Dry/Rain):</b>	Dry

# FIELD INSPECTION PHOTO LOG

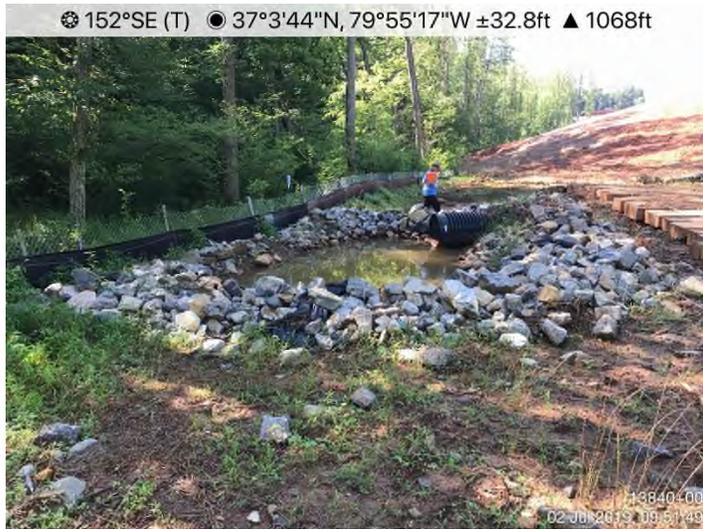
**Fig. 1: STA 13840+00** – Install and stabilize berm around CWD plunge pool.

**Recommended Corrective Action:** Maintain and install all controls per the approved plan and PSS&S.

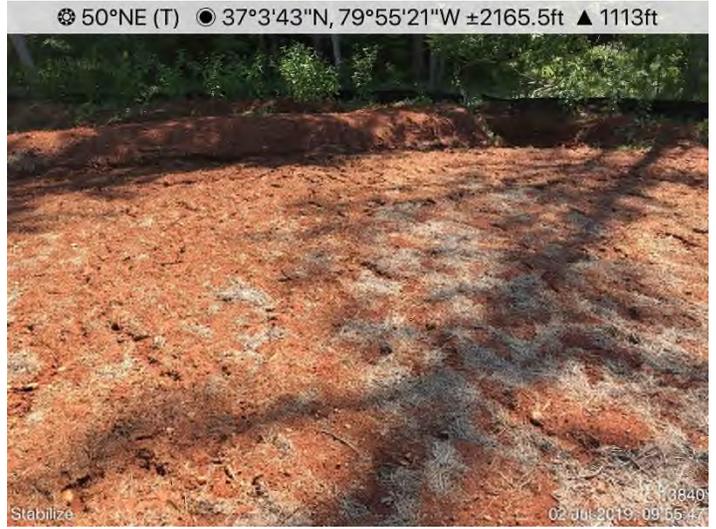
**Fig. 2: STA 13844+07 to 13846+78** – Repair rill erosion and adequately stabilize.

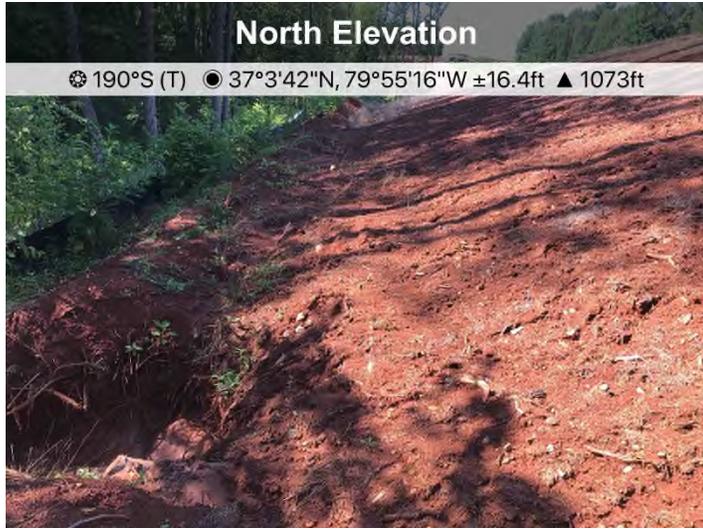
**Fig. 3: STA 13844+07 to 13846+78** – Repair and stabilize perimeter berms.

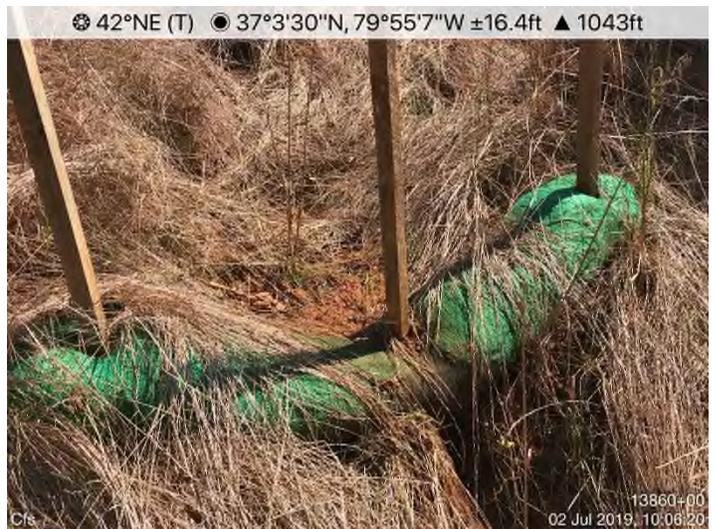
**Fig. 4: STA 13860+00** – CFS maintenance needed.

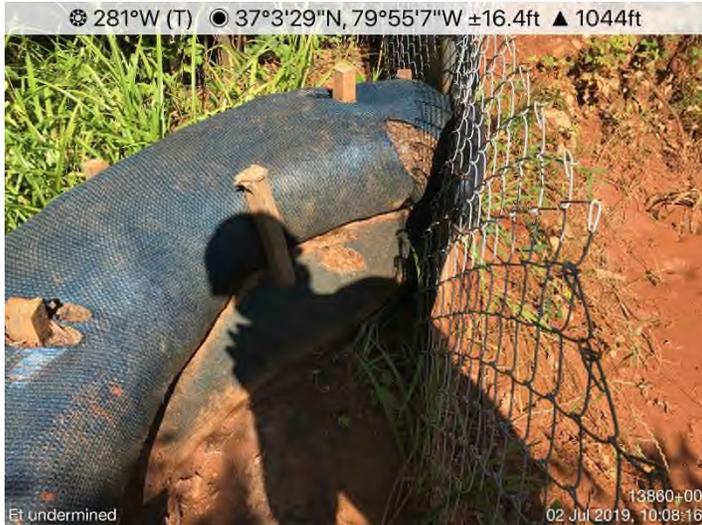
Fig. 5: **STA 13860+00** – CFS end treatment undermined.

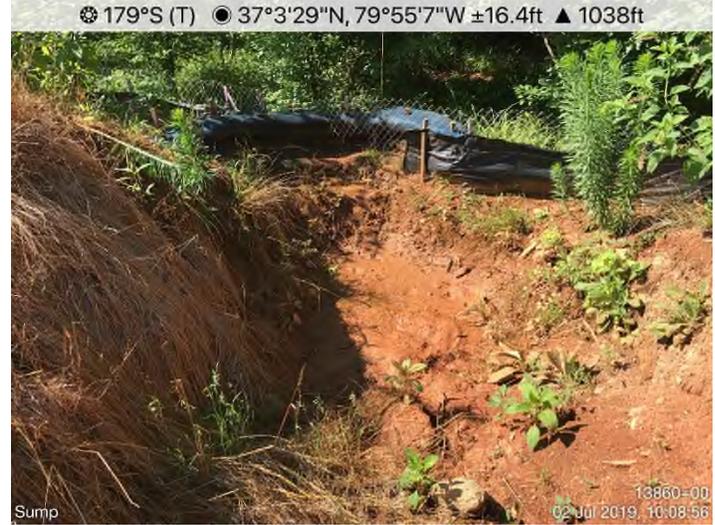
Fig. 6: **STA 13860+00** – Sump maintenance needed.

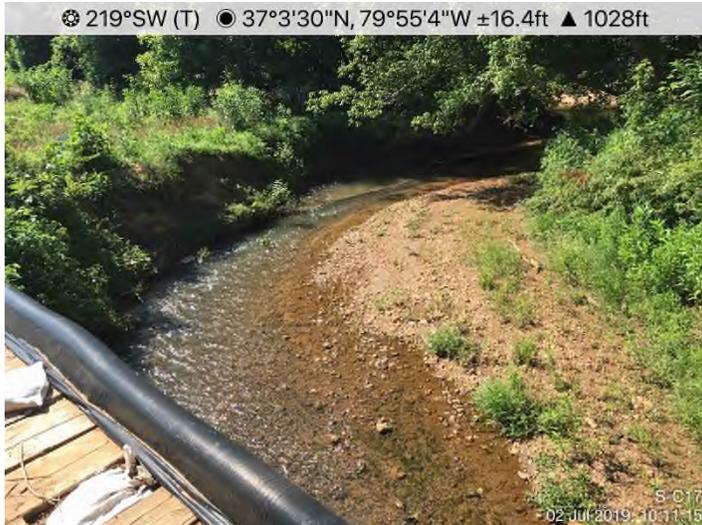
Fig. 7: **Stream S-C17** – Teels Creek. Controls in place.

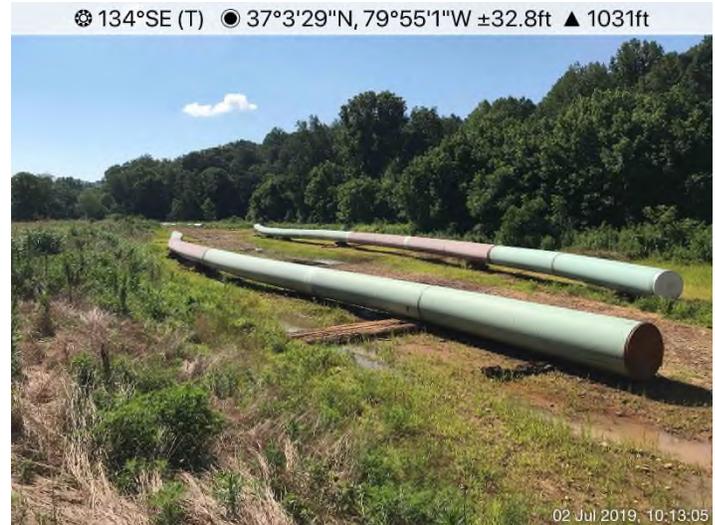
Fig. 8: **STA 13864+47** – Area stabilized. Controls in place.

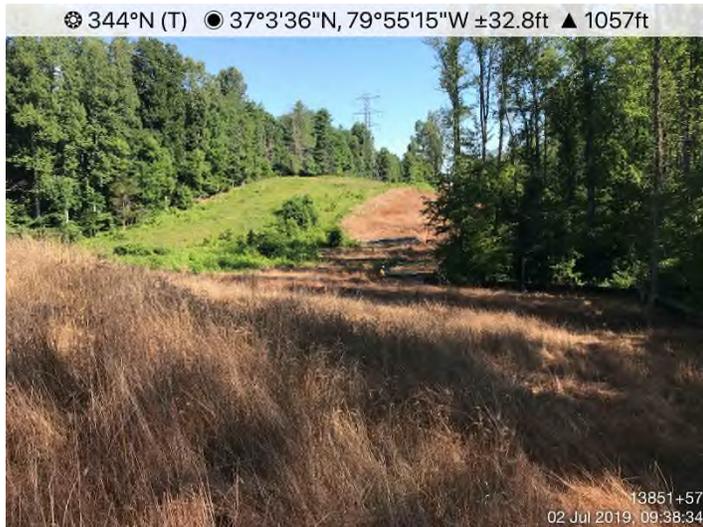
**Fig. 9: STA 13851+57** – Area stabilized. Controls in place.

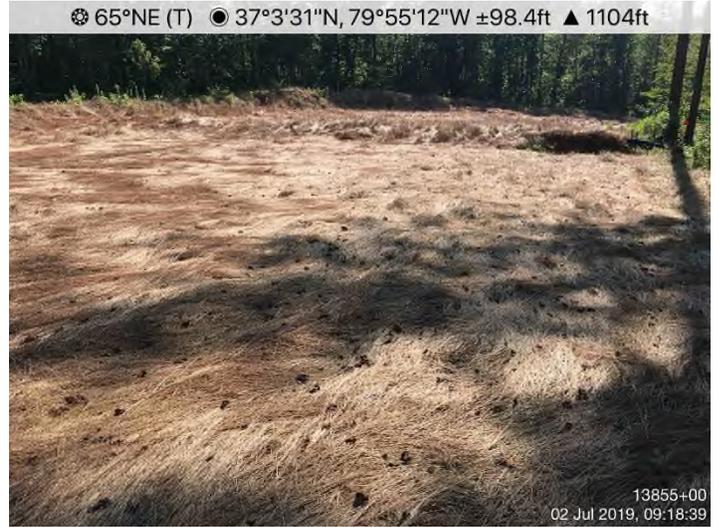
**Fig. 10: STA 13855+00** – Area stabilized. Controls in place.

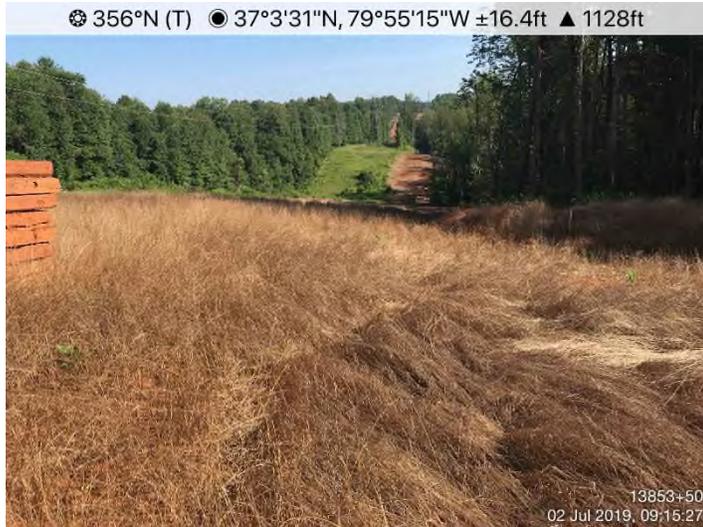
**Fig. 11: STA 13853+50** – Area stabilized. Controls in place.

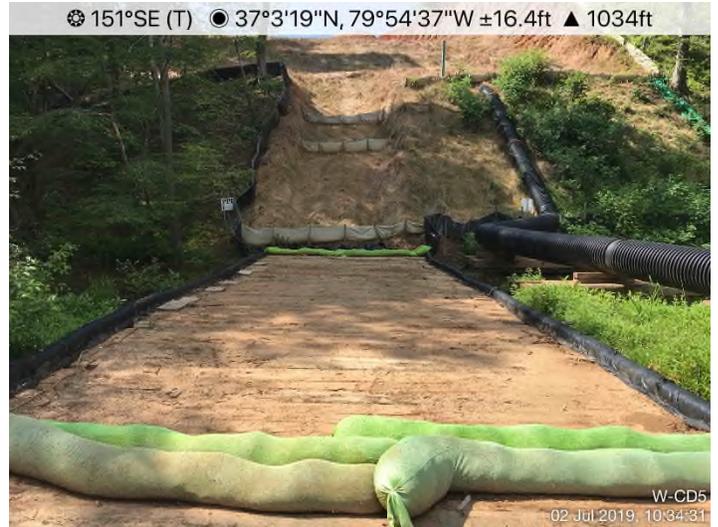
**Fig. 12: Wetland W-CD5** – Controls in place.
