COMPLAINT INSPECTION REPORT

Project Name:	Mountain Valley Pipeline	Inspector:	John McCutcheon
Inspection Date:	Wednesday, August 15, 2018	Project Contact:	Brian Clauto, Tracy Hilbun
Spread:	Spread I	Weather (Wet/Dry/Rain):	Dry

PIPELINE SWPPP INSPECTION REPORT REQUEST FOR CORRECTIVE ACTION

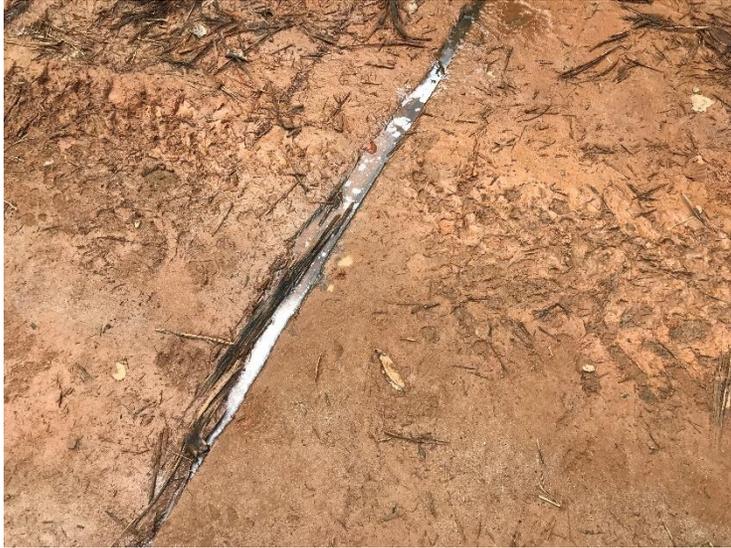
Comment 2.

1. Metal shavings were not found in this area. Crew typically remove shavings with magnets after pipe dressing operations conclude. Crews were working in cleaning and coating the welded pipe at the time of this inspection.
2. No petroleum-based oil was seen on the mats in the area, although an oil-like sheen from organic compounds in the iron-rich soils was seen in several places.
3. A field-constructed sediment trap constructed at the end of a pipe system next to wetland crossing W-CD5 had a gap in its impoundment dike and the dike was not stabilized.

Oil-like organic sheen on timber mats.

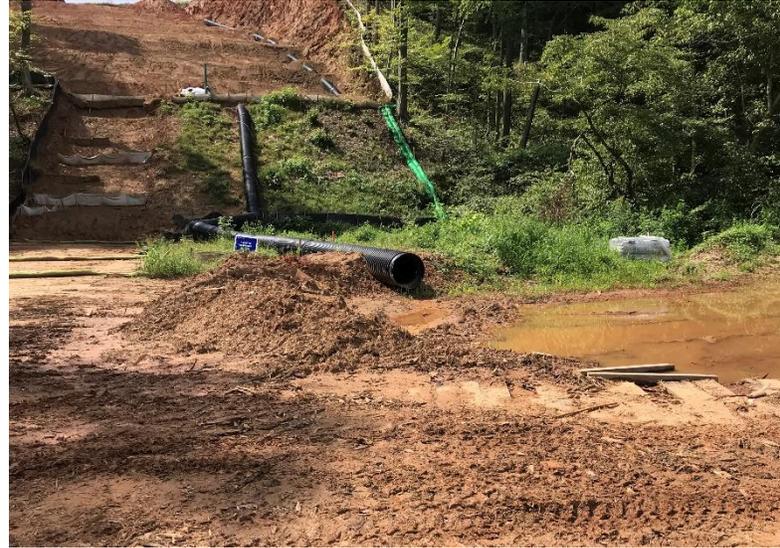
Comment 3.

Comment #	Regulatory Citation/Legal requirement ¹	Observation/Recommended Corrective Action
3	(Va. Code §62.1-44.15:31) (MVP Standards & Specifications for VA, p. 1) (9VAC 25-840-40.4, 9VAC 25-840-40.5).	<p>Observation Dike at sediment trap has a gap in it and the dike is not stabilized.</p> <p><u>Recommended Corrective Action:</u> <i>Close gap in dike and stabilize immediately..</i></p>

Gap in sediment trap dike.

Recommended Corrective Action Deadline: Within 24 Hours of notice

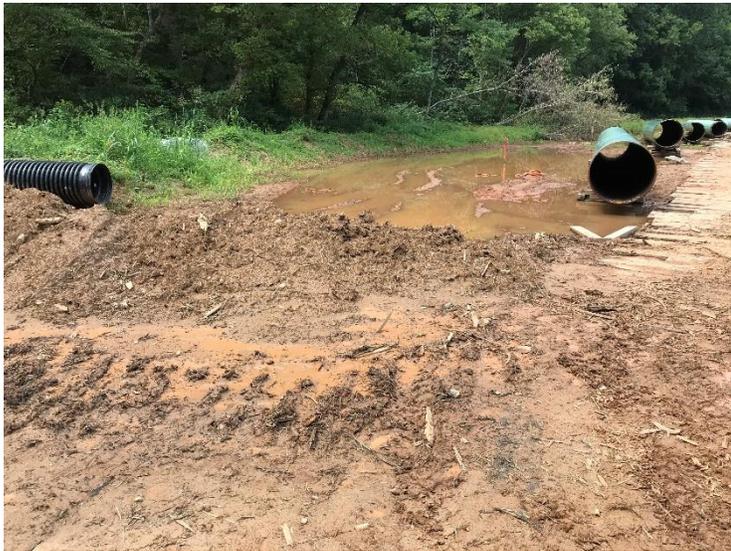
Comment 3

Unstabilized sediment trap dike.
