FIELD INSPECTION REPORT

Project Name:	Mountain Valley Pipeline	Inspector:	Marshall Willis
Inspection Date:	Thursday, January 30, 2020	Project Contact:	Brian Clauto, Cory Chalmers
Spread G: Giles County	STA 11236+21 – 11159+86 STA 10929+71 – 10971+74 MVP-GI-249.01/249.02/242.01	Weather:	Dry

FIELD INSPECTION PHOTO LOG

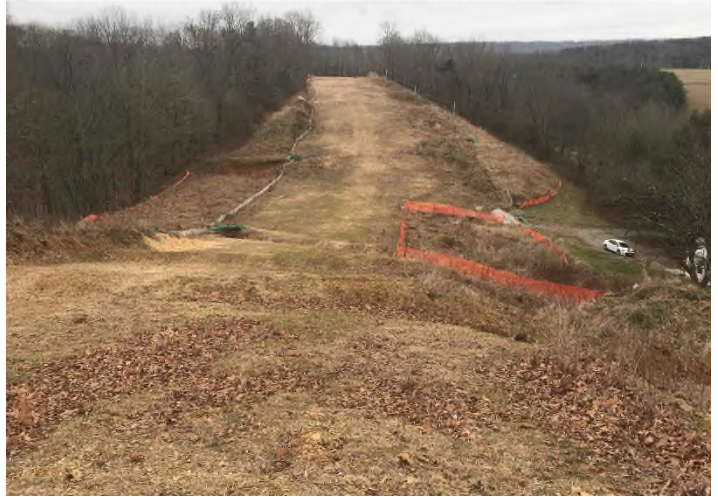
Figure 2: STA 11203+00 – Controls in place and functioning properly. Area stabilized with straw.

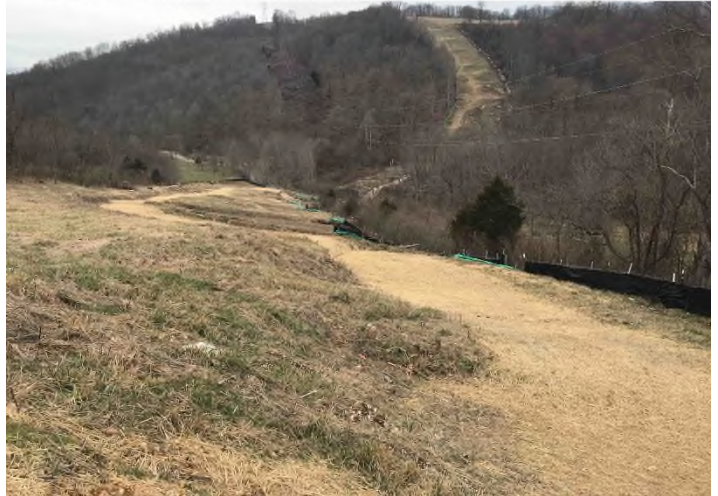
Figure 4: STA 10932+00 – Controls in place and functioning properly. Area stabilized with straw.
