FIELD INSPECTION

Project Name:	Mountain Valley Pipeline	Inspector:	Marshall Willis
Inspection Date:	Monday, January 6, 2020	Project Contact:	Brian Clauto, Cory Chalmers
Spread G: Montgomery County Giles County	STA 11596+94 – 11618+91 STA 11204+61 – 11246+69 MVP-MN-258.03/258.04/MLV-AR-25 ATWS 1373/1057/1370/1370A/1347	Weather (Wet/Dry/Rain):	Dry

FIELD INSPECTION PHOTO LOG

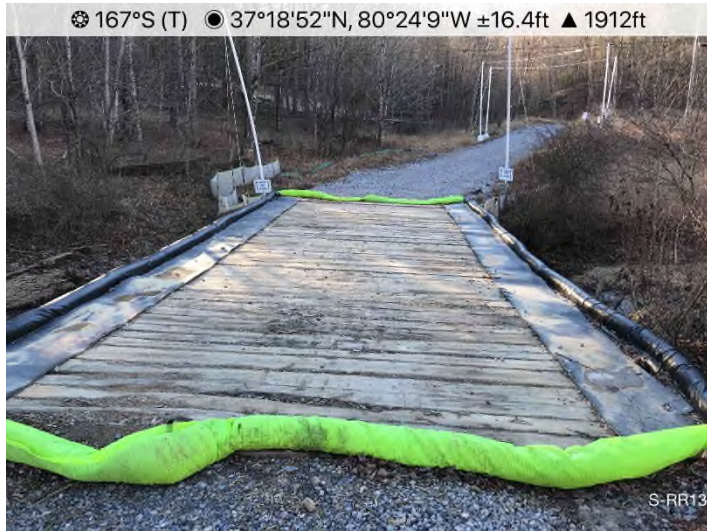
Fig. 1: **Stream S-RR13** – Controls in place and functioning properly.

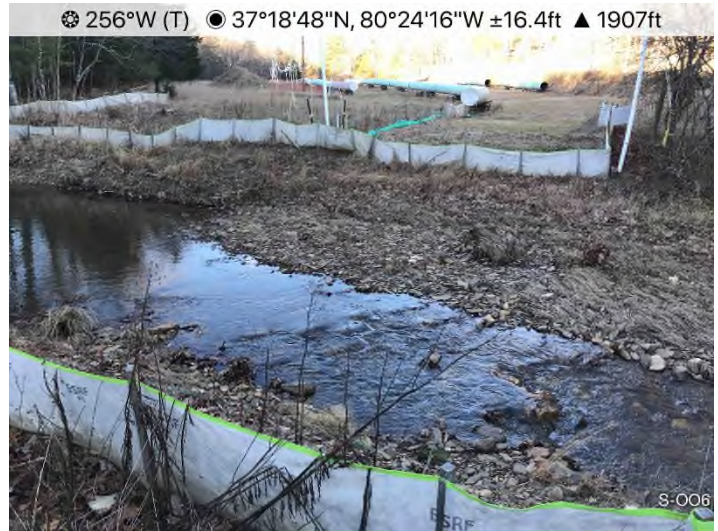
Fig. 2: **Stream S-006** – Controls in place and functioning properly.

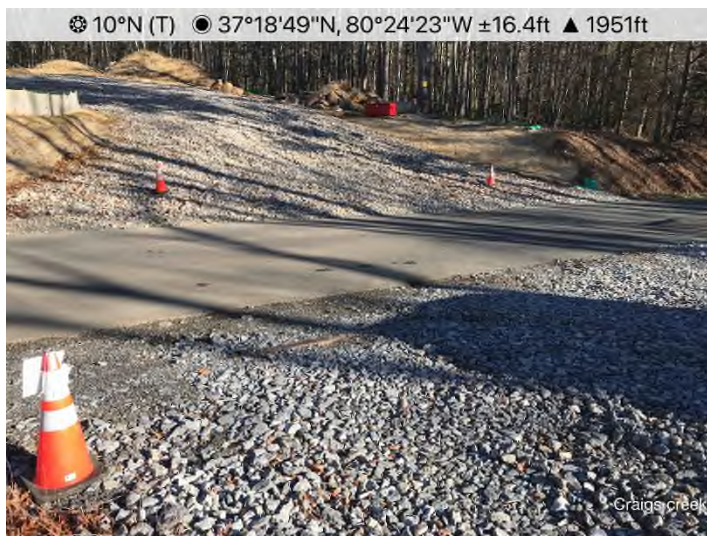
Fig. 3: **STA 11600+00** – Craig's Creek Road crossing controls in place and functioning properly.

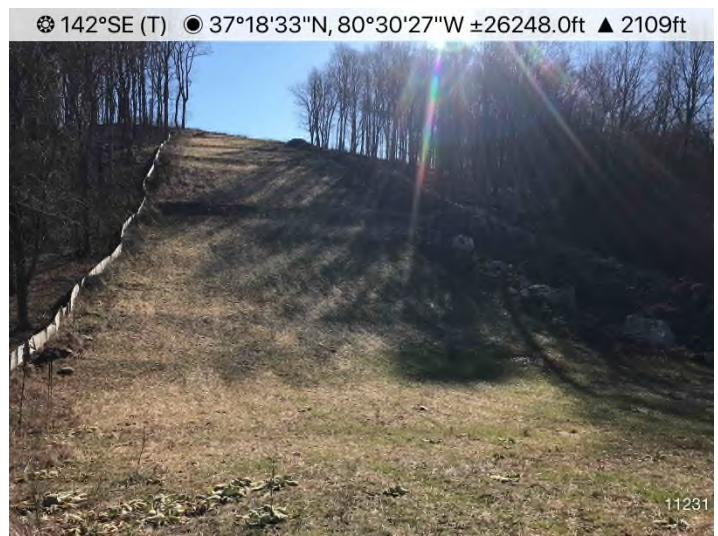
Fig. 4: **STA 11231+00** – Controls in place and functioning properly. Area stabilized with straw and vegetation.
