FIELD INSPECTION

Project Name:	Mountain Valley Pipeline	Inspector:	Marshall Willis
Inspection Date:	Friday, October 4, 2019	Project Contact:	Brian Clauto, Cory Chalmers
Spread G: Giles County Craig County	MVP-CR-258.02 STA 11227+59 – 11600+01 STA 11236+90 – 11210+00 STA 11520+90 – 11530+00	Weather (Wet/Dry/Rain):	Dry

FIELD INSPECTION PHOTO LOG

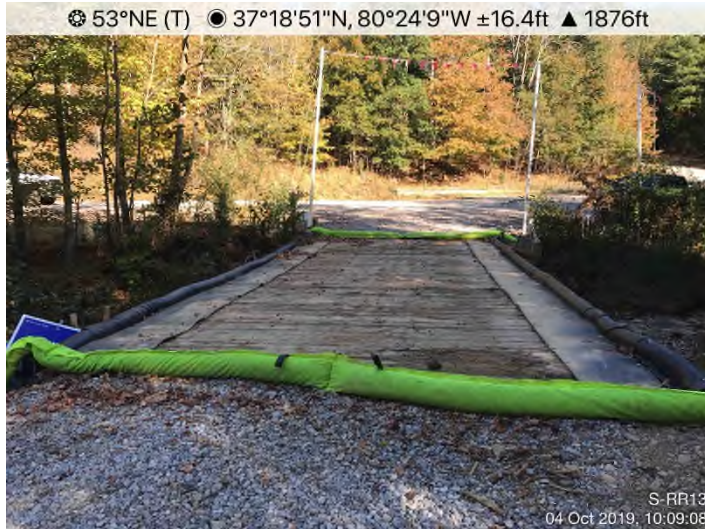
Fig. 1: **Stream S-RR13** – Controls in place and functioning properly.

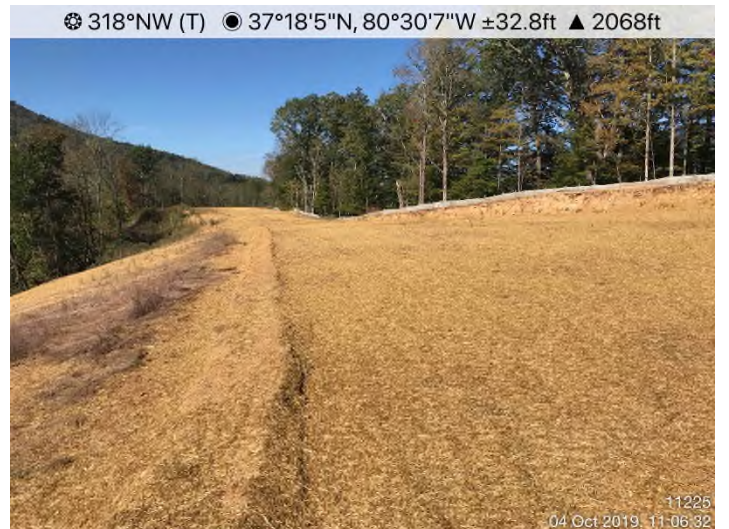
Fig. 2: **STA 11225+00** – Controls in place and appear to be functioning properly. Area stabilized.

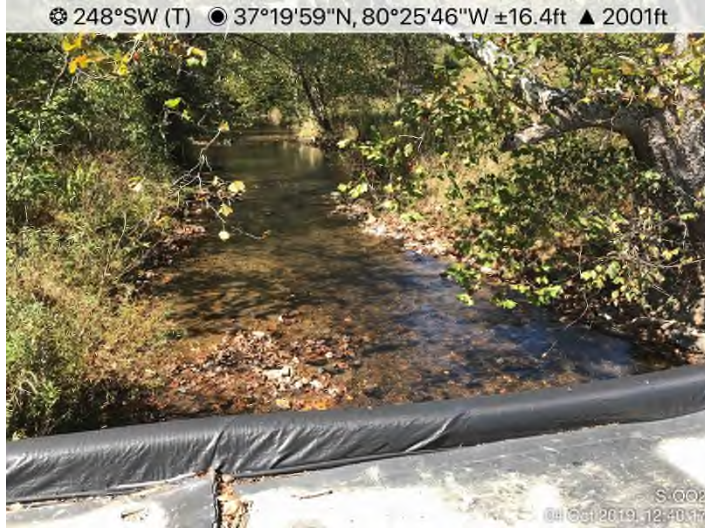
Fig. 3: **Stream S-002** – Sinking Creek crossing, downstream view. Controls in place and functioning properly.

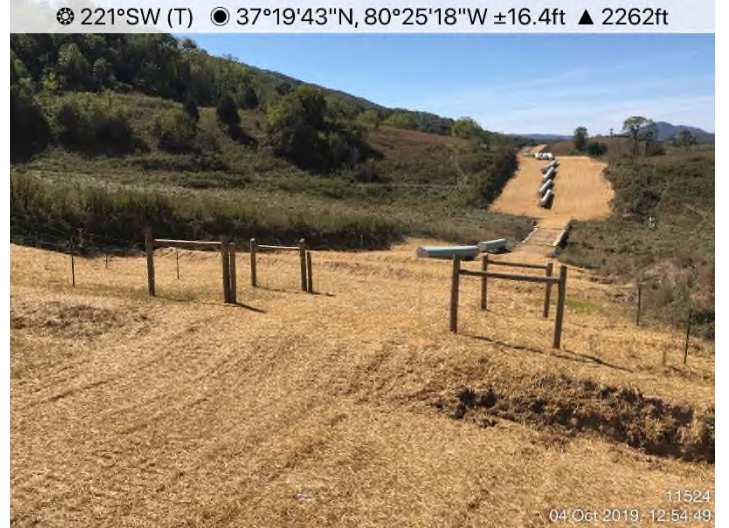
Fig. 4: **STA 11524+00** – Controls in place. Area stabilized.
