FIELD INSPECTION

Project Name:	Mountain Valley Pipeline	Inspector:	Marshall Willis
Inspection Date:	Wednesday, November 20, 2019	Project Contact:	Brian Clauto, Cory Chalmers
Spread G: Montgomery County	STA 11327+85 – 11471+52 MVP-GI-258.01/256.02/256 ATWS 633/633A	Weather (Wet/Dry/Rain):	Dry

FIELD INSPECTION PHOTO LOG

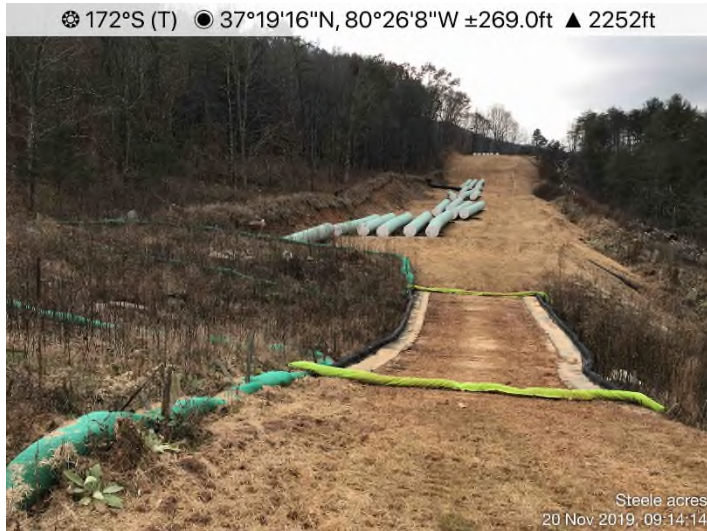
Fig. 1: **STA 11469+60** – Controls in place and functioning properly. Area adequately stabilized with straw.

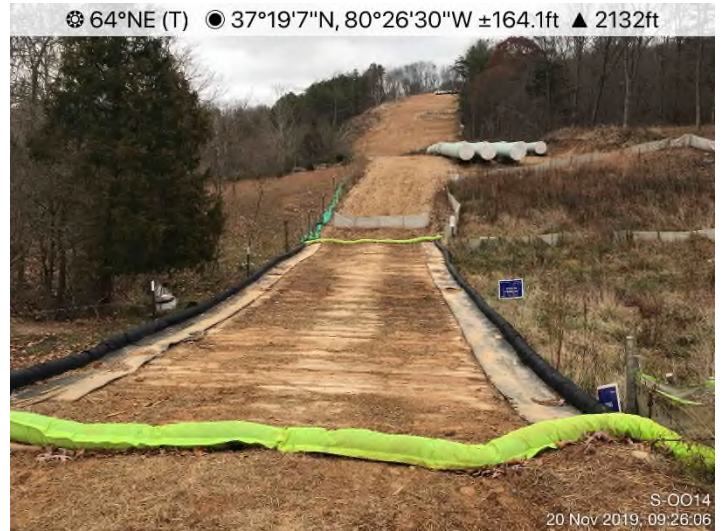
Fig. 2: **STA 11448+93** – Controls in place and functioning properly along Stream S-OO14. Area adequately stabilized with straw.

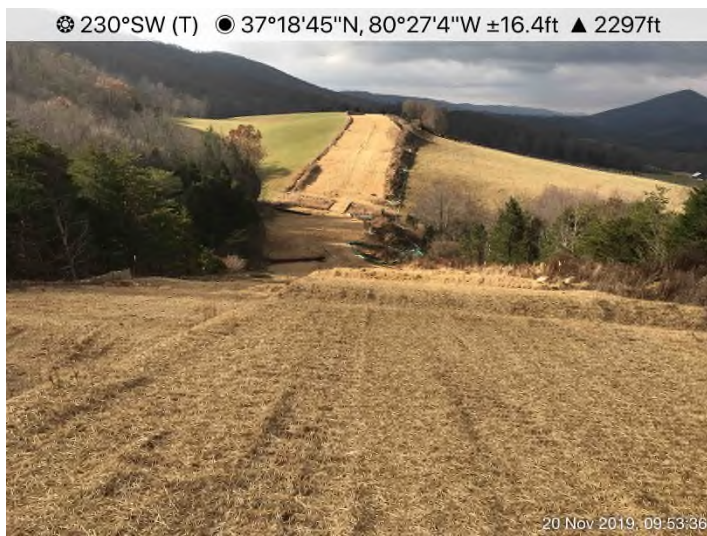
Fig. 3: **STA 11412+71** – Controls in place and functioning properly. Area adequately stabilized.

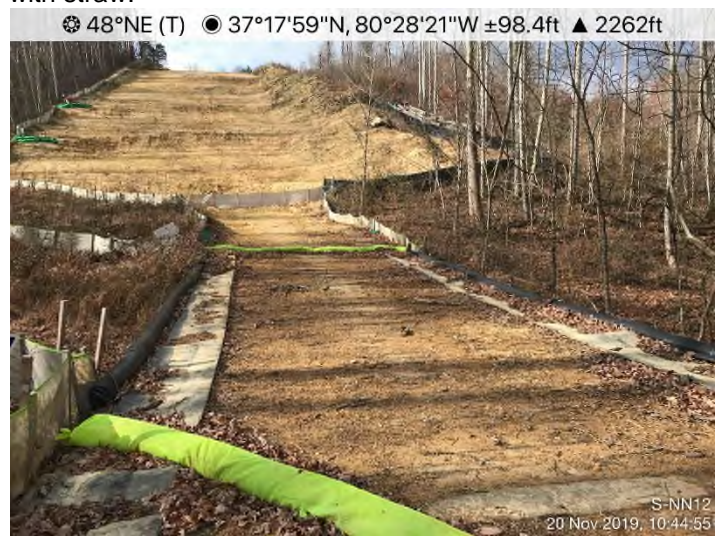
Fig. 4: **STA 11327+85** – Controls in place and functioning properly along Stream S-NN12. Area adequately stabilized with straw.
