## FIELD INSPECTION

<b>Project Name:</b>	Mountain Valley Pipeline	<b>Inspector:</b>	Matthew Grant
<b>Inspection Date:</b>	Thursday, February 14, 2019	<b>Project Contact:</b>	Brian Clauto
<b>Spread: Giles County MP 215 St#11329- 11328</b>	Spread G	<b>Weather (Wet/Dry/Rain):</b>	Dry

# FIELD INSPECTION PHOTO LOG

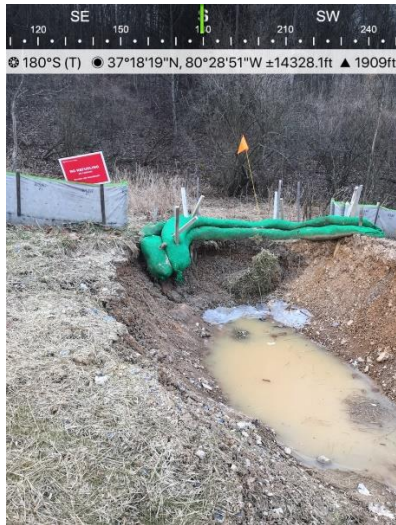
- Inspected stream included designated stream NN12, no impacts were observed at the time of the inspection.
- St#11329+48 sump end treatment triple stack requires maintenance

- Fig. 1 St#11329+48 sump end treatment triple stack requires maintenance

**Recommended Corrective Action:** Maintain all controls per the annual standards and specs.

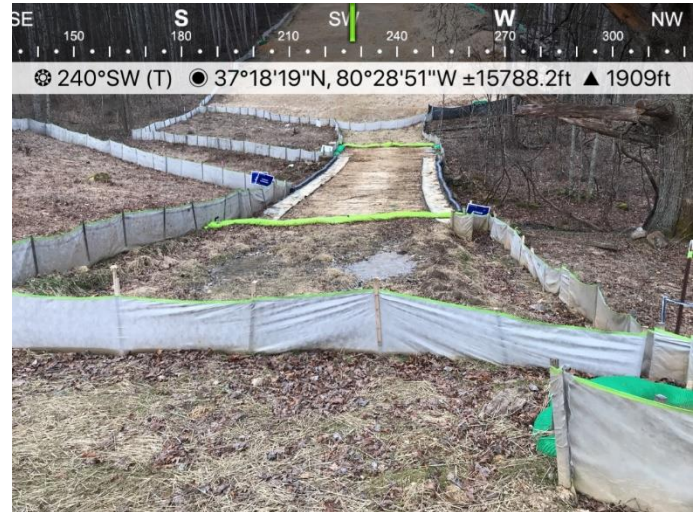
- Fig. 2 Area near designated stream NN-12 has been temporarily stabilized and controls are in place.

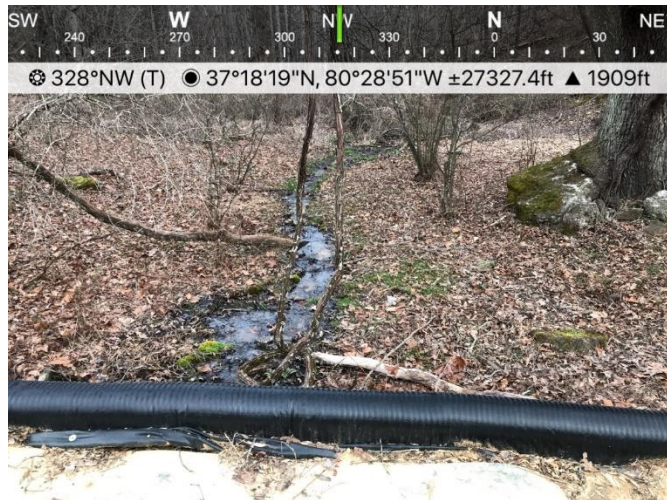
- Fig. 3 Upstream photo of designated stream NN-12

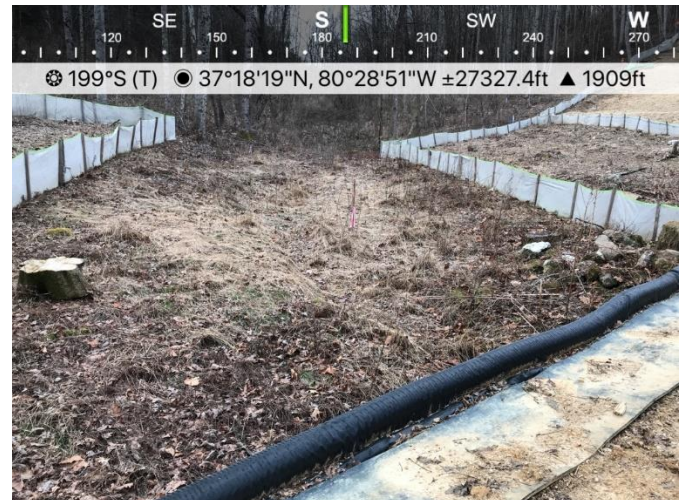
- Fig. 4 Downstream photo of designated stream NN-12

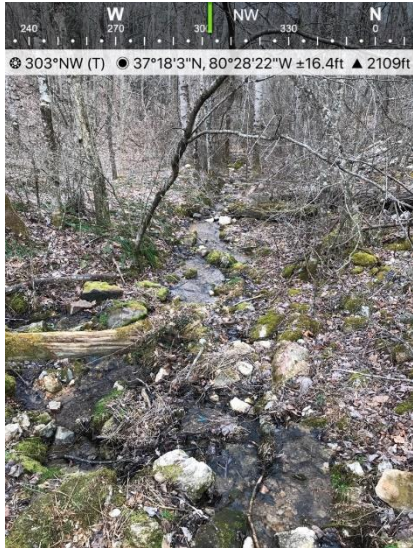
- Fig. 5 Downstream photo of designated stream NN-12
