## FIELD INSPECTION REPORT

<b>Project Name:</b>	Mountain Valley Pipeline	<b>Inspector:</b>	Matthew Grant
<b>Inspection Date:</b>	Tuesday, February 25, 2020	<b>Project Contact:</b>	Brian Clauto,
<b>Spread G: Montgomery</b>	MP 225.9-222.8 MN 266 ATWS 1487 MLV 26	<b>Weather:</b>	Wet

## FIELD INSPECTION PHOTO LOG

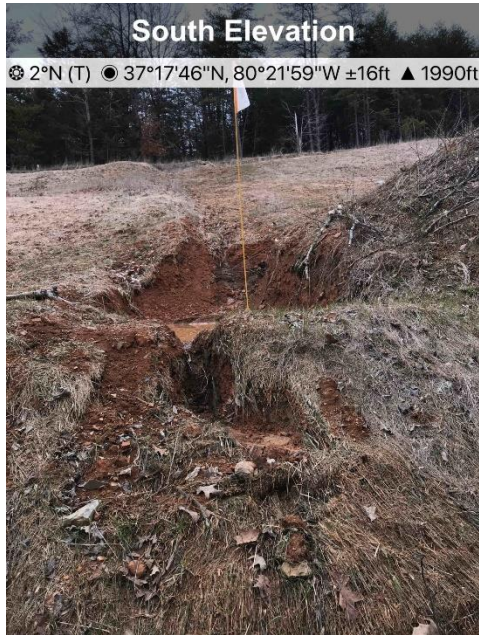
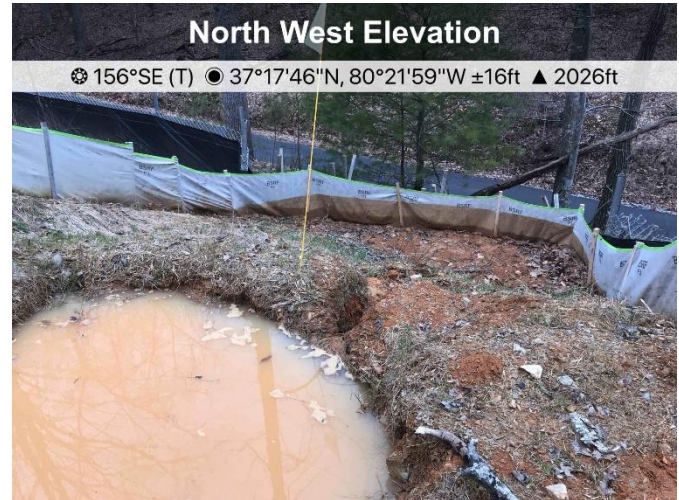
- St11770+00 sump outfall has eroded and requires maintenance

- Figure 1: St11770+00 sump outfall has eroded and requires maintenance.

- Figure 2: St11770+00 sump outfall has eroded and requires maintenance.

**Recommended Corrective Action:** Maintain and install all controls per the approved PSS&S.

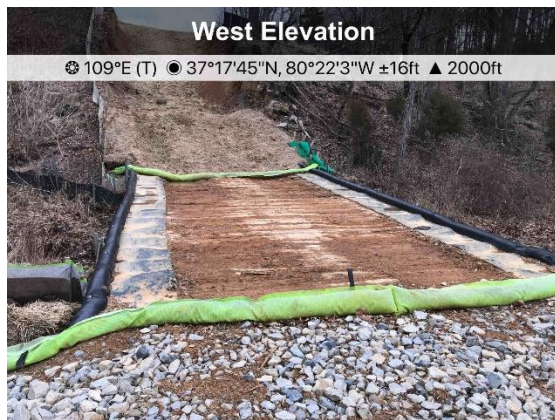
- **Comments:** Inspected the following resources: S-IJ52
- ECD's were in place at the designated crossing.

- Figure 3: Designated crossing S-IJ52, ECD's are in place

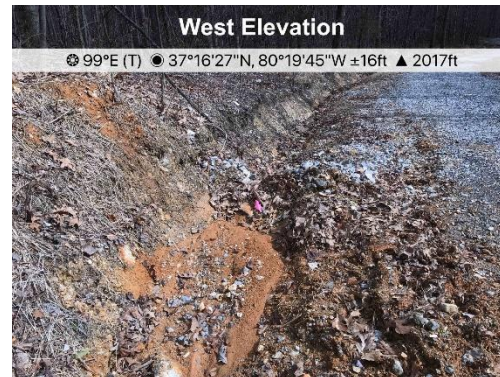
- On AR MN 266 check dam requires maintenance/ clean out.

- Figure 4: On AR MN266, check dam requires maintenance/ clean out.
