FIELD INSPECTION

| Project Name: | Mountain Valley Pipeline | Inspector: | Matthew Grant |
| Inspection Date: | Thursday, March 21, 2019 | Project Contact: | Brian Clauto |

FIELD INSPECTION PHOTO LOG

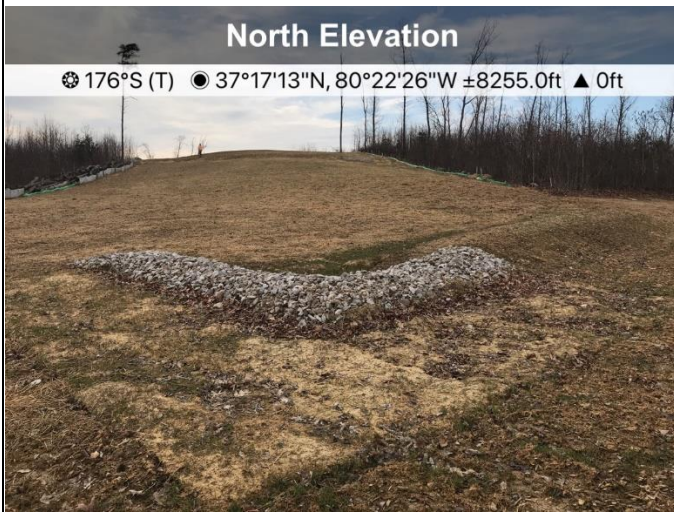
- Fig. 1 Near St#11932+54 permanent waterbar has been installed and area has been stabilized

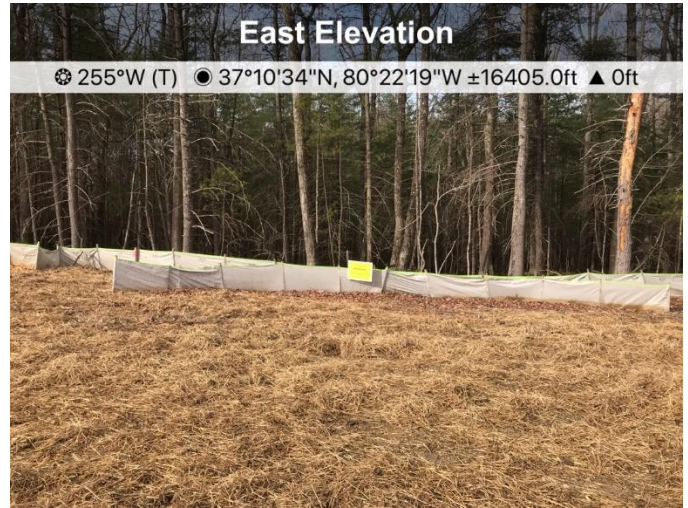
- Fig. 2 At karsts feature 226.42, ECD's are in place and functioning

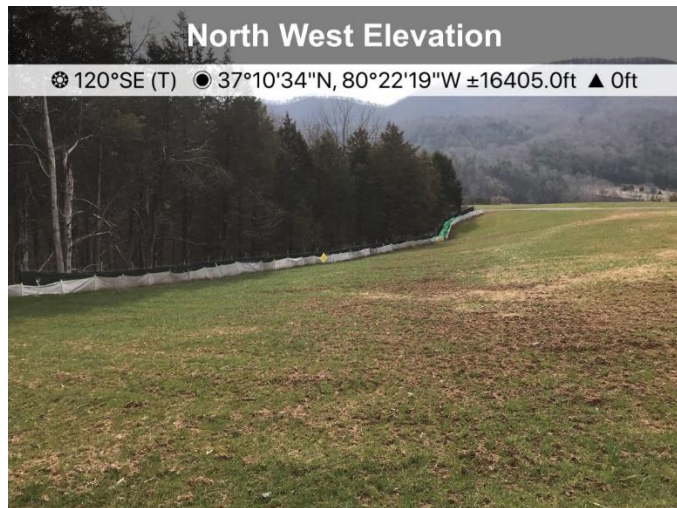
- Fig. 3 Near St#11979+30 ECD's are in place and functioning
