FIELD INSPECTION REPORT

Project Name:	Mountain Valley Pipeline	Inspector:	Marshall Willis
Inspection Date:	Friday, March 6, 2020	Project Contact:	Brian Clauto, Cory Chalmers
Spread G: Montgomery County	STA 11788+43 – 11930+00 MVP-MN-266.03/266 ATWS 1487/1456/1457	Weather:	Snow

FIELD INSPECTION PHOTO LOG

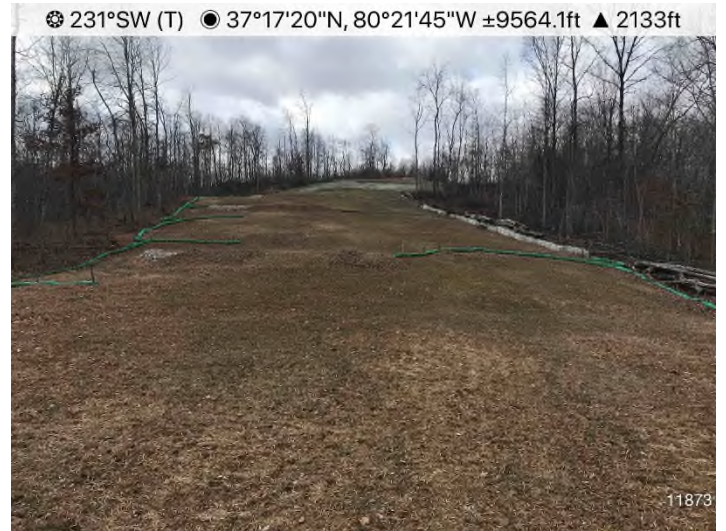
Figure 2: STA 11873+00 – Controls in place and functioning properly.

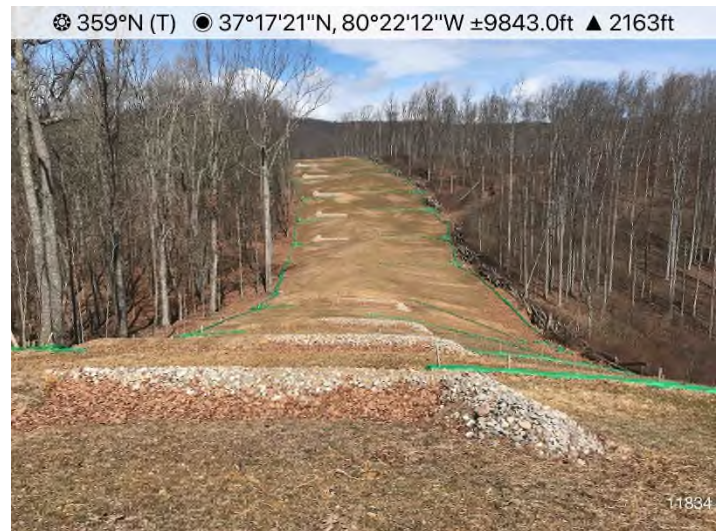
Figure 4: STA 11834+00 – Controls in place and functioning properly.
