FIELD INSPECTION

Project Name:	Mountain Valley Pipeline	Inspector:	Matthew Grant
Inspection Date:	Thursday, April 18, 2019	Project Contact:	Brian Clauto
Spread: Craig County AR GI 258.02 MP 218 St#11254-11473	Spread G	Weather (Wet/Dry/Rain):	Dry

FIELD INSPECTION PHOTO LOG

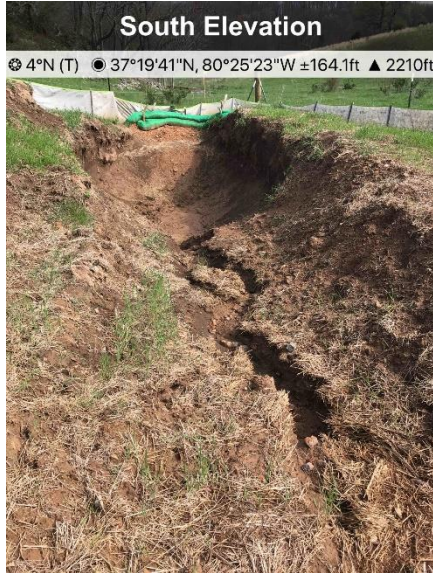
- Fig. 1 St#11517+81 water bar conveyance is eroding

Recommended Corrective Action: Maintain all controls per the approved plan and specs.

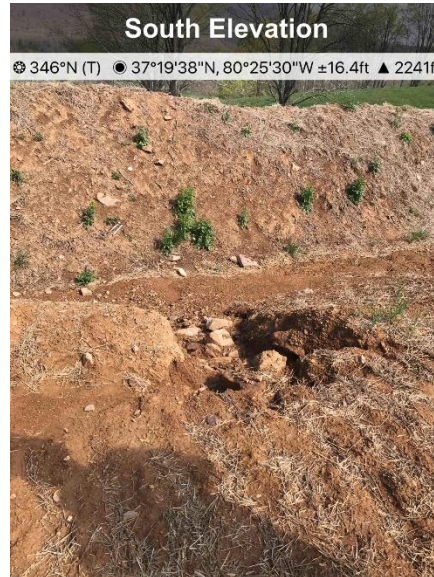
- Fig. 2 St#11511+00 two tone area is eroding and requires repair / stabilization

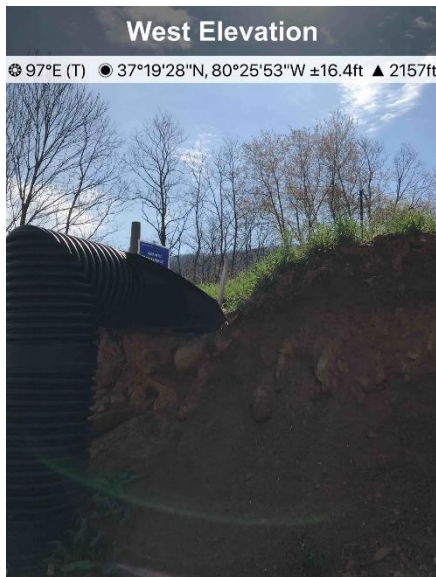
- Fig. 3 St#11489 clean water diversion inlet has eroded

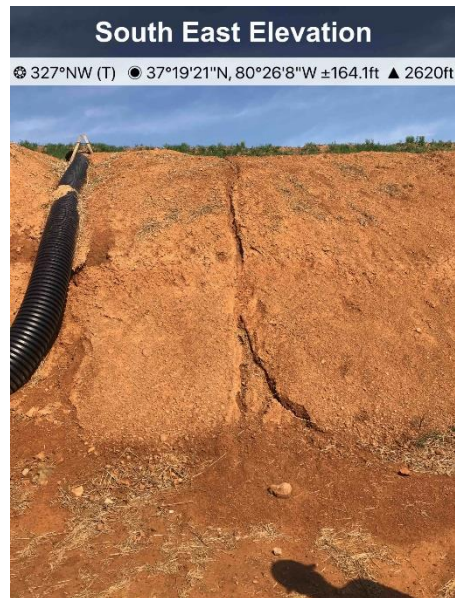
- Fig. 4 St#11473 two tone area is eroding and requires repair / stabilization
