FIELD INSPECTION

Project Name:	Mountain Valley Pipeline	Inspector:	Matthew Grant
Inspection Date:	Tuesday, May 28, 2019	Project Contact:	Brian Clauto
Spread: Montgomery County MP223-224 St11790-11849 MLV26 AR256.02	Spread G	Weather (Wet/Dry/Rain):	Dry

FIELD INSPECTION PHOTO LOG

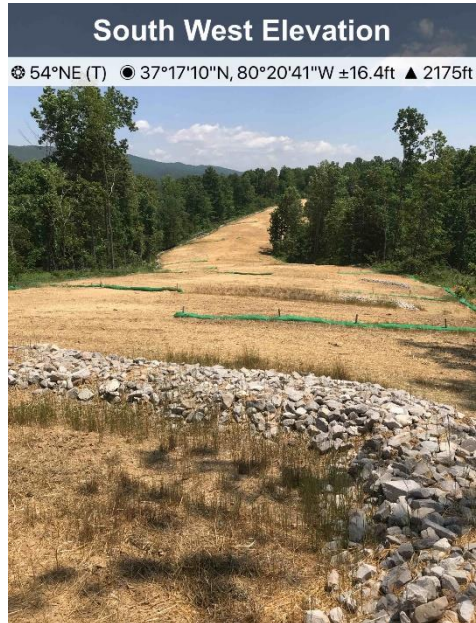
- Fig. 1. Near St11860+90 permanent stabilization has been applied

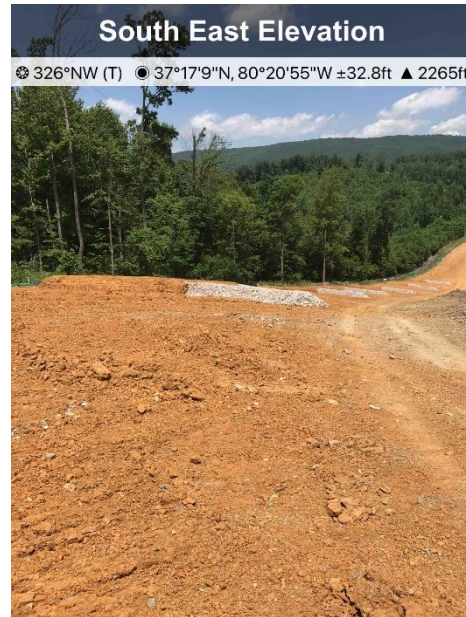
- Fig. 2. Near St#11857+00 new permanent water bar install

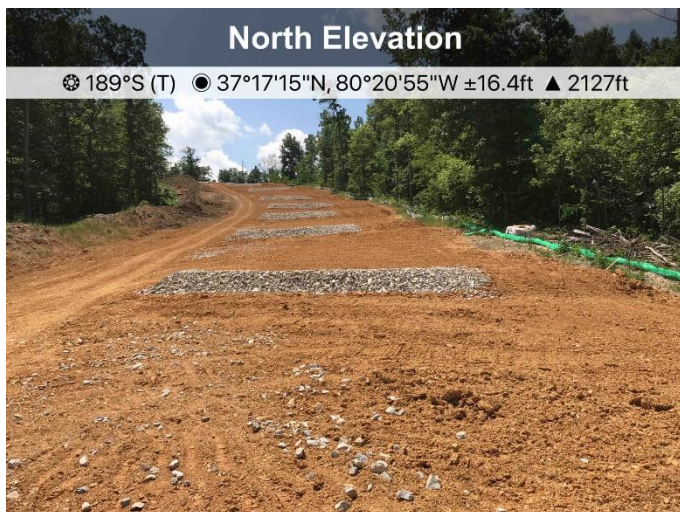
- Fig. 3 Near St#11790+28 new permanent water bar install

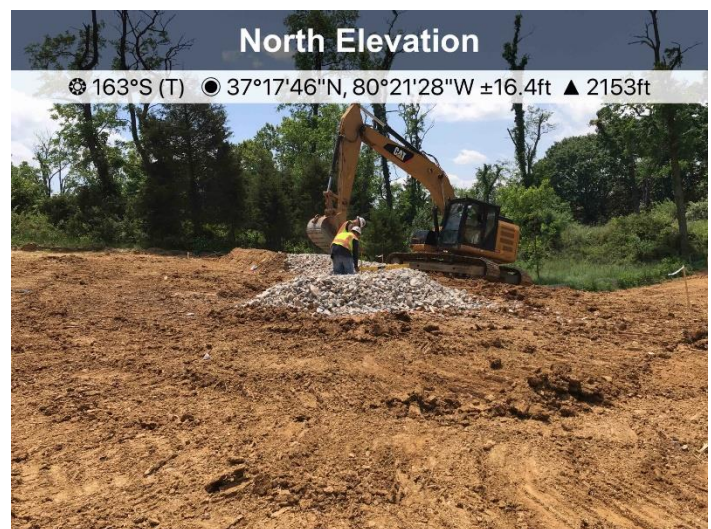
- Fig. 3 Active construction of permanent water bar
