## FIELD INSPECTION

<b>Project Name:</b>	Mountain Valley Pipeline	<b>Inspector:</b>	Matthew Grant
<b>Inspection Date:</b>	Wednesday, May 8, 2019	<b>Project Contact:</b>	Brian Clauto
<b>Spread: Craig County MP217 AR258.01</b>	Spread G	<b>Weather (Wet/Dry/Rain):</b>	Dry

## FIELD INSPECTION PHOTO LOG

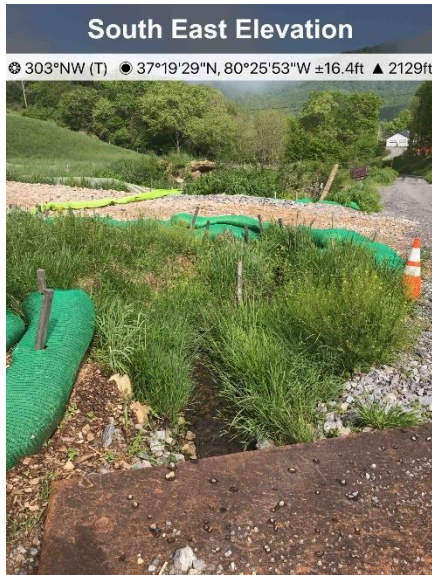
- Fig. 1 Designated stream SPP-1 ECD's are in place and functioning.

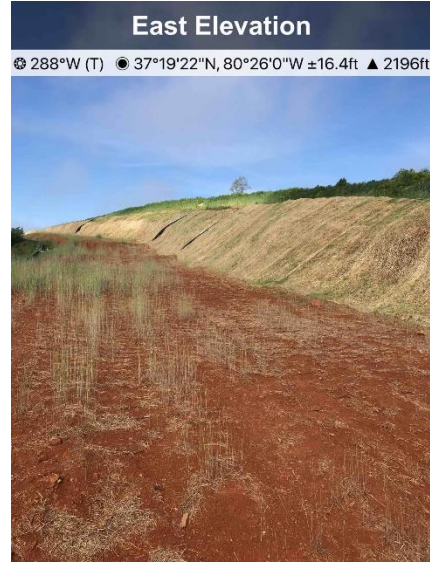
- Fig. 2 St#11478+00 two-tone areas have been blanket matted.

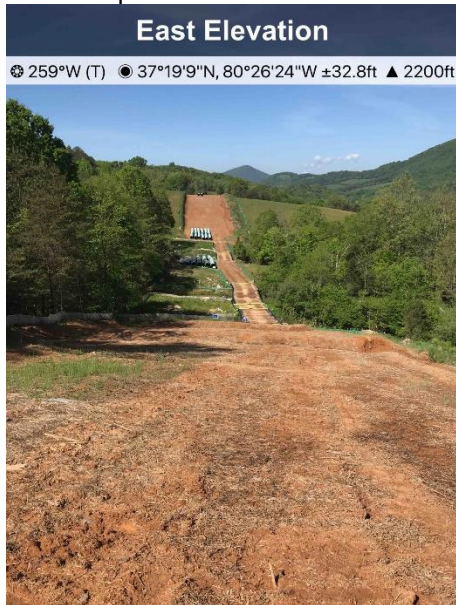
- Fig. 3 Above designated streams S-0012 and S-0013, ECD's in place.

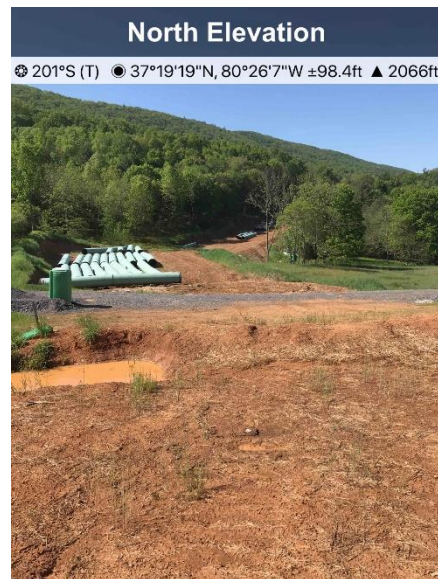
- Fig. 4 Access road 258.01 controls in place and functioning.
