FIELD INSPECTION

Project Name:	Mountain Valley Pipeline	Inspector:	Matthew Grant
Inspection Date:	Thursday, June 13, 2019	Project Contact:	Brian Clauto
Spread: Montgomery County MP219-220 MP223	Spread G	Weather (Wet/Dry/Rain):	Dry

FIELD INSPECTION PHOTO LOG

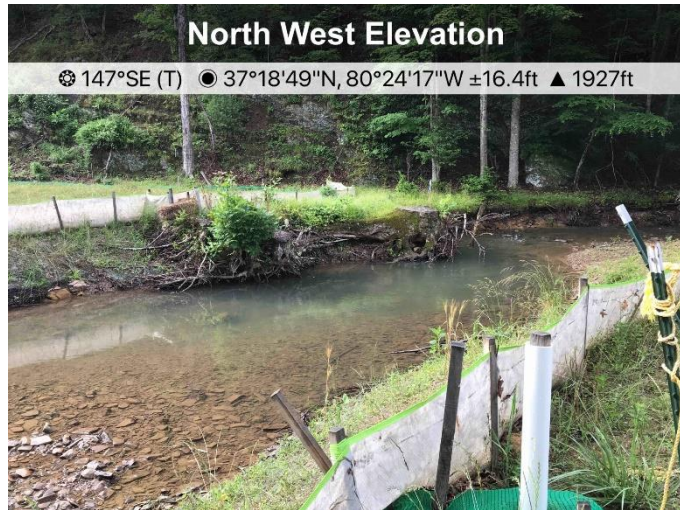
Fig. 1. ECD controls in place for designated stream S-006

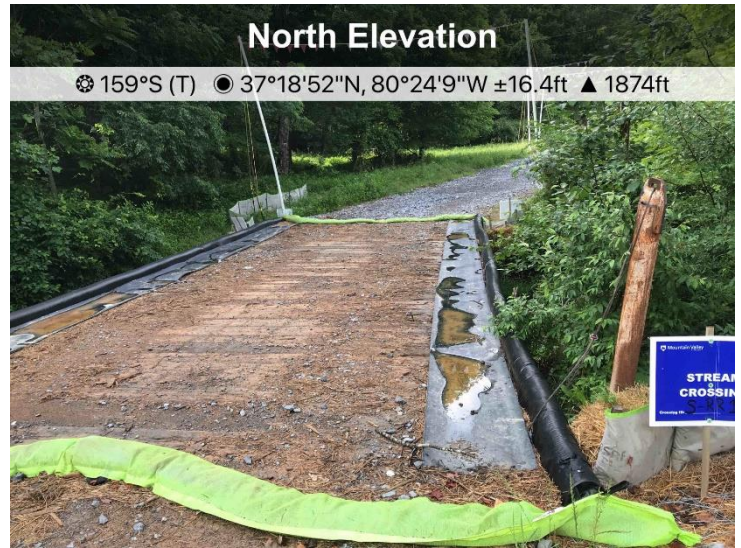
Fig. 2. ECD controls in place for designated stream S-RR13

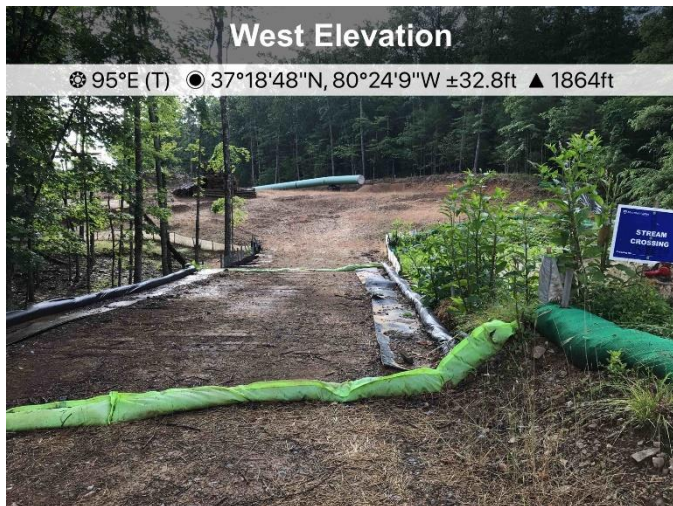
Fig. 3. ECD controls in place for designated stream S-RR14

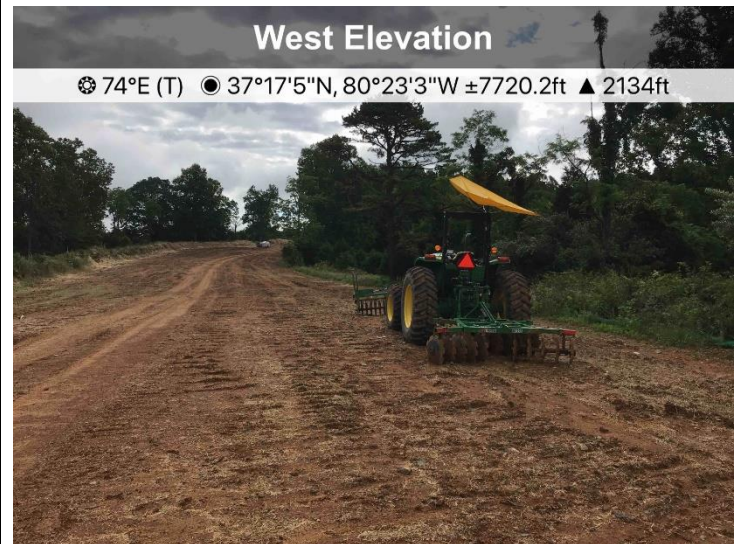
Fig. 4. Near MP 223 tractor for disking of soil on site
