FIELD INSPECTION

Project Name:	Mountain Valley Pipeline	Inspector:	Matthew Grant
Inspection Date:	Thursday, June 27, 2019	Project Contact:	Brian Clauto
Spread: Giles County MP207-208 AR244 St11023-10964	Spread G	Weather (Wet/Dry/Rain):	Dry

FIELD INSPECTION PHOTO LOG

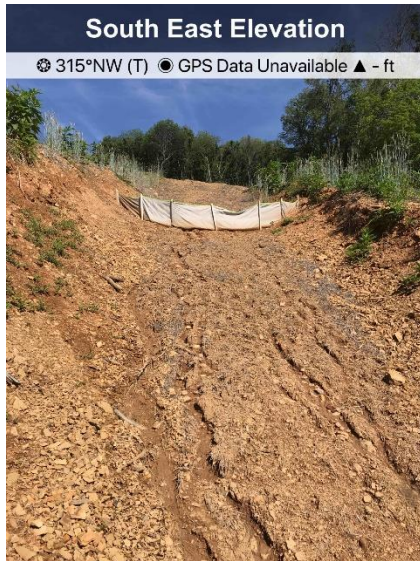
- Designated streams inspected included: S-R5, S-IJ18. ECD controls were in place at crossings.
- St11014+00 rill erosion has occurred and waterbar has sediment build up in flow path.
- St11014+00 waterbar flow path requires maintenance
- MP207.9 waddle at bridge requires maintenance
- St10964 sump requires maintenance

Fig. 1. St11014+00 rill erosion has occurred

Recommended Corrective Action: Maintain all controls per the approved plan and specs

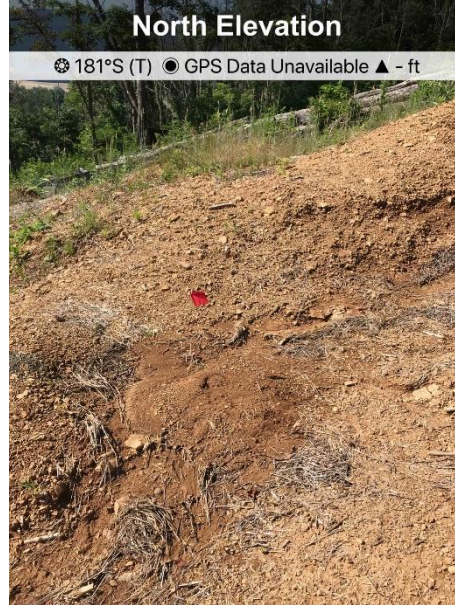
Fig. 2. St11014+00 waterbar flow path requires maintenance

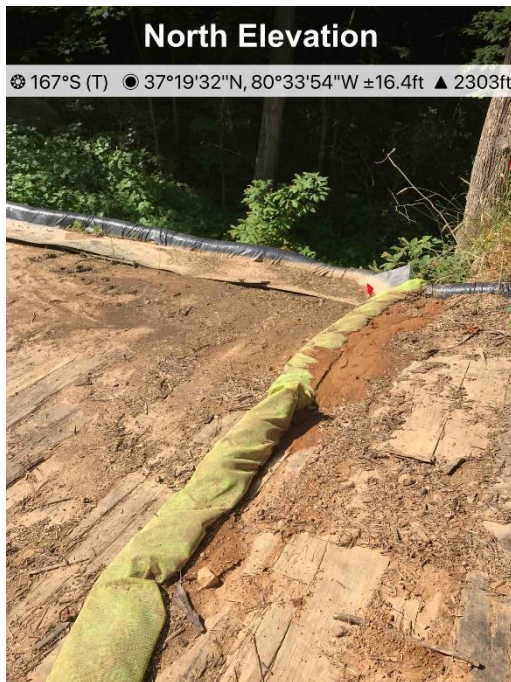
Fig. 3. MP207.9 waddle at bridge requires maintenance.

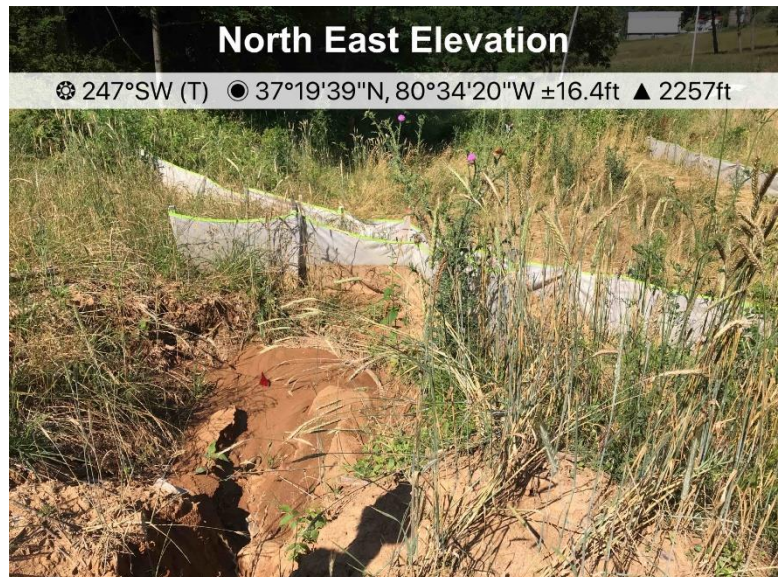
Fig. 4. St10964 sump requires maintenance
