FIELD INSPECTION

Project Name:	Mountain Valley Pipeline	Inspector:	Matthew Grant
Inspection Date:	Wednesday, August 15, 2018	Project Contact:	Brian Clauto
Spread: Locations in Spread G inspected included MP 218.31-218.37, MP 222.04-222.90, MP 211.76, MP 209.86,MP 214.36	Spread G	Weather (Wet/Dry/Rain):	Dry

FIELD INSPECTION PHOTO LOG

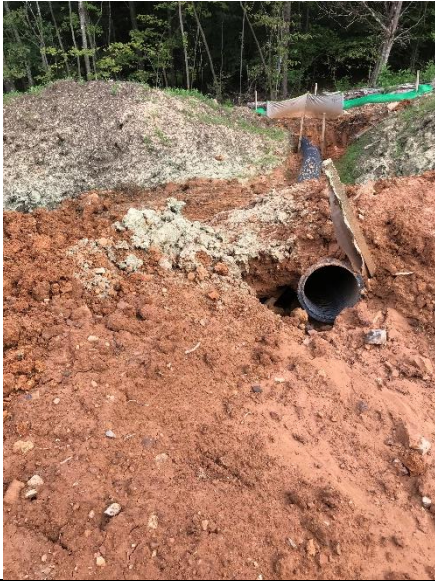
Area 1 - Spread G, near MP 218 station 11527+00 through 11530+00 slope drains observed were not built to spec.
Recommended Corrective Action: Build all slope drains with inlet protection per the spec

Fig. 1
Near MP258 station 11529+00, slope drain observed was not built to spec and water bar required maintenance

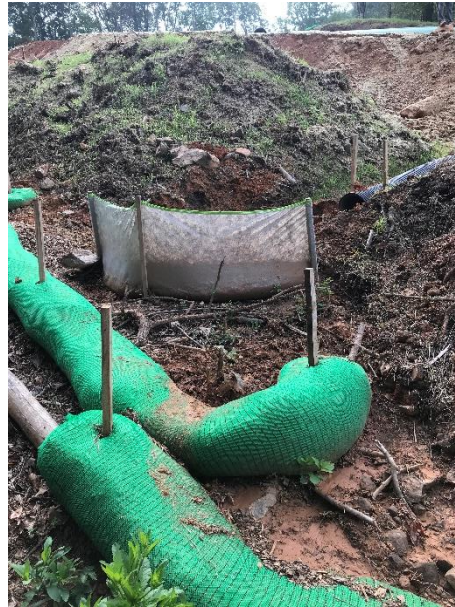
Area 2 - Spread G, near MP 218 near station 11529+00 the water bar observed required maintenance including the end treatment
Recommended Corrective Action: Repair all controls per the annual standard and specs.

Fig. 2
Near station 11529+00 end treatment observed required maintenance

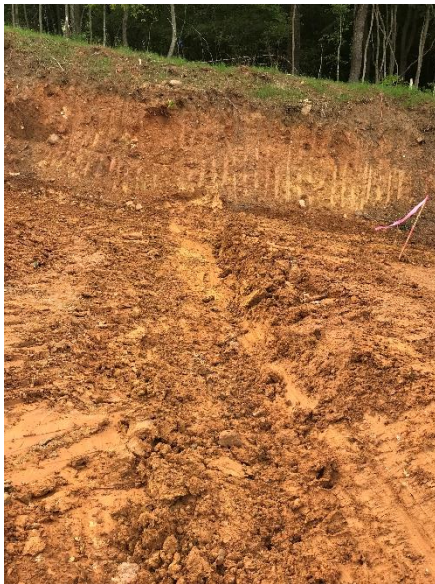
Fig. 3
Near station 11529+00 water bar observed required maintenance

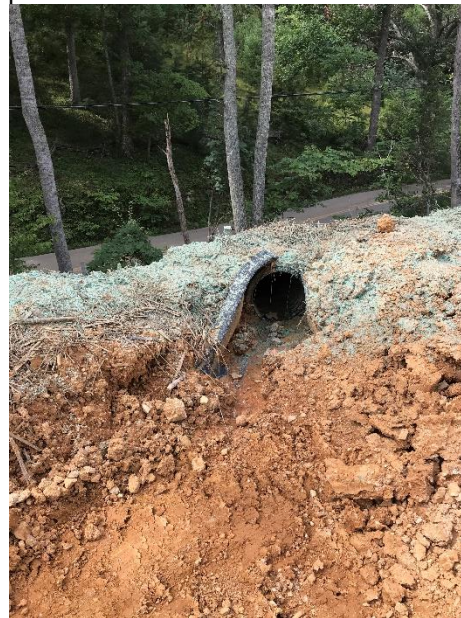
Area 3 – Spread G, near MP223 station 11776+80 through MP 222.9 station 11769+60, slope drains observed were not built to spec.
Recommended Corrective Action: Build all slope drain with inlet protection per the spec.

Fig.
Near station 11776+80 slope drain observed lacked inlet protection
