FIELD INSPECTION

Project Name:	Mountain Valley Pipeline	Inspector:	Matthew Grant
Inspection Date:	Thursday, August 15, 2019	Project Contact:	Cory Chalmers
Spread: Montgomery County MLV26 MP222-224 St11769-11858	Spread G	Weather (Wet/Dry/Rain):	Dry

FIELD INSPECTION PHOTO LOG

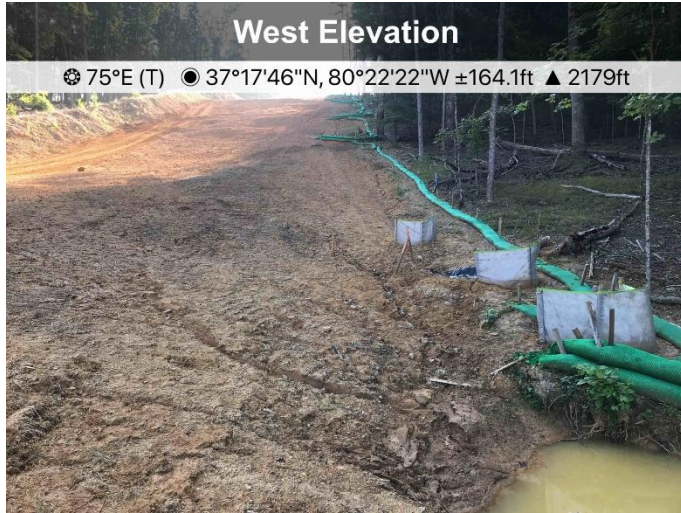
- Fig. 1. St11749 rill erosion requires repair and stabilization of eroded area

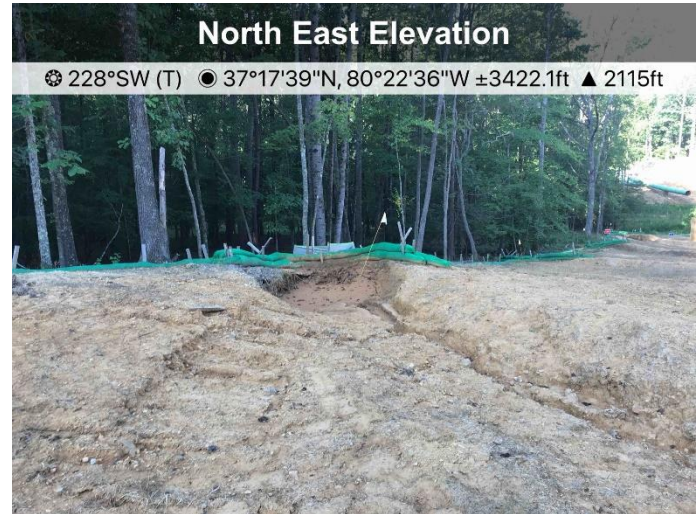
- Fig. 2. St11747 sump has reached maintenance level

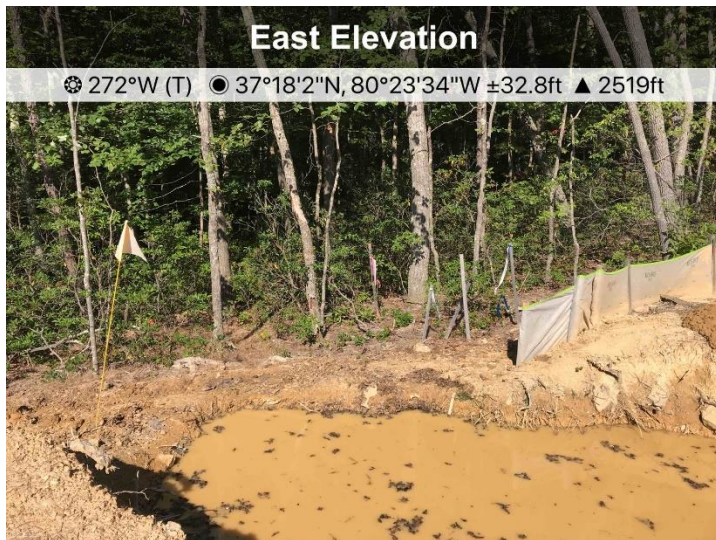
- Fig. 3. St11689 sump not built to spec.

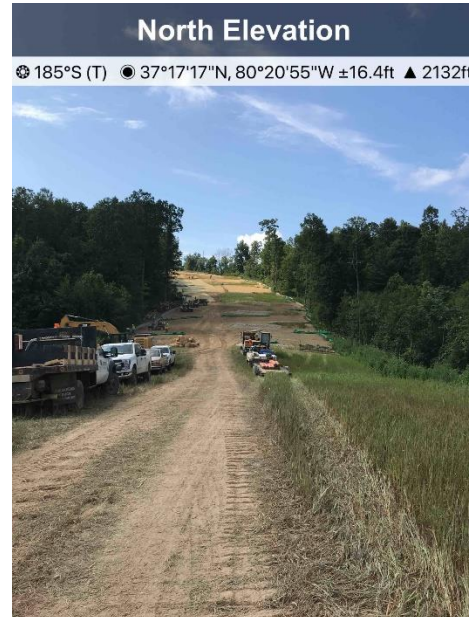
- Fig. 4. Permanent stabilization methods from St11840-11858
