FIELD INSPECTION

Project Name:	Mountain Valley Pipeline	Inspector:	Marshall Willis
Inspection Date:	Monday, September 23, 2019	Project Contact:	Brian Clauto, Cory Chalmers
Spread G: Montgomery County	STA 11788+23 – 11900+00 MVP-MN-266.03	Weather (Wet/Dry/Rain):	Dry

FIELD INSPECTION PHOTO LOG

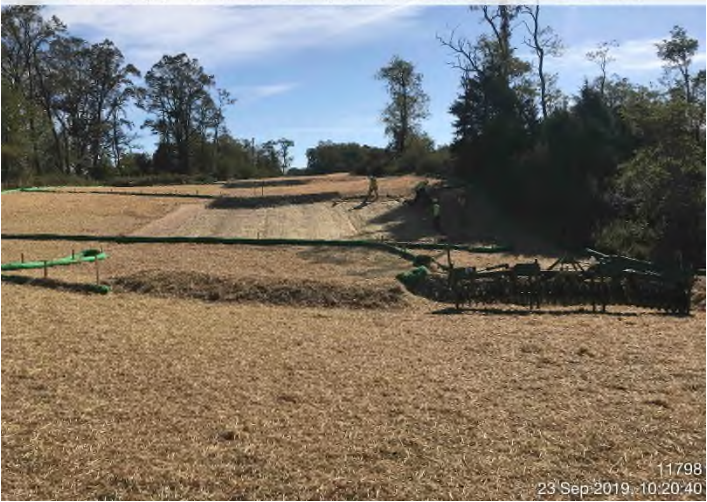
<p>Fig. 1: STA 11798+00 – Final restoration in progress. Installation of erosion fabric. Area stabilized with seed and straw.</p> <p style="text-align: center;">📍 95°E (T) 📍 37°17'46"N, 80°21'28"W ±32.8ft ▲ 2146ft</p>

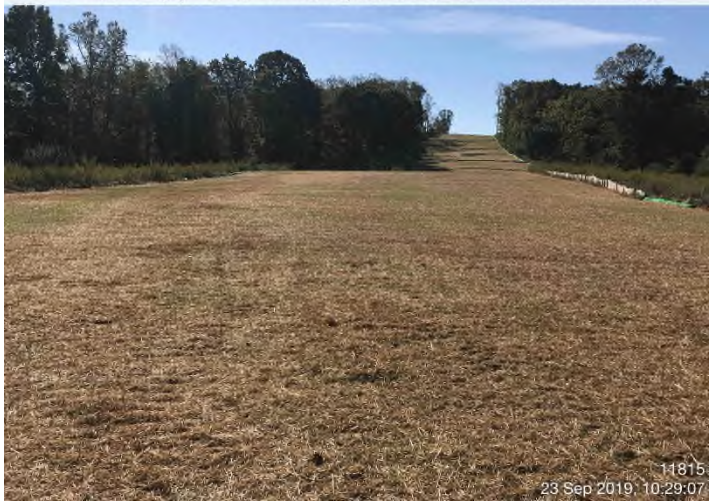
<p style="text-align: right; font-size: small;">11798 23 Sep 2019, 10:20:40</p>	<p>Fig. 2: STA 11815+00 – Controls in place. Area stabilized with seed and straw.</p> <p style="text-align: center;">📍 148°SE (T) 📍 37°17'46"N, 80°21'10"W ±32.8ft ▲ 2210ft</p>

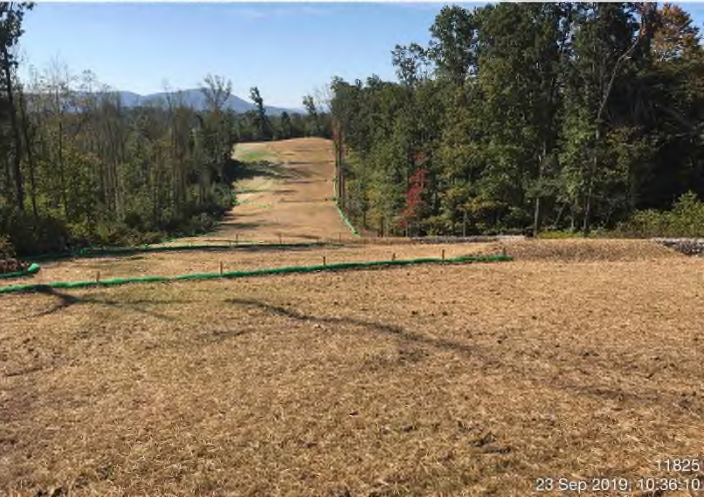
<p style="text-align: right; font-size: small;">11815 23 Sep 2019, 10:29:07</p>
<p>Fig. 3: STA 11825+00 – Controls in place. Area stabilized with seed and straw.</p> <p style="text-align: center;">📍 179°S (T) 📍 37°17'36"N, 80°21'3"W ±16.4ft ▲ 2276ft</p>

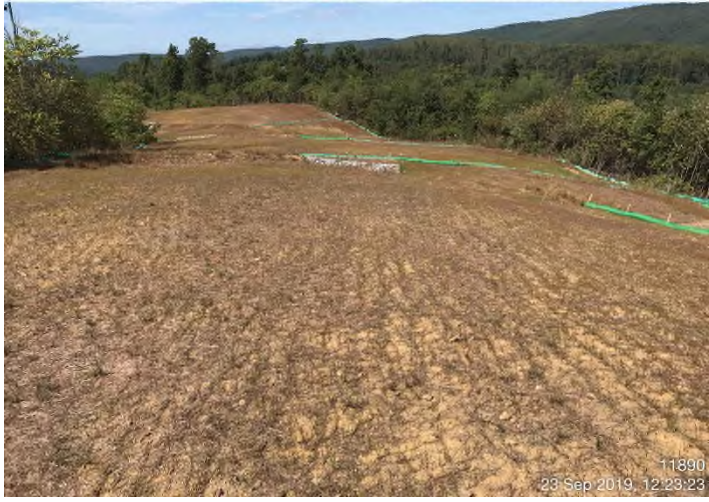
<p style="text-align: right; font-size: small;">11825 23 Sep 2019, 10:36:10</p>	<p>Fig. 4: STA 11890+00 – Controls in place. Area stabilized with seed and straw.</p> <p style="text-align: center;">📍 291°W (T) 📍 37°17'15"N, 80°20'15"W ±16.4ft ▲ 2205ft</p>
