FIELD INSPECTION

Project Name:	Mountain Valley Pipeline	Inspector:	Matthew Grant
Inspection Date:	Tuesday, September 3, 2019	Project Contact:	Brian Clauto
Spread: Montgomery County AR 266 MP225 MP223-224 Giles County AR256.02 MP217.1-215.7	Spread G	Weather (Wet/Dry/Rain):	Dry

FIELD INSPECTION PHOTO LOG

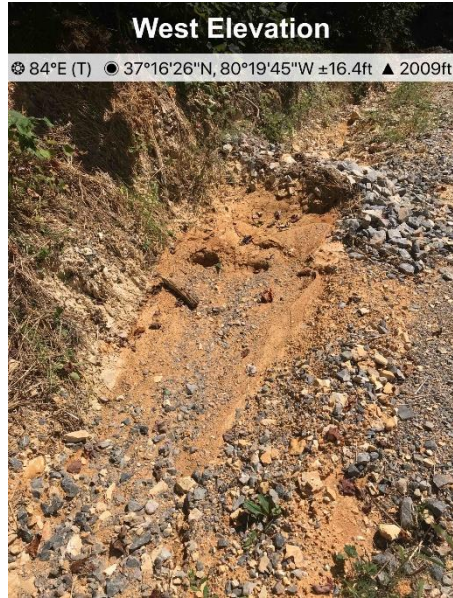
Fig. 1 AR266 check dam is at capacity for maintenance

Recommend Corrective Action: Maintain and install all controls per the approved plan and specs

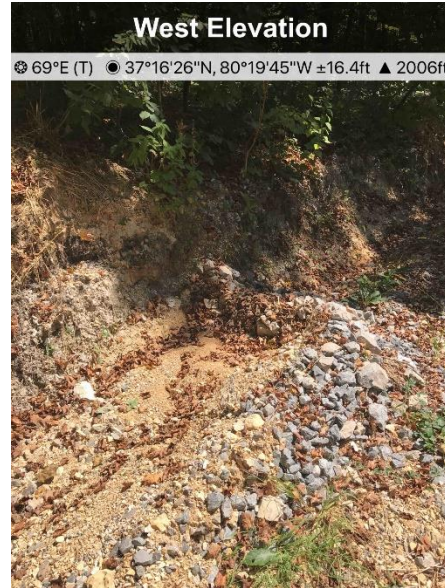
Fig. 2 AR266 check dam is at capacity for maintenance

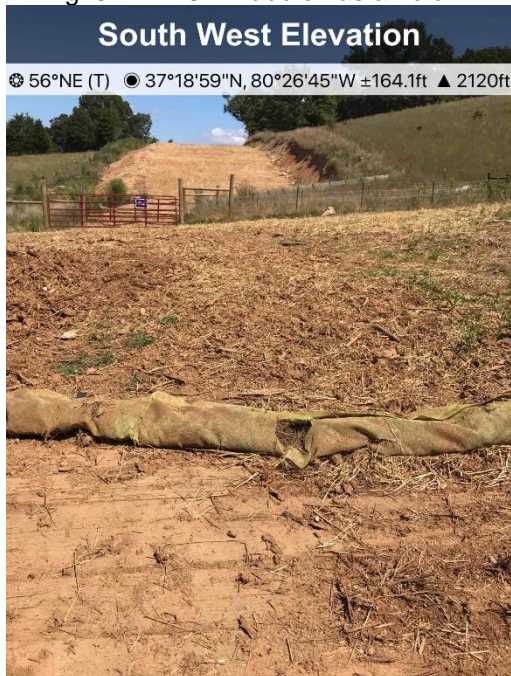
Fig. 3 MP216.4 waddle has a hole

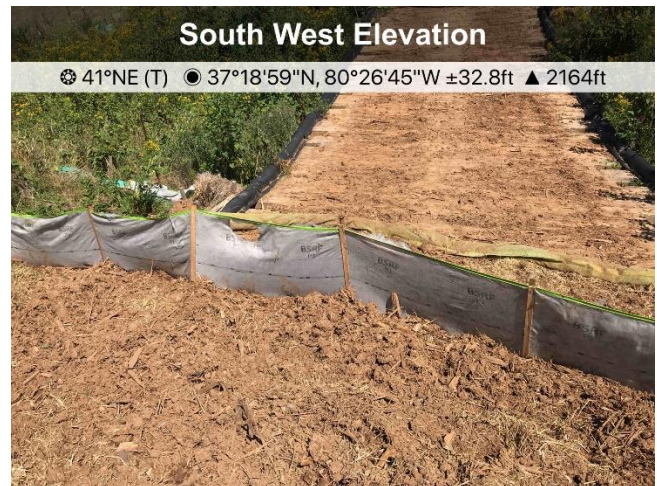
Fig. 4 MP216.4 P1 fence had a hole
