FIELD INSPECTION

Project Name:	Mountain Valley Pipeline	Inspector:	Matthew Grant
Inspection Date:	Tuesday, January 22, 2019	Project Contact:	Brian Clauto
Spread: Montgomery County MP234-235	Spread H	Weather (Wet/Dry/Rain):	Dry

FIELD INSPECTION PHOTO LOG

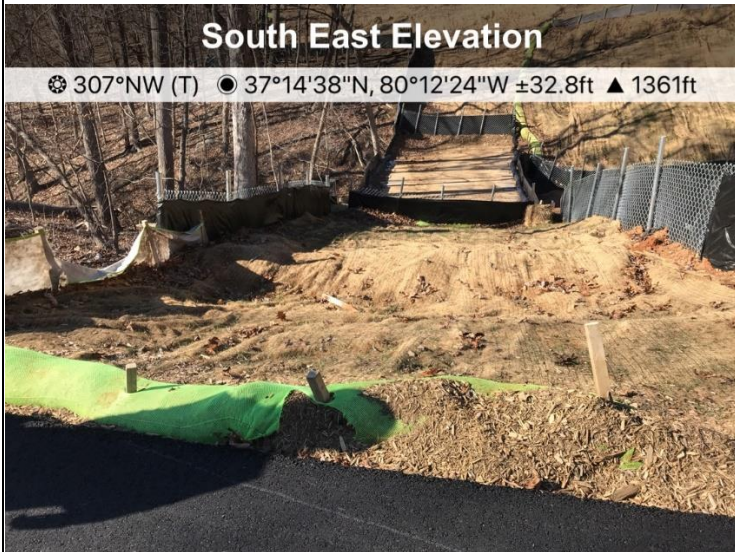
- MP 234 St#12381+00 CFS and P1 silt fence is torn.

- Fig. 1 MP 234 St#12381+00 CFS and P1 silt fence is torn.

Recommended Corrective Action: Maintain all controls per the approved plan and annual standards and specs.

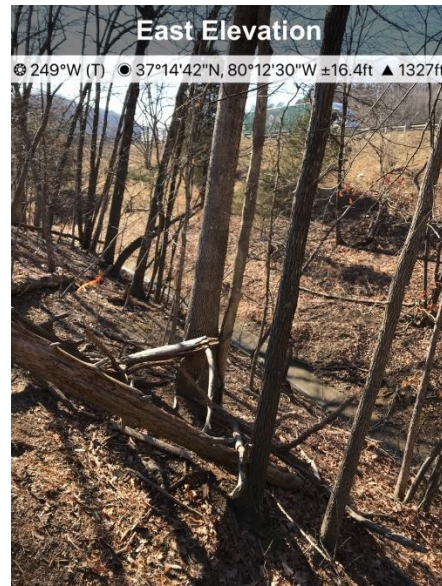
- Fig. 2 St#12374+56 no activity at designated stream crossing S-0016.

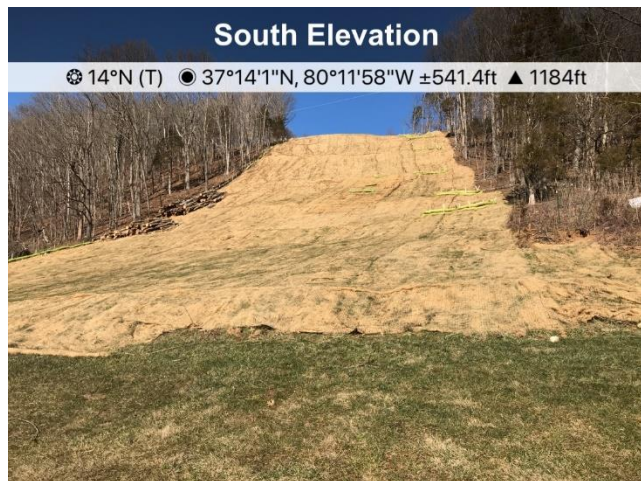
- Fig. 3 At St#12420+44 matting has been installed
