FIELD INSPECTION REPORT

Project Name:	Mountain Valley Pipeline	Inspector:	Marshall Willis
Inspection Date:	Thursday, January 23, 2020	Project Contact:	Brian Clauto, Cory Chalmers
Spread H: Montgomery County	STA 12445+86 – 12544+27 MVP-MLV-AR-28 MVP-MN-278.01	Weather:	Dry

FIELD INSPECTION PHOTO LOG

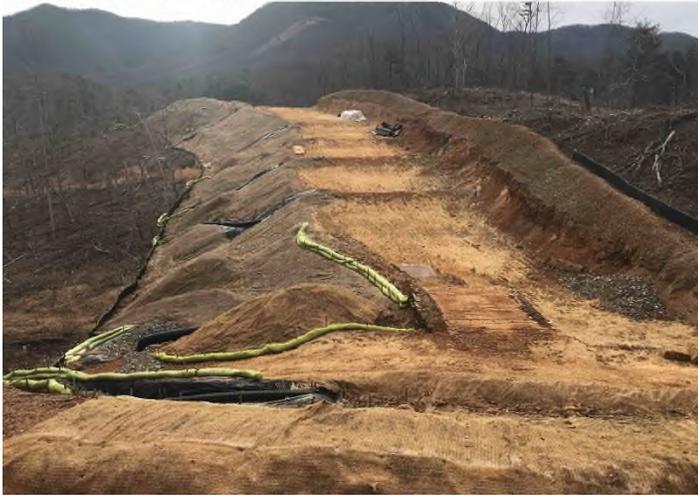
Figure 1: STA 12532+00 – Controls in place and functioning properly. Area stabilized with straw, hydro-mulch and erosion matting.

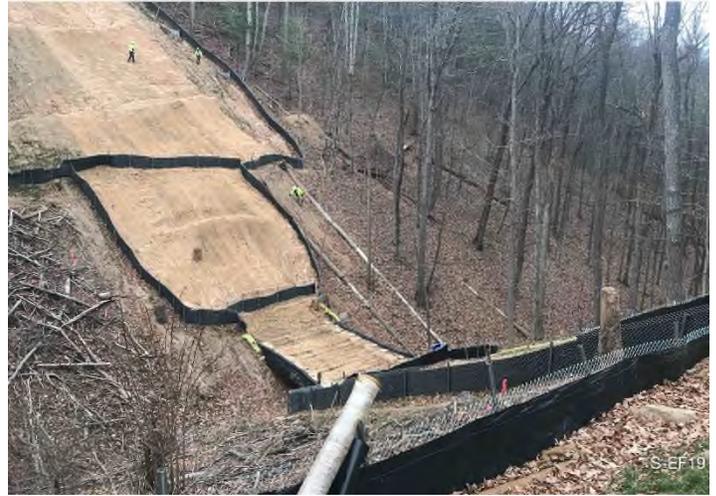
Figure 2: Stream S-EF19 – Controls in place and functioning properly.

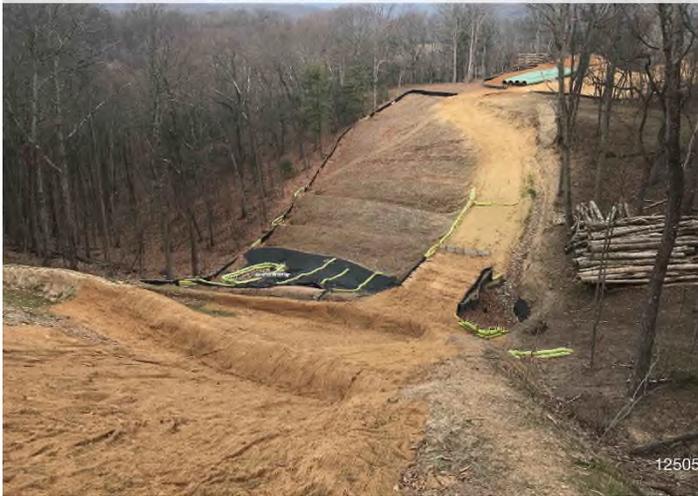
Figure 3: STA 12505+00 – Controls in place and functioning properly. Area stabilized with straw, hydro-mulch and erosion matting.

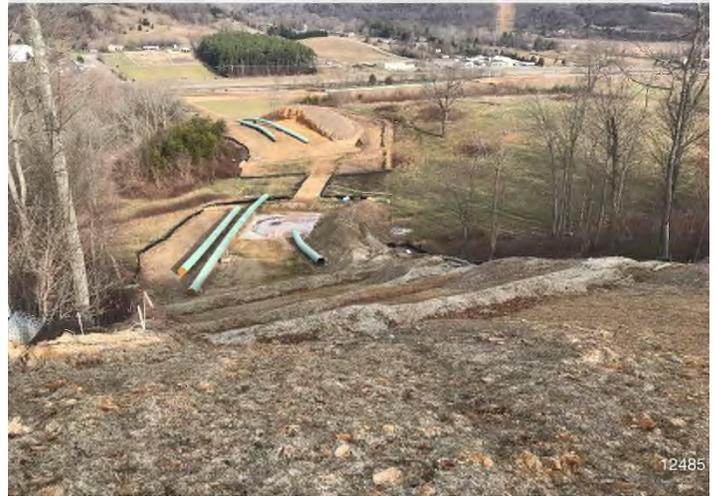
Figure 4: STA 12485+00 – Controls in place and functioning properly. Area stabilized with straw, hydro-mulch and erosion matting.
