FIELD INSPECTION REPORT

Project Name:	Mountain Valley Pipeline	Inspector:	Marshall Willis
Inspection Date:	Monday, January 27, 2020	Project Contact:	Brian Clauto, Cory Chalmers
Spread H: Franklin County	STA 13333+96 – 13337+82	Weather:	Wet

FIELD INSPECTION PHOTO LOG

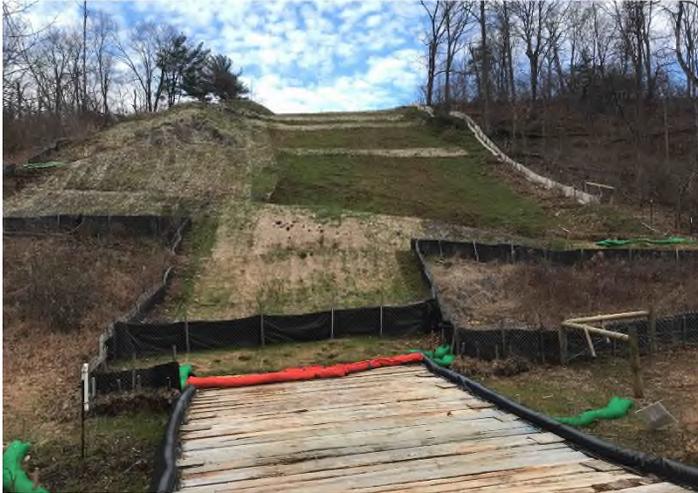
Figure 1: Stream S-GH11 – Controls in place and functioning properly. Area stabilized with erosion matting and vegetation. No evidence of sediment discharge off ROW.

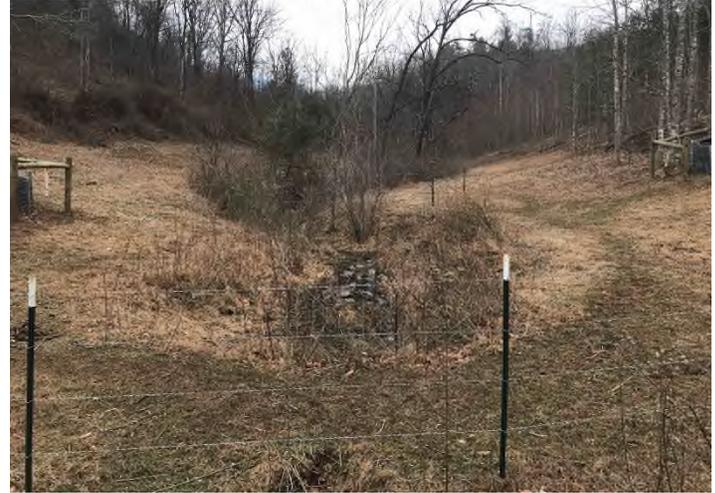
Figure 2: Stream S-GH11 – Looking upstream of ROW at S-GH11 crossing.

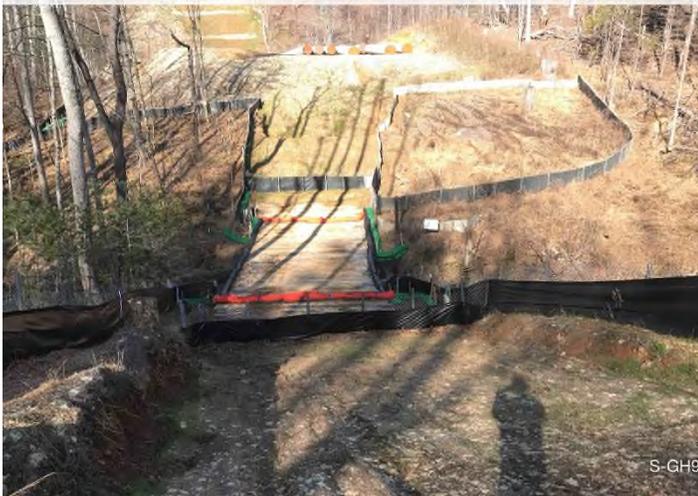
Figure 3: Stream S-GH9 – Controls in place and functioning properly. Area stabilized with erosion matting. No evidence of sediment discharge off ROW.

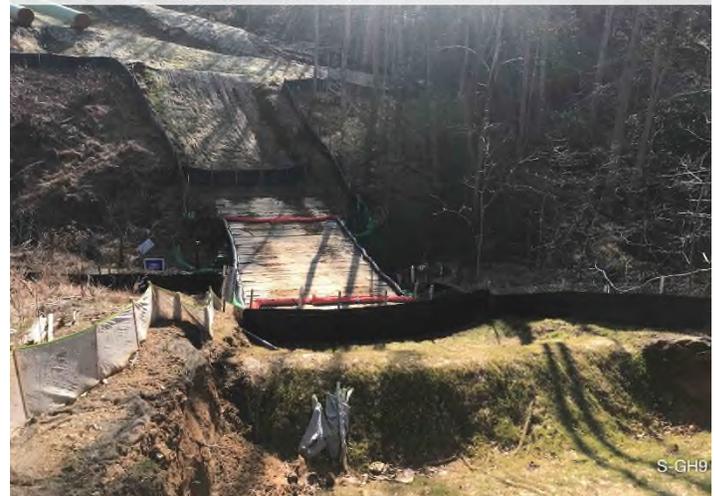
Figure 4: Stream S-GH9 – Controls in place and functioning properly. Area stabilized with erosion matting. No evidence of sediment discharge off ROW.
