FIELD INSPECTION REPORT

Project Name:	Mountain Valley Pipeline	Inspector:	Marshall Willis
Inspection Date:	Wednesday, January 29, 2020	Project Contact:	Brian Clauto, Cory Chalmers
Spread H: Franklin County	STA 13316+13 - 13415+51 ATWS 1352	Weather:	Wet

FIELD INSPECTION PHOTO LOG

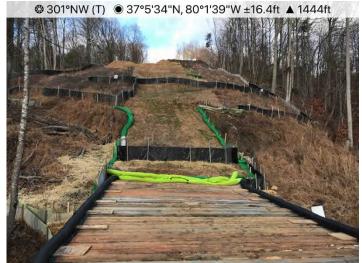
Figure 1: STA 13413+00 - Controls in place and functioning properly around Stream S-IJ1.

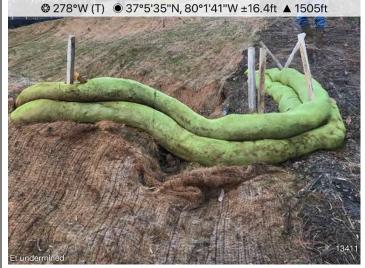
3. Areas of	offsite sediment deposition	observed?					\boxtimes			
 <u>Comments:</u> Inspected the following resources: S-IJ3, W-IJ2-PSS, S-IJ2, W-IJ1, S-IJ1, S-RR11, S-RR09, S-RR08, S-GH9, S-GH11, S-GH14 and S-GH15. Ineffective Controls: (<u>24-Hour Deadline</u> from Notification) STA 13411+00: End-treatment maintenance required. End treatment undermined. <u>Recommended Corrective Action:</u> Maintain and install all controls per the approved PSS&S. 											
	Deadline: Within 24-Hour of Notification The recommended corrective action deadline date applies to all conditions noted on this report unless otherwise noted. If listed condition(s) currently constitute non-compliance and/or corrective actions are not completed by the deadline, other enforcement actions may be issued to the entity responsible for ensuring compliance on the above project.										
	Inspector Sig	gnature: // (MMM)	H Will	W

Figure 2: **STA 13411+00** – End treatment CFS undermined. Maintenance needed.

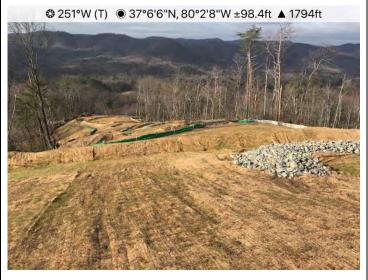
Figure 3: STA 13371+00 - Controls in place and functioning properly. Area stabilized with erosion matting.

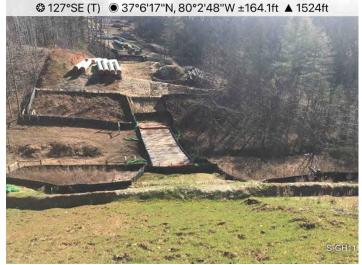
Figure 4: STA 13333+00- Controls in place and functioning properly above Stream S-GH11.
