FIELD INSPECTION

Project Name:	Mountain Valley Pipeline	Inspector:	Matthew Grant
Inspection Date:	Thursday, January 31, 2019	Project Contact:	Brian Clauto
Spread: Franklin County MP246 St13012-12993, St1303013038, MP248 St13117	Spread H	Weather (Wet/Dry/Rain):	Wet

FIELD INSPECTION PHOTO LOG

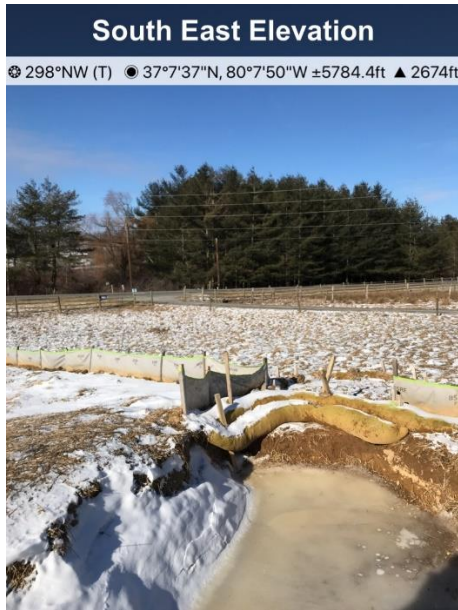
- MP 246.07 St#12993+00 CFS triple stack at sump requires maintenance.

- Fig. 1 MP 246.07 St#12993+00 CFS triple stack at sump requires maintenance.

Recommended Corrective Action: Maintain all controls per the approved plan and annual standards and specs.

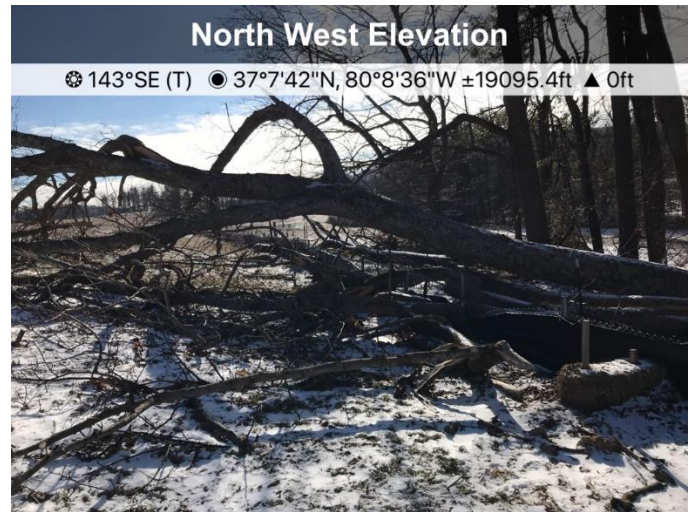
- Fig. 2 Near St#12299 tree fallen on ECD waiting on NPS approval.

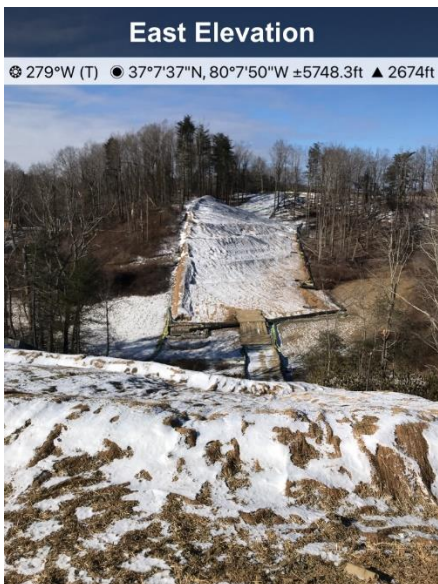
- Fig. 3 Near St#13023 slopes have been stabilized.

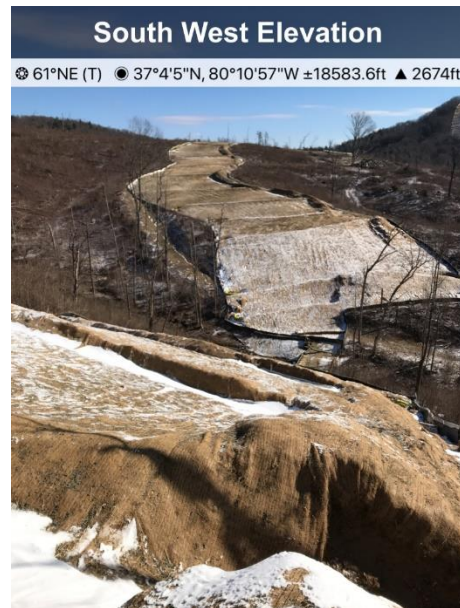
- Fig. 4 Near St13038 slopes have been stabilized.
