FIELD INSPECTION

Project Name:	Mountain Valley Pipeline	Inspector:	Marshall Willis
Inspection Date:	Wednesday, January 8, 2020	Project Contact:	Brian Clauto, Cory Chalmers
Spread H: Montgomery County	STA 12001+72 – 12016+29 STA 12182+33 – 12199+00 MVP-MN-268/268.01/274 ATWS 473/474/1375/1446/704	Weather (Wet/Dry/Rain):	Wet

FIELD INSPECTION PHOTO LOG

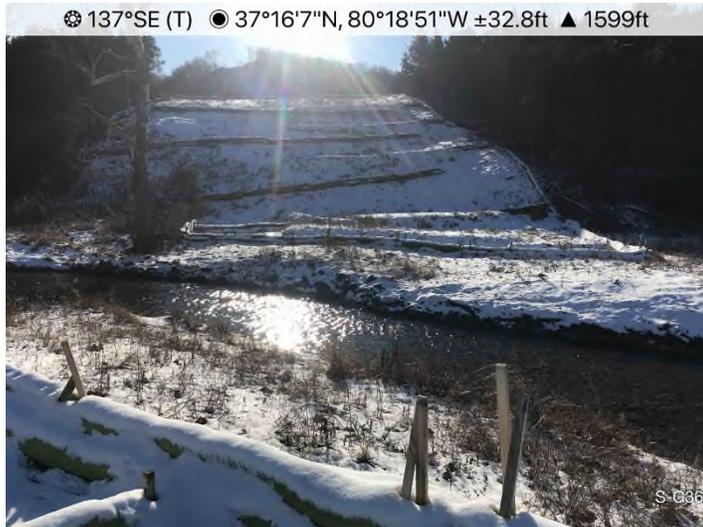
Fig. 1: **Stream S-G36** – Controls in place and functioning properly along the North Fork Roanoke River.

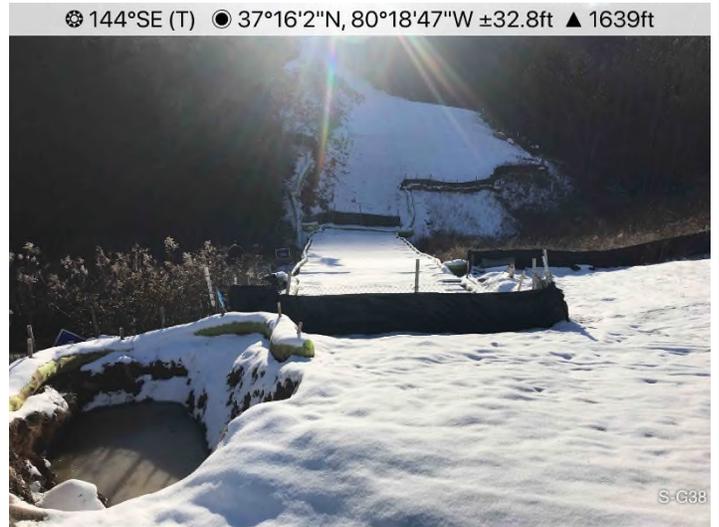
Fig. 2: **Stream S-G38** – Controls in place and functioning properly.

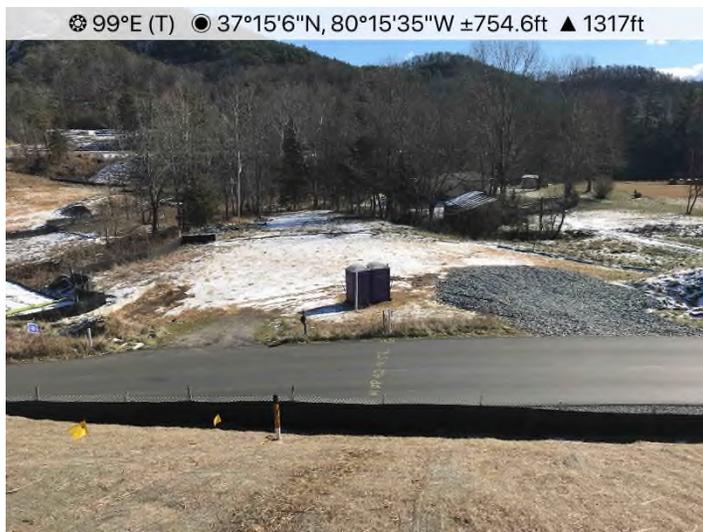
Fig. 3: **STA 12190+00** – Bradshaw Road crossing controls in place and functioning properly.

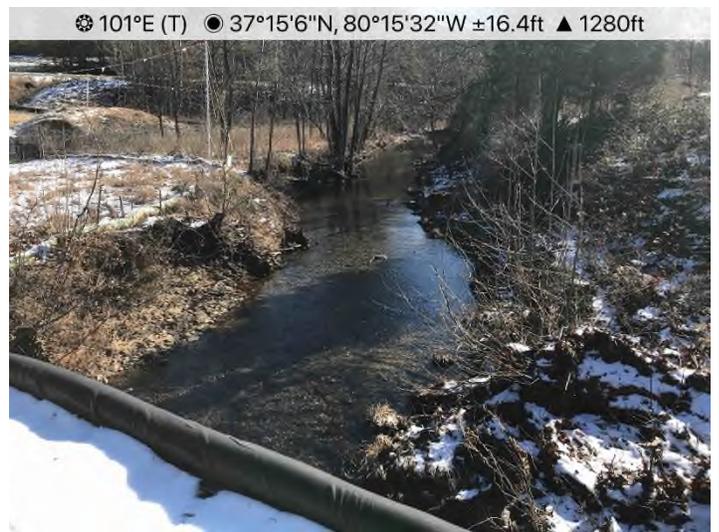
Fig. 4: **Stream S-C21** – Controls in place and functioning properly at Bradshaw Creek crossing.
