FIELD INSPECTION

Project Name:	Mountain Valley Pipeline	Inspector:	Matthew Grant
Inspection Date:	Thursday, October 10, 2019	Project Contact:	Brian Clauto
Spread: Franklin County MP252.6-252.1 St13338+00-13260 ATWS 1055	Spread H	Weather (Wet/Dry/Rain):	Dry

FIELD INSPECTION PHOTO LOG

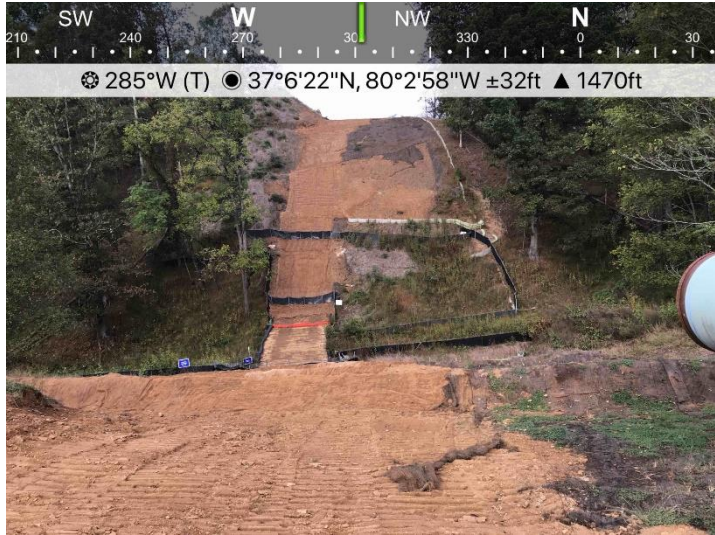
- Fig. 1 Above designated stream S-GH9, ECD's are in place and functioning

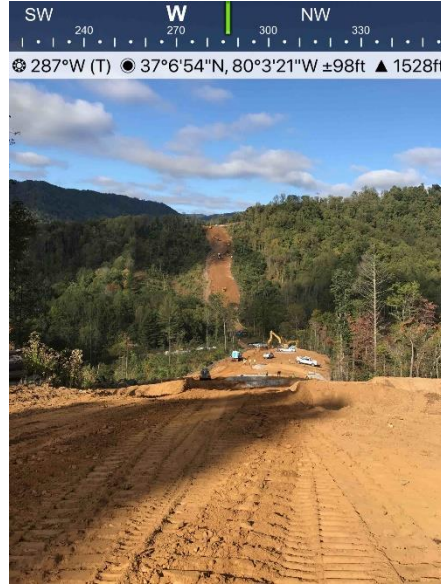
- Fig. 2 Near St13275+00 waterbars are being constructed and stabilized.

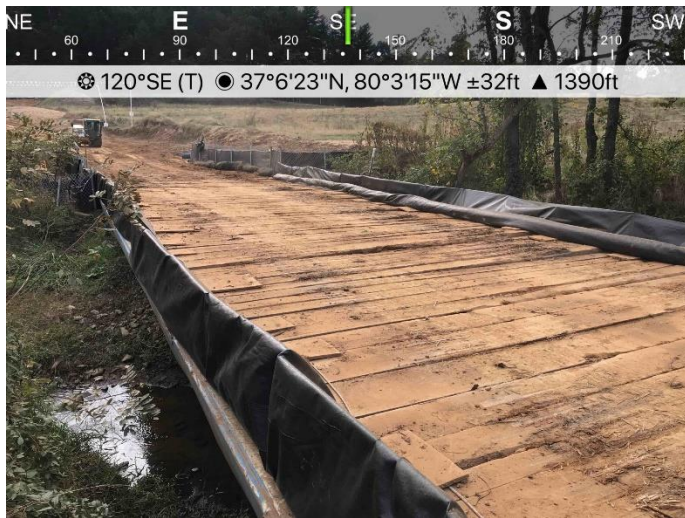
- Fig. 3 At designated stream S-GH7 controls are in place per active construction, no impacts were observed.

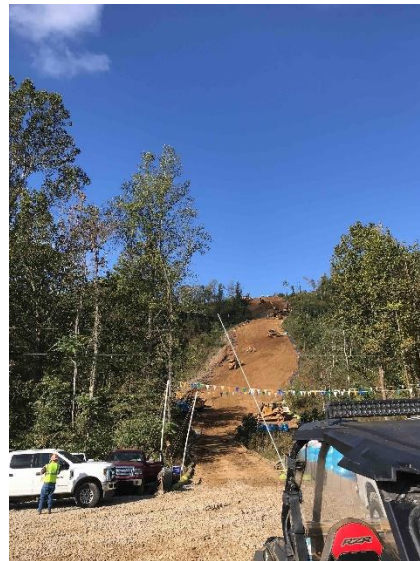
- Fig. 4 Near ATWS1055 and designated stream S-II4, ECD's are in place and functioning per active construction.
