## FIELD INSPECTION

| <b>Project Name:</b> | Mountain Valley Pipeline | <b>Inspector:</b> | Matthew Grant |
| <b>Inspection Date:</b> | Thursday, October 25, 2018 | <b>Project Contact:</b> | Brian Clauto |

## FIELD INSPECTION PHOTO LOG

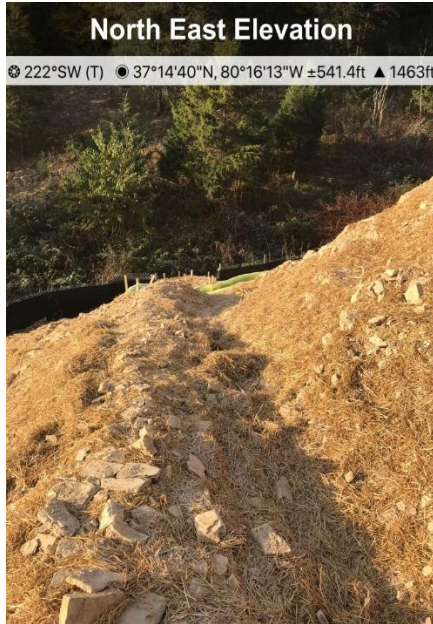
- Fig. 1 St#12158 water bar flow path requires maintenance

**Recommended Corrective Action:** replace and maintain all controls per the annual standard and specs.

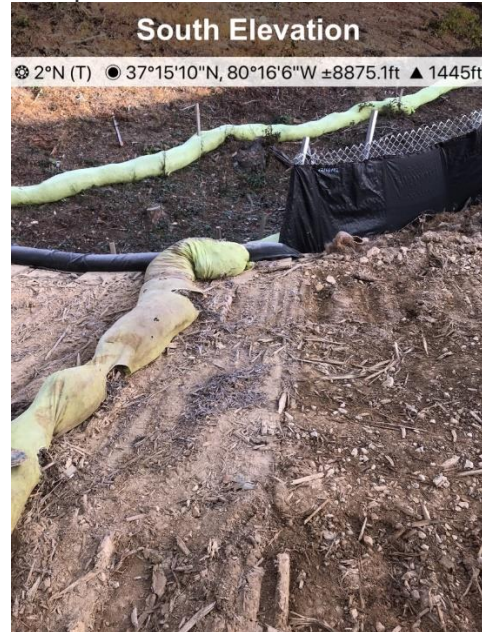
- Fig. 2 St#12167 silt sock is torn and requires replacement

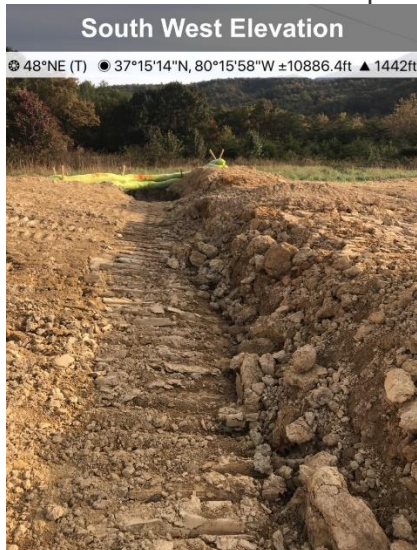
- Fig. 3 St#12184+60 waterbar requires maintenance and to be re constructed per the spec.

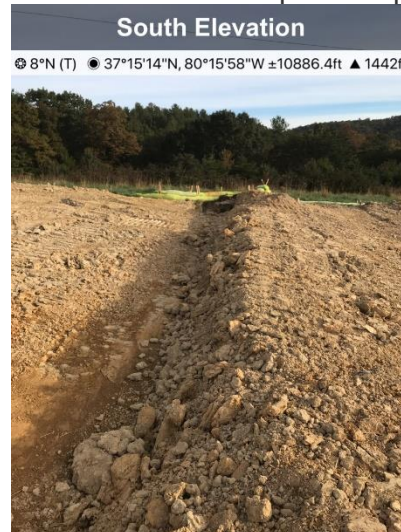
- Fig. 4 St#12185+58 waterbar requires maintenance and to be re constructed per the spec
