FIELD INSPECTION

Project Name:	Mountain Valley Pipeline	Inspector:	Marshall Willis
Inspection Date:	Thursday, October 3, 2019	Project Contact:	Brian Clauto, Cory Chalmers
Spread H: Roanoke County	MVP-RO-288 STA 12994+02 – 13012+63 ATWS 1309/1310	Weather (Wet/Dry/Rain):	Dry

FIELD INSPECTION PHOTO LOG

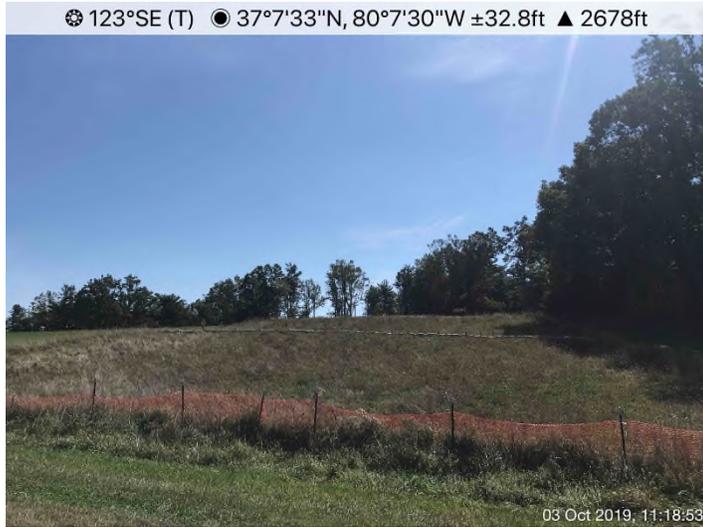
Fig. 1: **STA 13012+74** – Controls in place and appear to be functioning properly. Area stabilized.

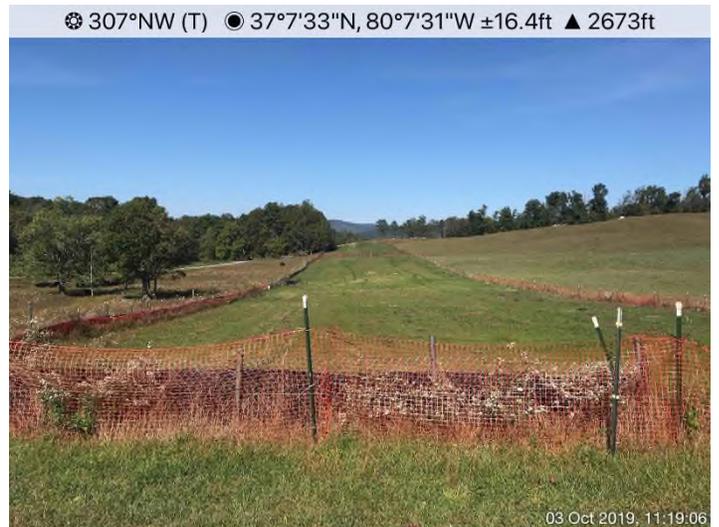
Fig. 2: **STA 13012+53** – Controls in place and appear to be functioning properly. Area stabilized.

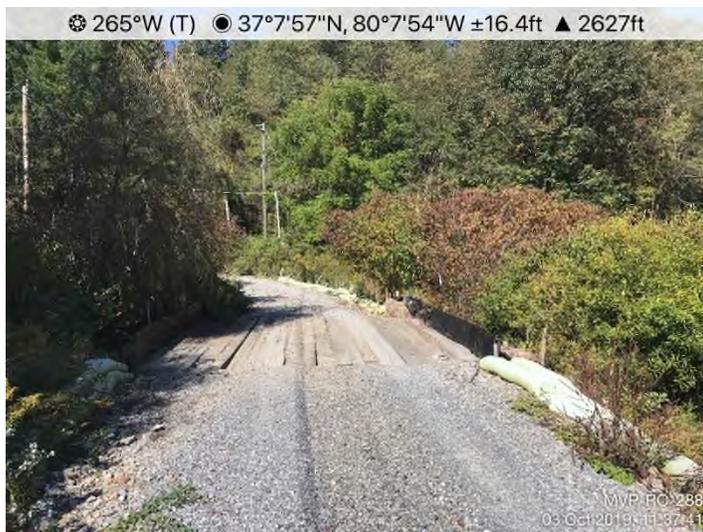
Fig. 3: **MVP-RO-288** – Stream S-Q20 crossing. Controls in place and functioning properly.

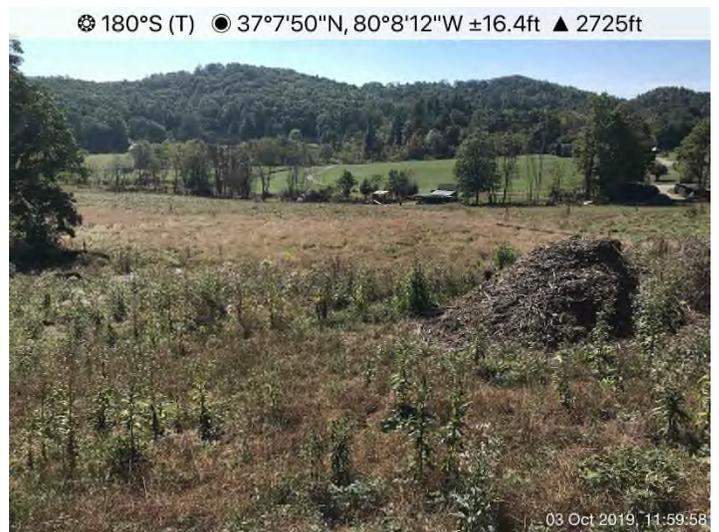
Fig. 4: **12973+43** – Controls in place. Area stabilized.
