FIELD INSPECTION

Project Name:	Mountain Valley Pipeline	Inspector:	Matthew Grant
Inspection Date:	Thursday, November 21, 2019	Project Contact:	Brian Clauto
Spread: Montgomery Co. MP 229-231 AR 270.01 ATWS1062 ATWS 10446 ATWS 704A	Spread H	Weather (Wet/Dry/Rain):	Dry

FIELD INSPECTION PHOTO LOG

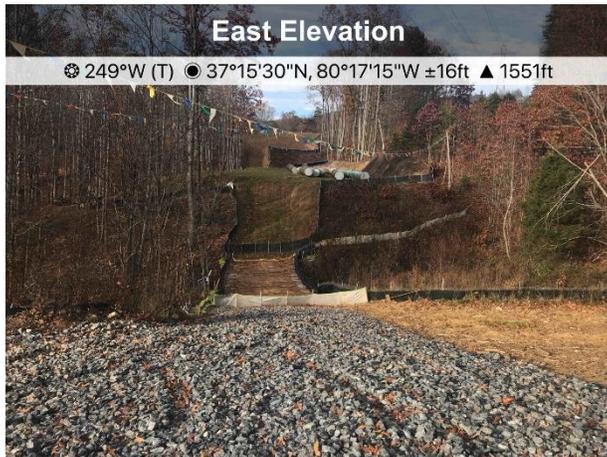
- Fig. 1. Above designated stream S-MM11, ECD's in place and functioning.

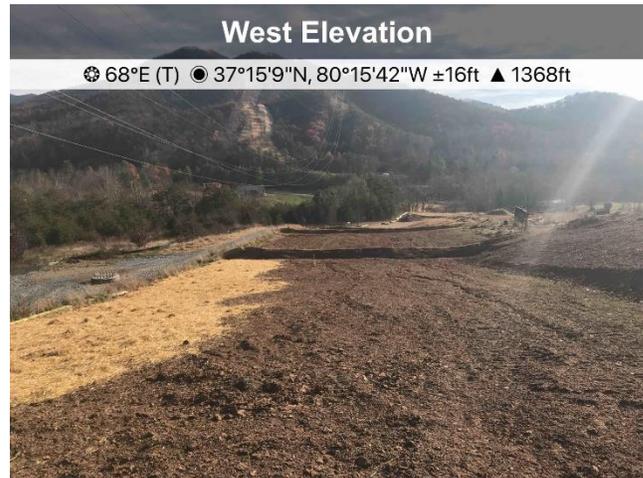
- Fig. 2. Near MP 230.6 area has been stabilized with straw and proganics.

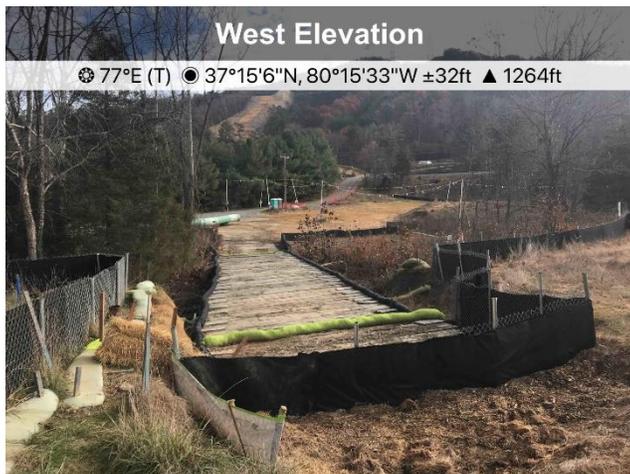
- Fig. 3. At designated stream S-C21, ECD's are in place and functioning.

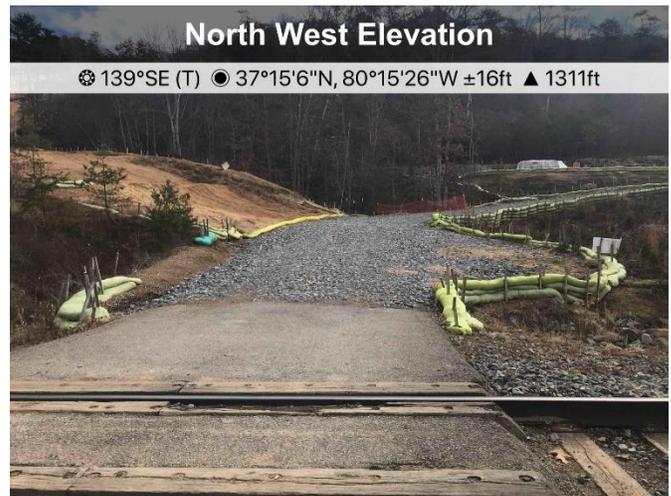
- Fig. 4. Near MP 230.8 ECD's are in place and functioning.
