FIELD INSPECTION

Project Name:	Mountain Valley Pipeline	Inspector:	Marshall Willis
Inspection Date:	Thursday, November 21, 2019	Project Contact:	Brian Clauto, Cory Chalmers
Spread H: Montgomery County	STA 12102+69 – 12203+82 MVP-MN-271/270.01/274 ATWS 703/704/704A/1375	Weather (Wet/Dry/Rain):	Dry

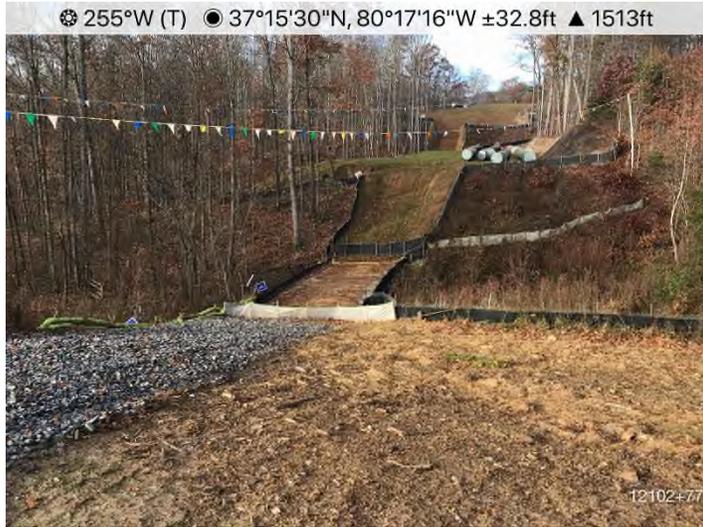
Fig. 1: **STA 12102+77** – Controls in place and functioning. Area stabilized.

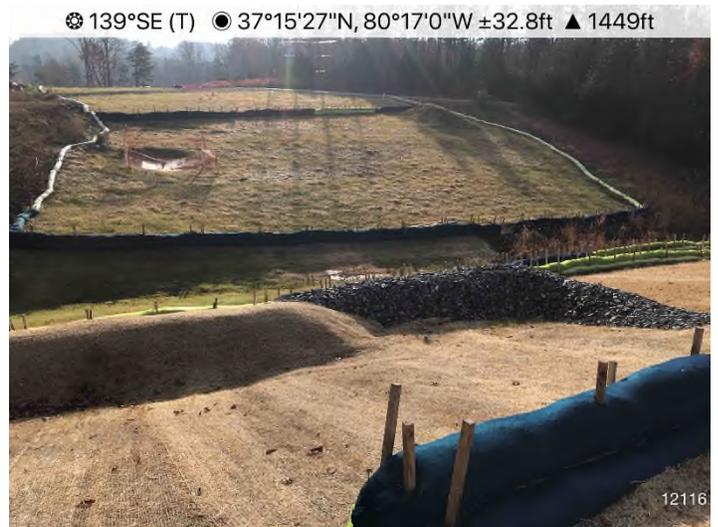
Fig. 2: **STA 12115+00** – Controls in place. Area stabilized with straw and erosion control matting.

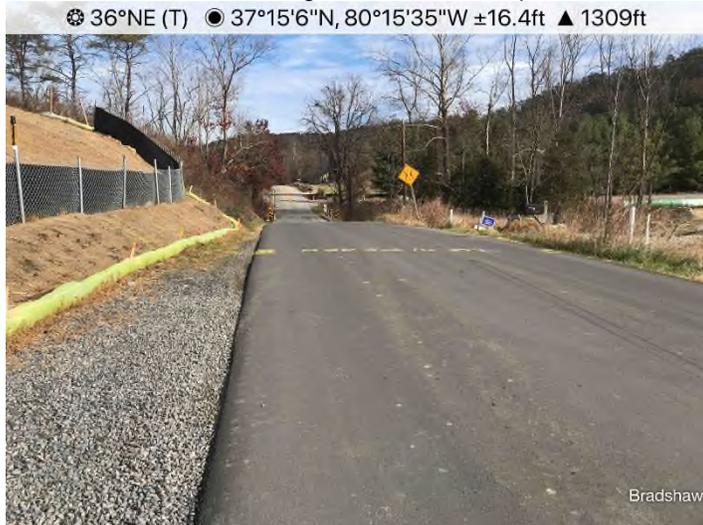
Fig. 3: **STA 12190+85** – Controls in place along Bradshaw Road. Controls functioning at the time of inspection.

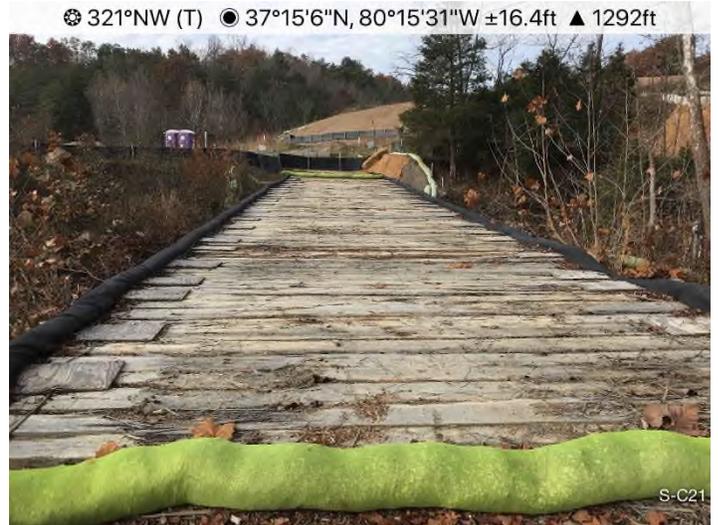
Fig. 4: **S-C21** – Controls in place and functioning along Bradshaw Creek.
