FIELD INSPECTION

Project Name:	Mountain Valley Pipeline	Inspector:	Matthew Grant
Inspection Date:	Thursday, November 29, 2018	Project Contact:	Brian Clauto
Spread: Franklin County MP 252 St#13317-13362	Spread H	Weather (Wet/Dry/Rain):	Wet

FIELD INSPECTION PHOTO LOG

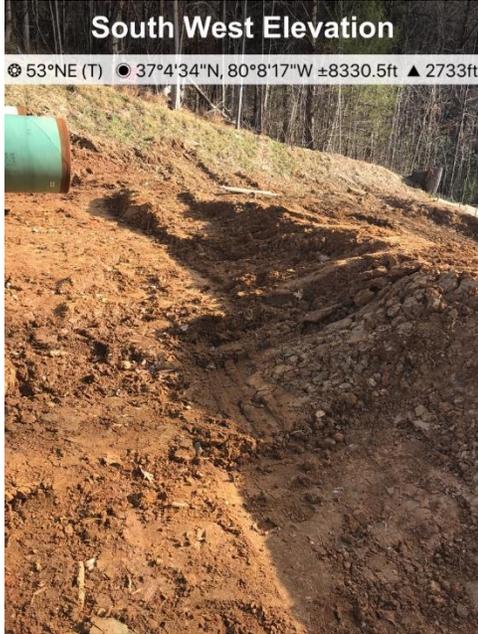
- St#13336+00 waterbar not built to spec

- Fig. 1 St#13336+00 waterbar not built to spec

Recommended Corrective Action: repair and maintain all controls per the approved plan.

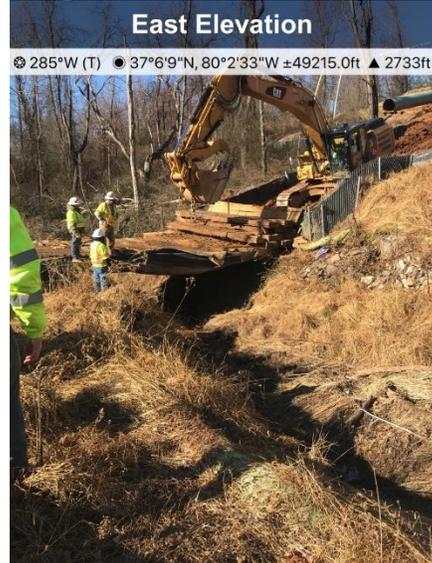
- Fig. 2 designated stream SRR-11 bridge maintenance was being conducted

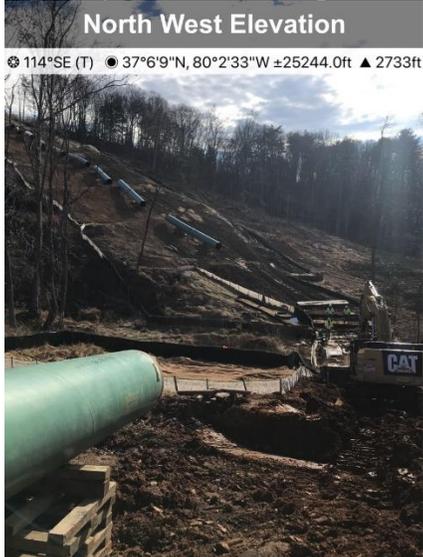
- Fig. 3 Pipe has been strung near Webster's Corner
