## FIELD INSPECTION

<b>Project Name:</b>	Mountain Valley Pipeline	<b>Inspector:</b>	Marshall Willis
<b>Inspection Date:</b>	Tuesday, December 10, 2019	<b>Project Contact:</b>	Brian Clauto, Cory Chalmers
<b>Spread H: Montgomery County</b>	STA 12175+00 – 12190+85 ATWS 703 MVP-MN-274	<b>Weather (Wet/Dry/Rain):</b>	Rainy

## FIELD INSPECTION PHOTO LOG

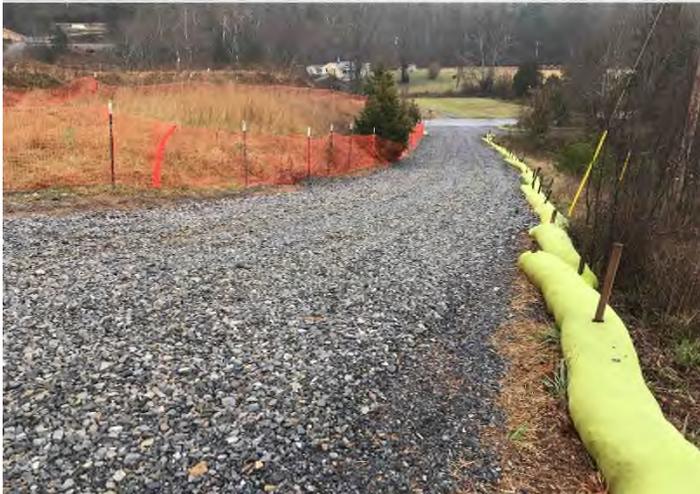
Fig. 1: **MVP-MN-273** – Controls in place and properly functioning along MVP-MN-273.

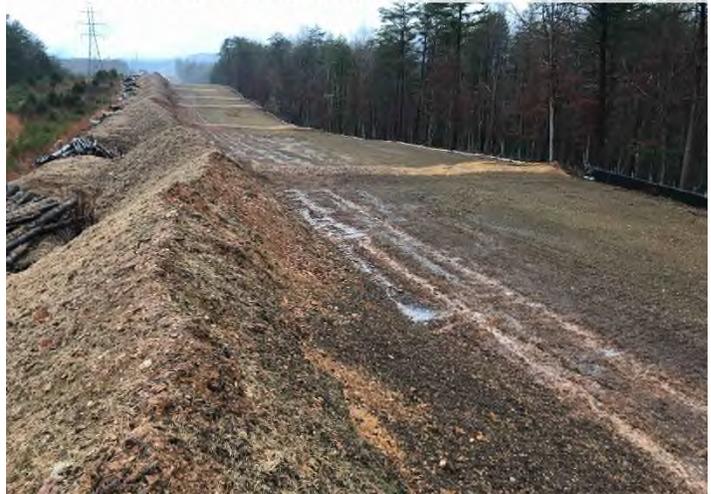
Fig. 2: **STA 12178+00** – Controls in place and functioning properly. Area stabilized with hydro-mulch and erosion fabric.

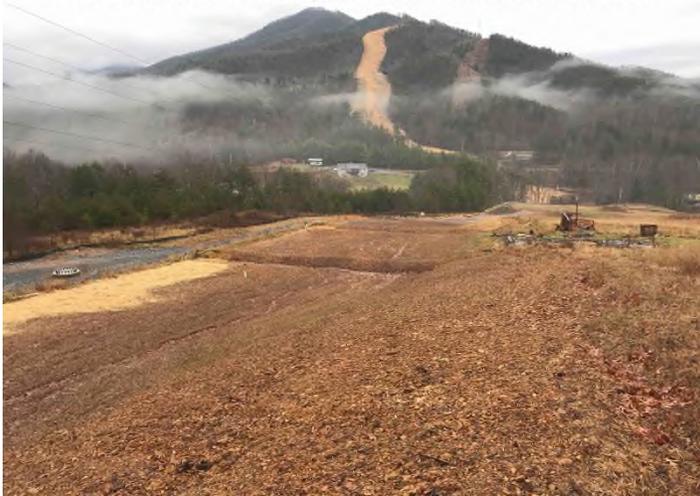
Fig. 3: **STA 12183+33** – Controls in place and functioning. Area stabilized with seed, straw and hydro-mulch.

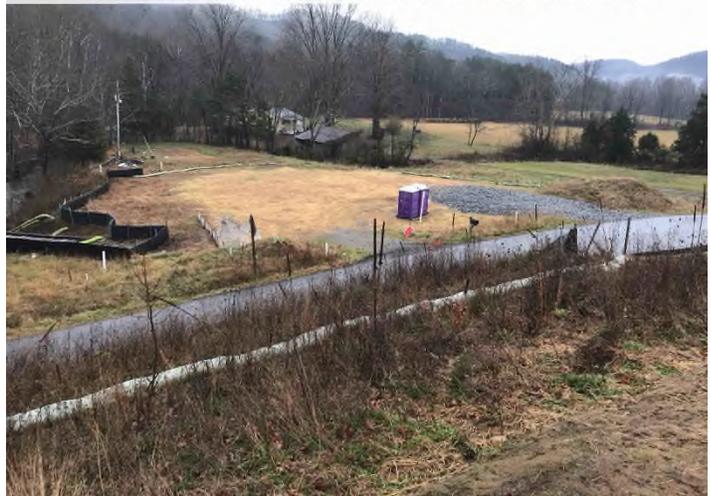
Fig. 4: **Bradshaw Road** – Controls in place and properly functioning along Bradshaw Road.
