FIELD INSPECTION

Project Name:	Mountain Valley Pipeline	Inspector:	Marshall Willis
Inspection Date:	Friday, December 27, 2019	Project Contact:	Brian Clauto, Cory Chalmers
Spread H: Franklin County	STA 13316+13 – 13415+51 ATWS 1352	Weather (Wet/Dry/Rain):	Dry

FIELD INSPECTION PHOTO LOG

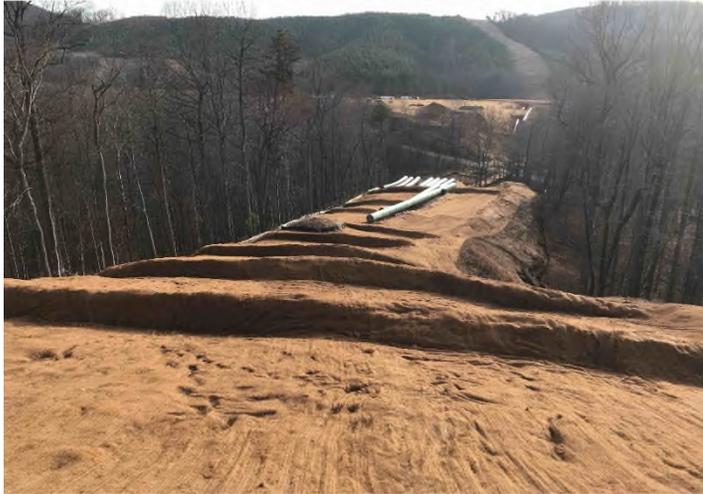
Fig. 1: **STA 13403+00** – Controls in place and properly functioning. Area stabilized with erosion matting.

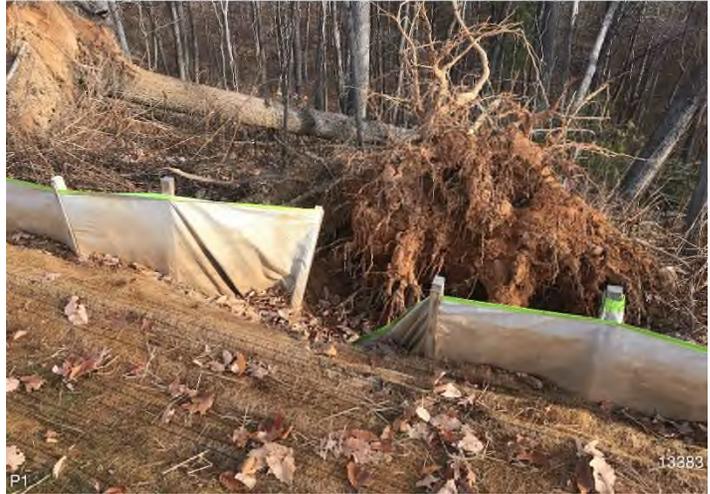
- STA 13383+00: P1 maintenance needed.

Fig. 2: **STA 13383+00** – P1 maintenance needed.

Recommended Corrective Action: Maintain and install all controls per the approved plans and PSS&S.

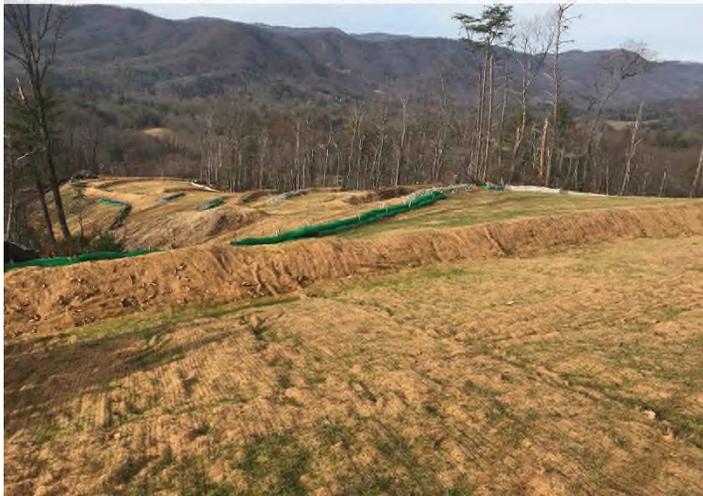
Fig. 3: **STA 13371+00** – Controls in place and functioning. Area stabilized with erosion matting.

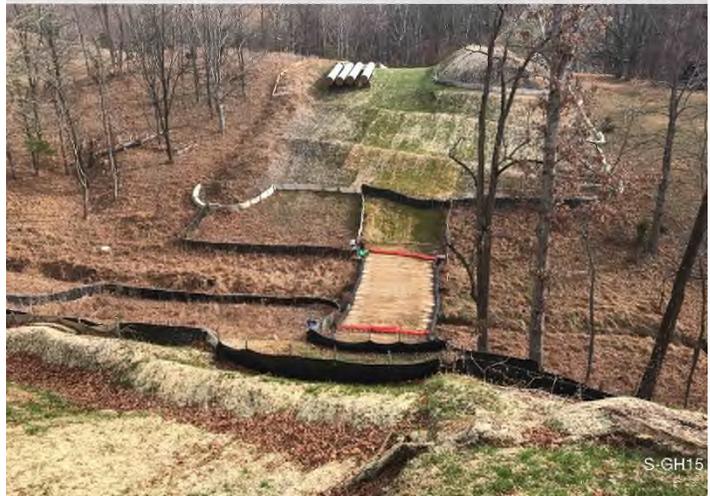
Fig. 4: **Stream S-GH15**– Controls in place and properly functioning along stream S-GH15. Area stabilized with erosion matting.
