FIELD INSPECTION

Project Name:	Mountain Valley Pipeline	Inspector:	Marshall Willis
Inspection Date:	Wednesday, December 4, 2019	Project Contact:	Brian Clauto, Cory Chalmers
Spread H: Montgomery County Roanoke County	STA 12545+19 – 12544+06 MVP-MN-278.01/RO-270.01 MVP-MLV-AR-28	Weather (Wet/Dry/Rain):	Wet

FIELD INSPECTION PHOTO LOG

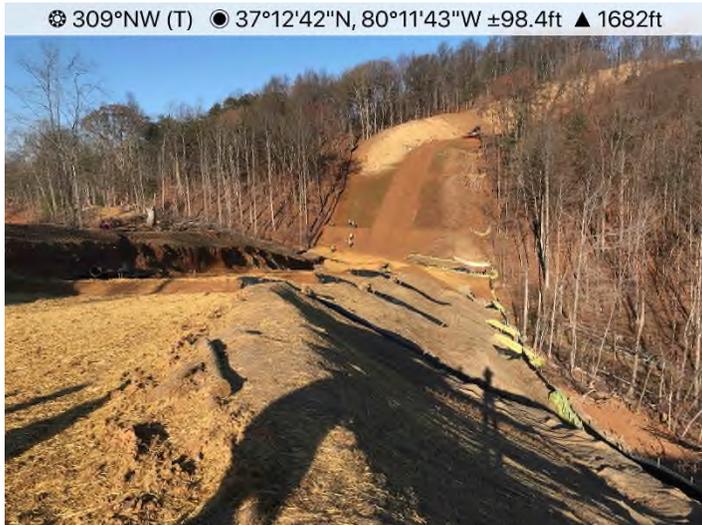
Fig. 1: **STA 12536+50** – Controls in place and functioning properly.

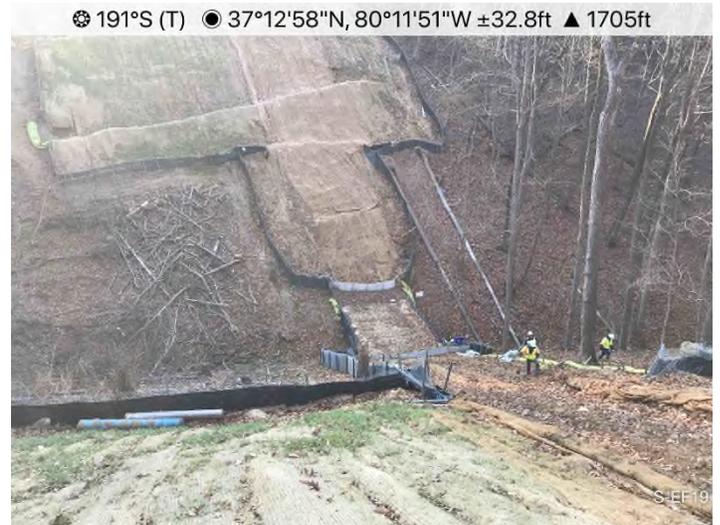
Fig. 2: **STA 12518+50** – Controls in place along Stream S-EF19.

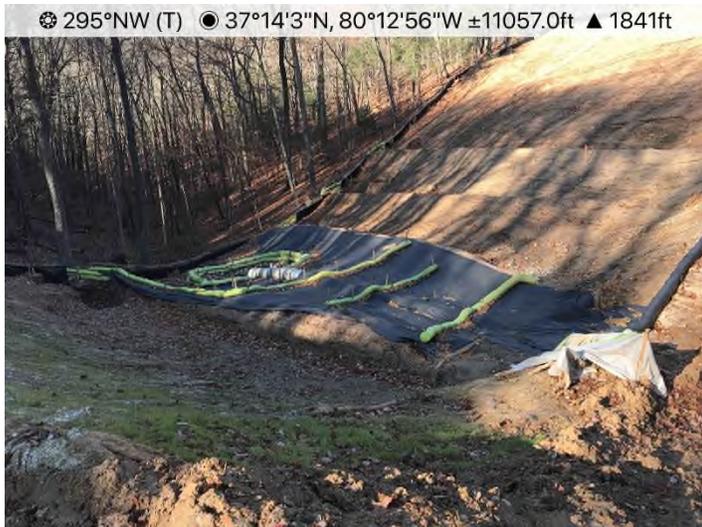
Fig. 3: **STA 12502+00** – Controls in place and functioning properly.

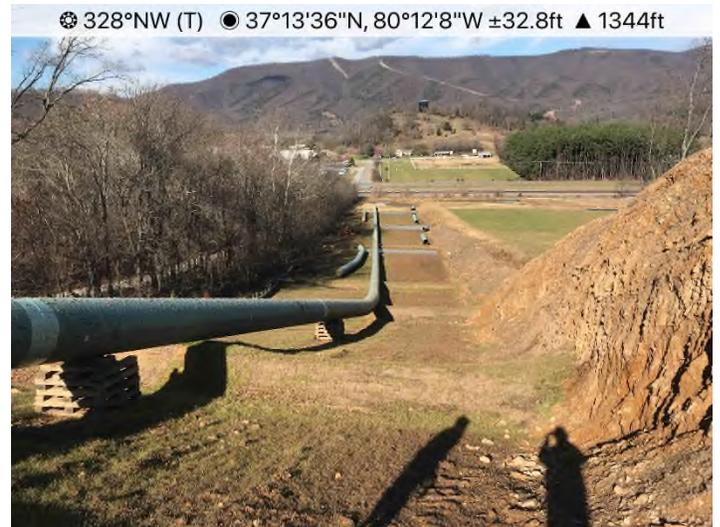
Fig. 4: **STA 12471+00** – Controls in place and functioning properly.
