FIELD INSPECTION REPORT

Project Name:	Mountain Valley Pipeline	Inspector:	Matthew Grant
Inspection Date:	Tuesday, February 11, 2020	Project Contact:	Brian Clauto,
Spread H: Montgomery	MP 230-229 ATWS 701,1168, 1167, AR-270, 272, 273	Weather:	Rainy

FIELD INSPECTION PHOTO LOG

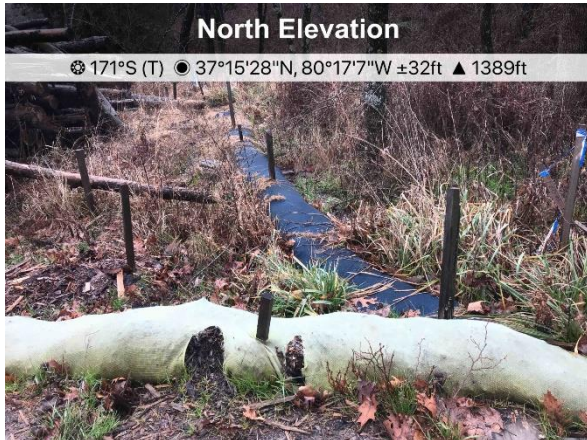
Figure 1: St12109+70 CFS requires maintenance.

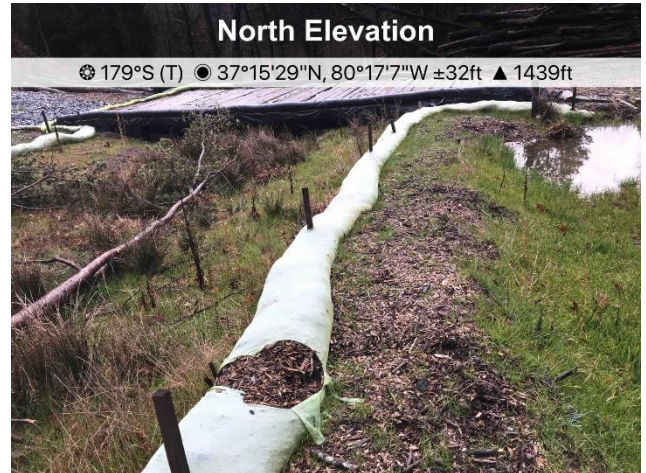
Figure 2: St12110+00 CFS requires maintenance.

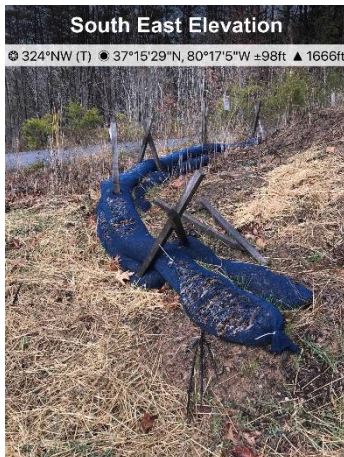
Figure 3: St1211+50 CFS triple stack requires maintenance

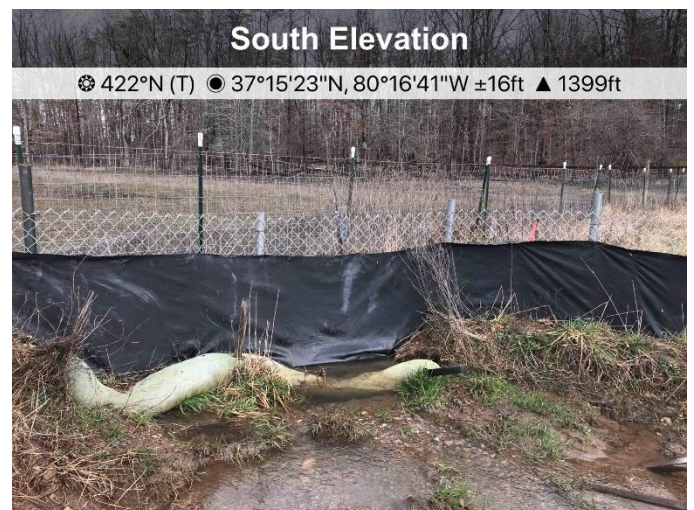
- St17132+00 silt fence has been undermined and requires repair.

Figure 4: St17132+00 silt fence has been undermined and requires repair.

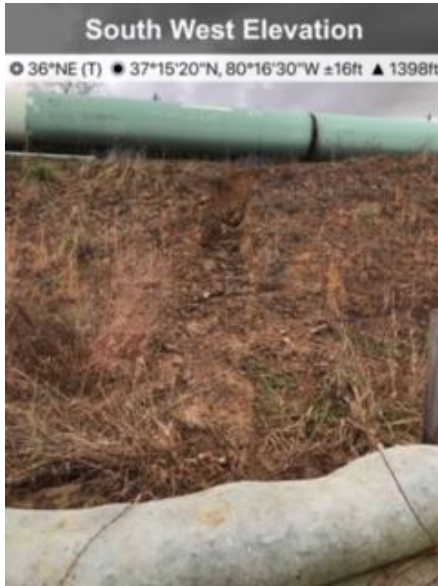
- Figure 5: St12141+00 fill slope has eroded and requires repair & stabilization.
