FIELD INSPECTION REPORT

Project Name:	Mountain Valley Pipeline	Inspector:	Marshall Willis
Inspection Date:	Tuesday, February 11, 2020	Project Contact:	Brian Clauto, Cory Chalmers
Spread H: Montgomery County	STA 12101+57 – 12153+28 MVP-MN-270.01/272/273 ATWS 701	Weather:	Rainy

FIELD INSPECTION PHOTO LOG

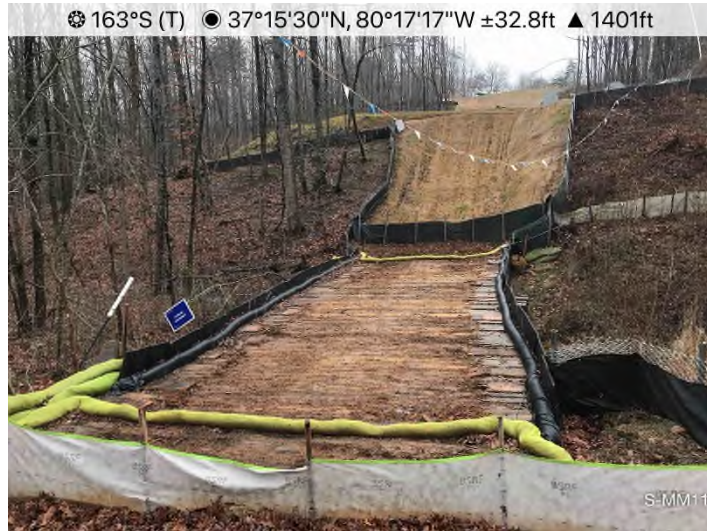
Figure 1: Stream S-MM11 – Controls in place and functioning properly around stream S-MM11.

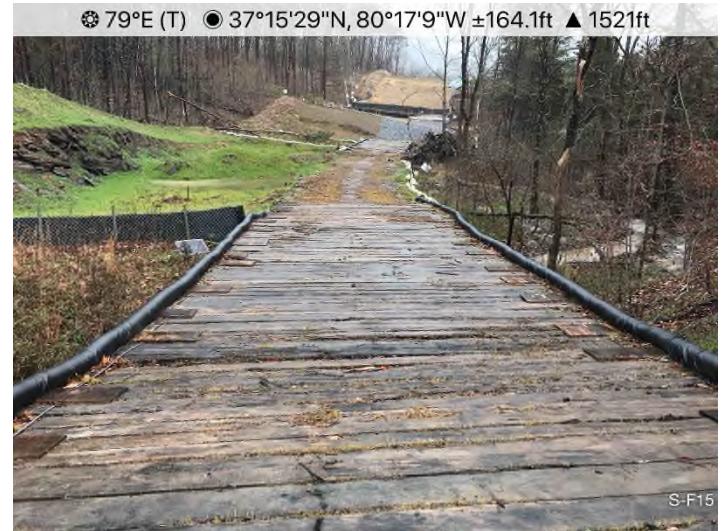
Figure 2: Stream S-F15 – Controls in place and functioning properly around stream S-F15.

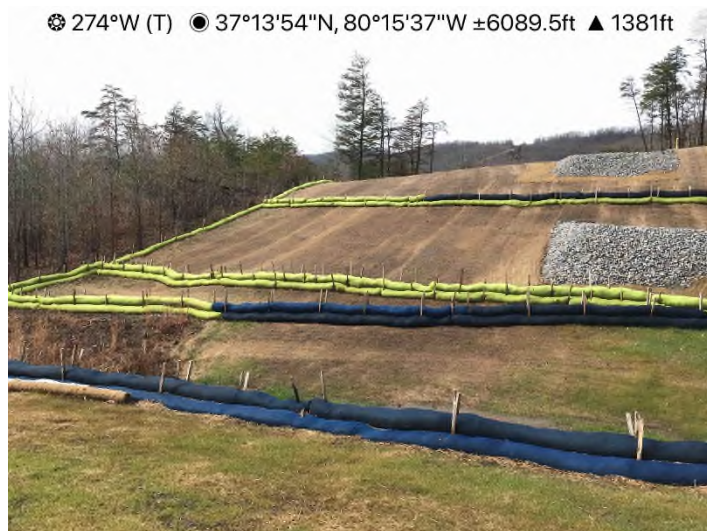
Figure 3: STA 12117+50 – Controls in place and functioning properly.

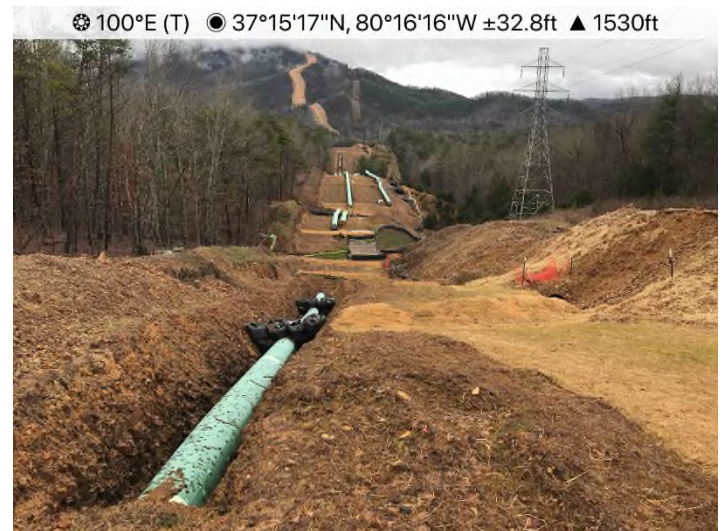
Figure 4: STA 12154+00 – Controls in place and functioning properly.
